4545 Linden Lane, Minneapolis, MN. 55014

Reliable Enterprises Home Inspections & Appraisals  
Ross Brown ASHI Certified

#### SUMMARY OF AREAS REQUIRING FURTHER EVALUATION

Report #1140.  
*Inspection Date:* 10/14/2010.  
*Client:* Amy Androle.  
*Inspection Site:* 4545 Linden Lane, Minneapolis, MN. 55014.  
*House Occupied?* Yes.  
*People Present:* Purchaser, Family Member and owner.

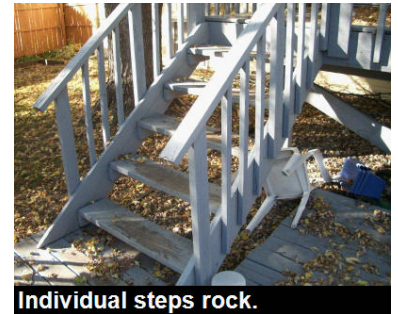
Wood. **Vertical balusters should not have more than a 4 inch gap.**  
**The steps are loose.** The deck is in useable condition.

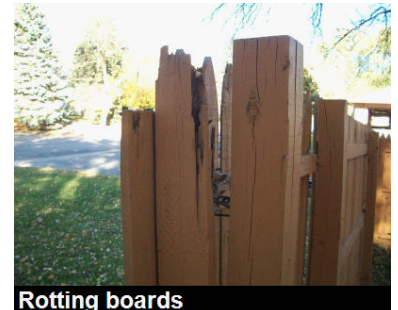
**Missing sections and boards- rot also noted.**  
**The fencing is not performing its intended function. Repair or replacement is suggested.**

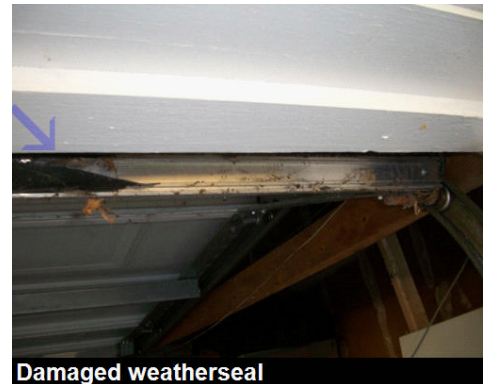
The overhead door is in satisfactory condition, and functional. **No electric eye sensors. Weather seal is damage.**

Damaged weatherseal

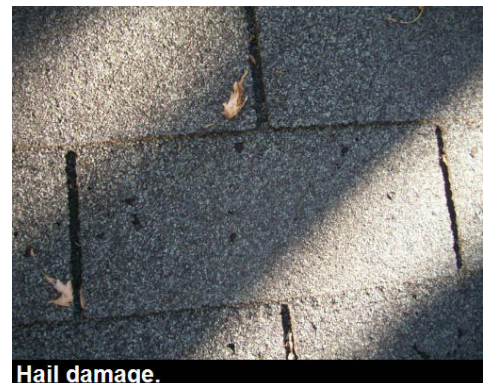
Type Roof:	Gable.
Roof Covering Materials:	Asphalt composition shingles.
Condition of Roof:	The roof is functional. <b>There are areas of the roof that appear to have hail damage.</b> These areas have less tree cover, near the chimney and the garage.
Estimated Age of Roof:	15 Years.
Flashings:	Metal. Plastic. The flashings around openings in the roof covering appear functional.
Means of Roof Inspection:	The roof covering was inspected by walking on the roof.
Valleys:	The valleys appear to be in satisfactory condition.
Roof Gutter System:	Full set of gutters and downspouts. <b>The gutters are not functioning properly because of debris.</b> The gutter system on the roof edge appears to be functional and adequately sloped to carry the water to the downspouts and away from the house.

**Hail damage noted.** The garage roof is in functional condition.

Hail damage.

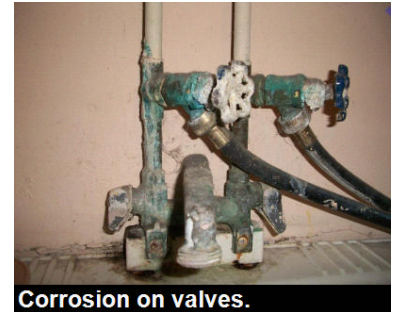
Basement/Utility Room. The laundry plumbing is functional. **Corrosion on the valves.** Grounded outlets. 220 volt outlet is provided.

**Corrosion on valves.**

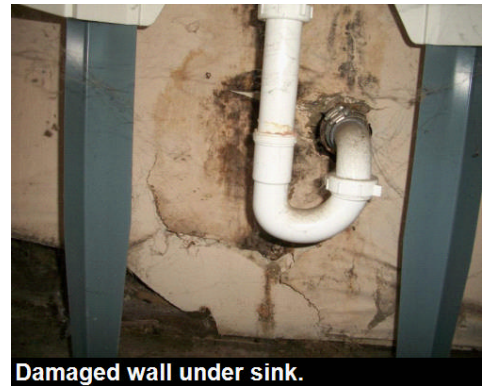
The sink is functional. **Damage under the sink.**

**Damaged wall under sink.**

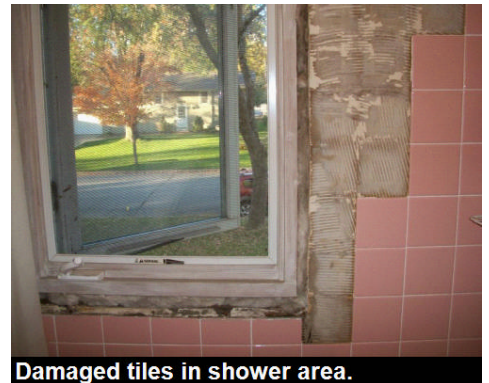
**The wall has tile damage.**

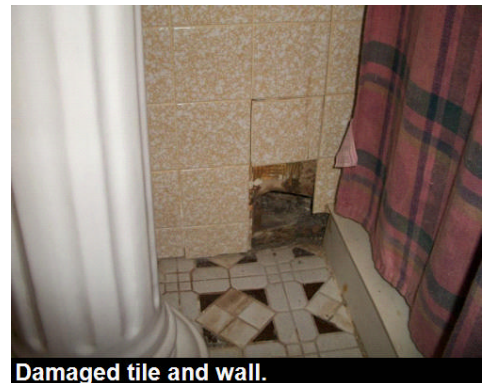
The sink and drainage fixture appears to be satisfactory. **The sink pedestal is at an angle. There is damaged tile and wall under sink. This area of damage is the same wall as the damaged wall under the utility sink.**

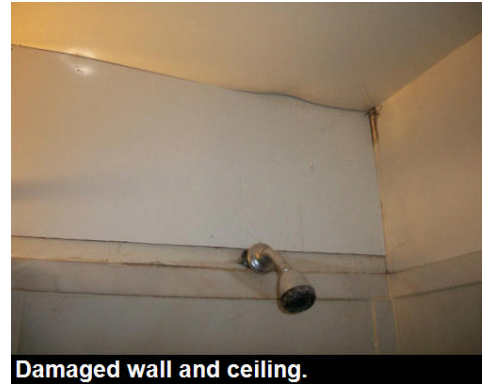
**Damage on wall and ceiling.**

**Damaged wall and ceiling.**

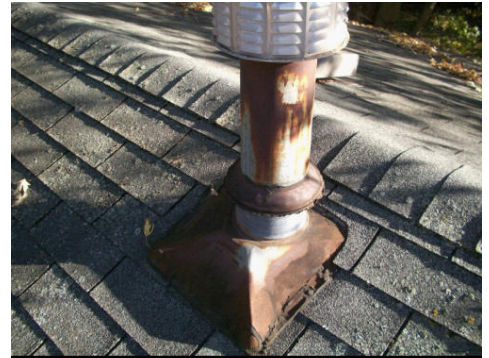
The chimney is metal. **Rust noted.**

**Rust on chimney.**

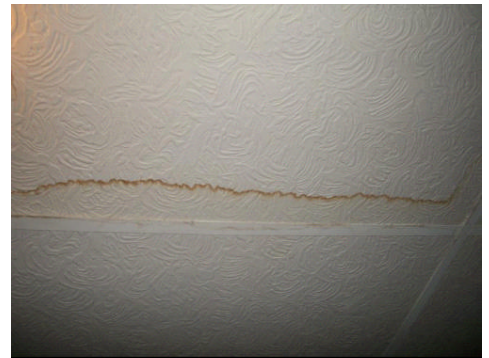
Drywall. Suspended. **Moisture stains noted on basement bedroom ceiling panels. No moisture detected.**

**Moisture stains.**

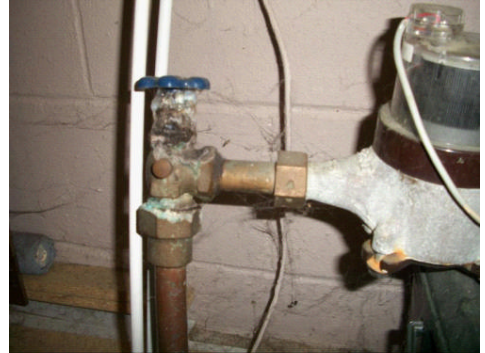
*Main Water Line Shutoff Location:* Basement/Utility room. **Corrosion on main shut off valve.**

**Corroded shut off valve.**

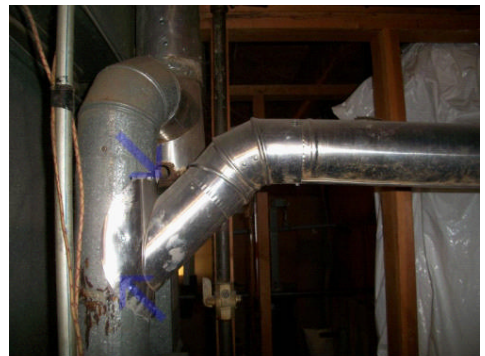
*Flue/Exhaust Pipe Condition:* **The exhaust flue appears to be improperly installed. 1 screws instead of 3 at vent pipe connections. The exhaust flue goes down instead of up and has a poor connection.**

**The exhaust flow goes down instead of up.**
