Roof Inspection for : [REDACTED]

Job Address : [REDACTED]

I inspected this roof on August 28th, 2021. This was our 2nd visit. We got on the roof. The roof is a new 30 year laminated asphalt shingle in the gray color. One layer over plywood. Separate photo emails will be sent. Each photo email will be numbered to correspond to the numbered items on the summary report. The following items should be noted :

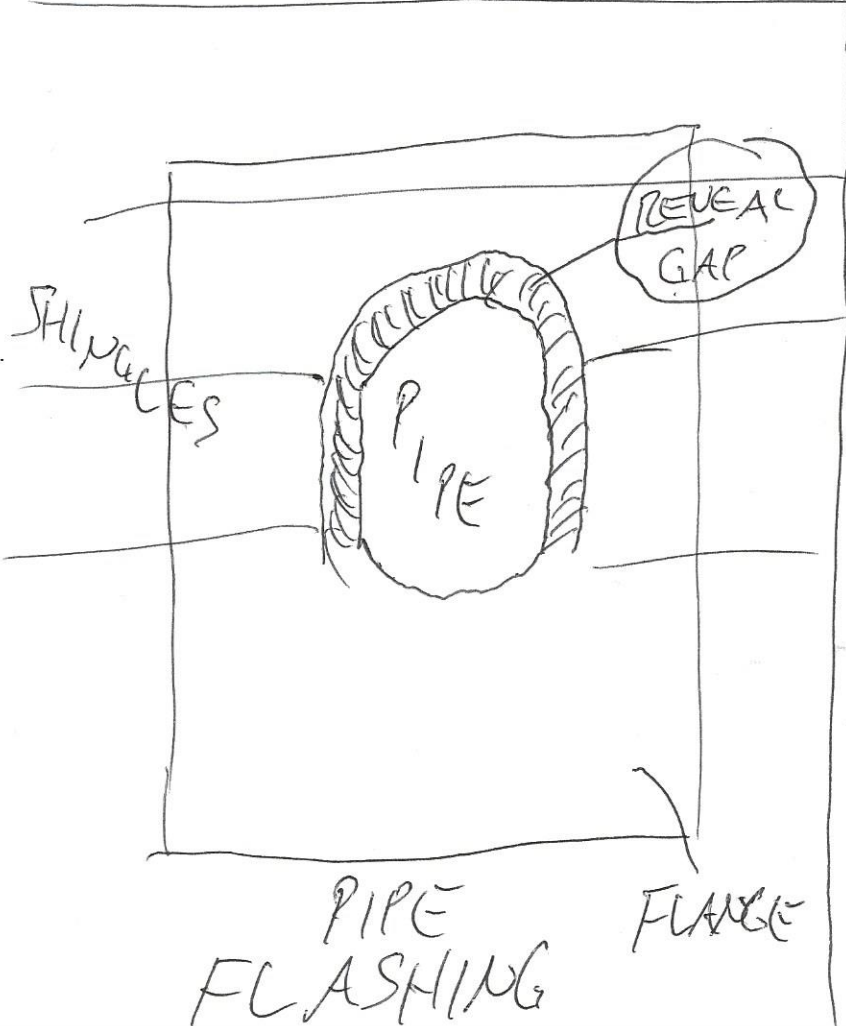
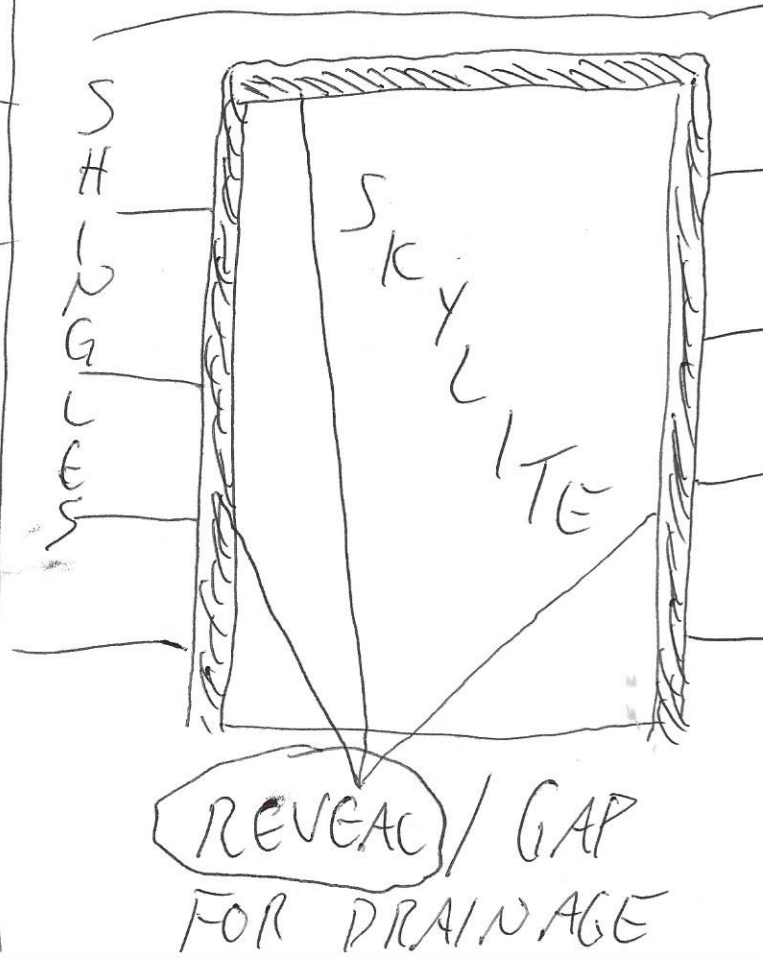
STEM VENT

1. Shingles are up tight against the sides of the skylites, stem vents, and pipe flashings. There should be a 1/2" +- 'reveal' (gap) here to allow for drainage. This is an industry standard. Over time debris/moss will accumulate here and tight shingles could create a dam and divert water where you don't want water to go.
