TRIENNIAL INSPECTION
OF PIER 3 NORTH
ALONG DELAWARE RIVER
PHILADELPHIA, PENNSYLVANIA
October 2022

Prepared For:
Pier 3 Condominium Association
3 N. Columbus Boulevard
Philadelphia, PA 19106

Prepared By:
W.J. Castle, P.E. & Associates, P.C.
1345 Route 38 West
Hainesport, NJ 08036
WJC No. 2631

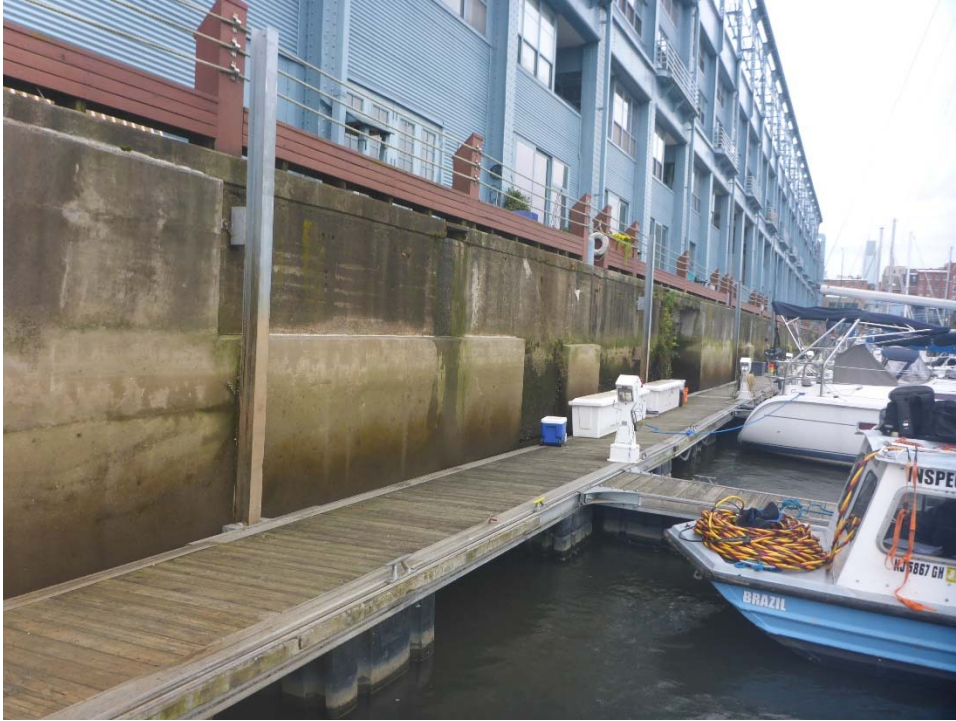
The upriver seawall exhibits significantly greater deterioration (**Photos 2, 5 & 6**). Several sections of the seawall have recently been repaired on the outshore and upriver faces of the pier (**Photos 1 & 3**). Repaired sections were typically found to be intact. The bottom 4'-0" of the un-repaired seawall was typically observed to have 1" deep general erosion with localized deeper erosion pockets. The deeper erosion pockets at the bottom of the seawall were most prominent at approximately 3-5 ft. inshore and outshore of each of the four (4) wharf drops (**Photo 5**). Spalling with 8" to 15" loss of section and rounding of edges was also observed at the inshore and outshore corners of seawall at each wharf drop. There were four (4) full height cracks with spalling at the edges up to 76" W x 12" D (**Photos 2 & 6**). There are two spalls between wharf drops 2 & 3 measuring up to 4' H X 10" D (**Photo 6**). The bottom 4" of the seawall exhibited deep erosion at a few locations, exposing the top of the timber low decking. Localized areas near the top of the seawall exhibited efflorescence.

Photo 1: North face of pier, looking southwest towards WD 4. The seawall is in generally satisfactory condition, with hairline map cracking and light efflorescence throughout. Random areas of the seawall have been repaired.

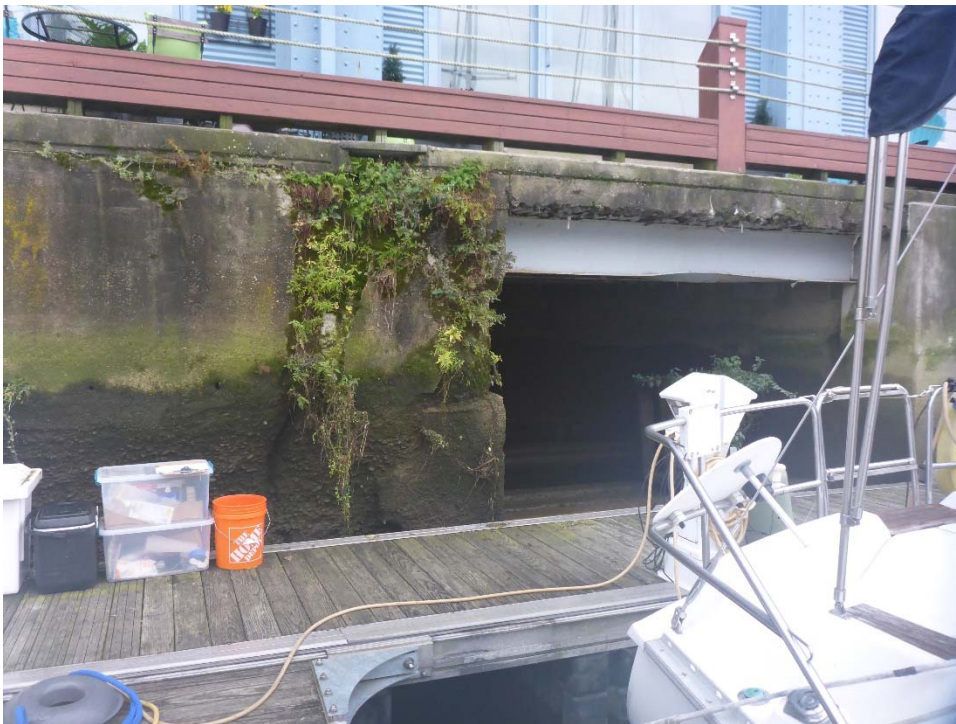
Photo 2: Upper east corner of WD 4, looking south. Full height crack up to 12" deep with significant erosion and spalling at the edges with adjacent hollow area in concrete up to 76" wide. Note heavy vegetation growth. There is ½" to 1" of typical spalling along the top of the wall and moderate abrasion in the lower 4.0'.

- Seawall: patch deep voids and cracks with wide edge spalling along the seawall that create a potential path for loss of fill.

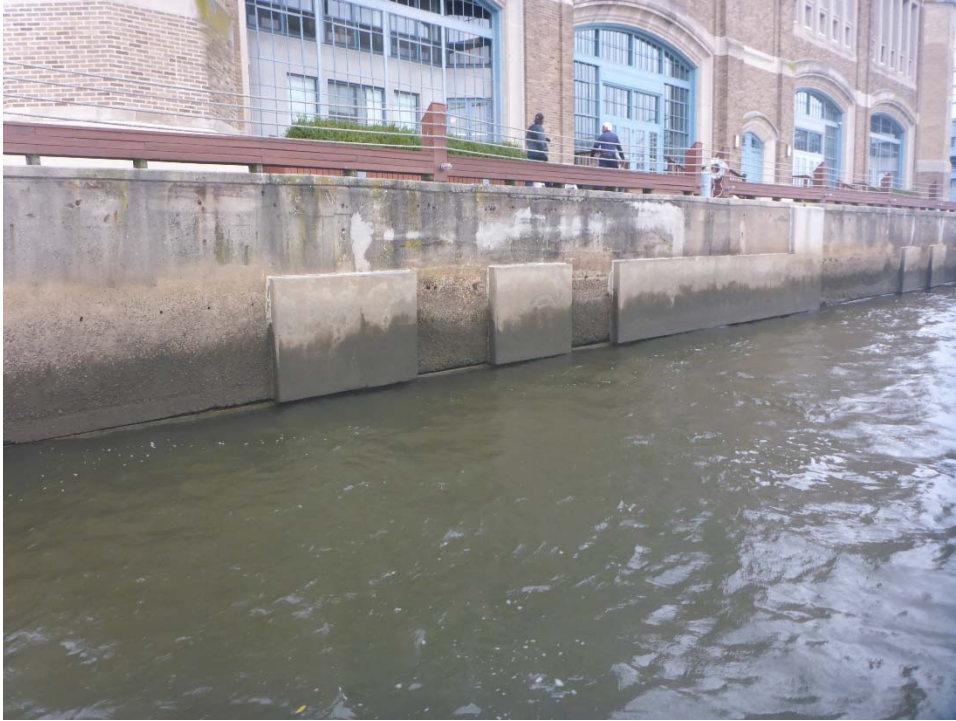
On the outshore face of the pier, multiple sections of the original concrete have recently been repaired. There is abrasion in the lower 4' of the seawall, and deeper erosion just above the timber deck (**Photo 3**).

Photo 3: Typical section of east face of pier, looking northwest. The seawall is in generally satisfactory condition with random areas of repairs. Note abrasion in the lower 4' of the seawall, and erosion just above the timber deck.

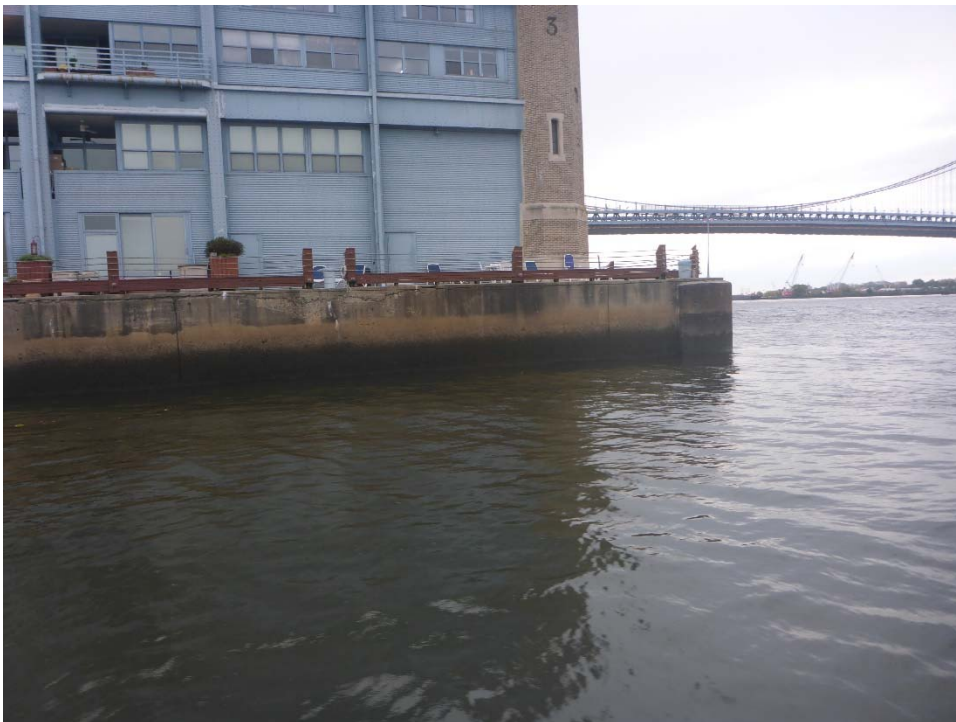
The south face of the pier seawall is in fair condition. There is a typical condition of spalling measuring up to 21" H x 48" W x 6" D with patches generally at the top of the seawall (**Photos 4 & 7**).

Photo 4: Typical section of south face of pier, east end, looking north. The seawall is in generally satisfactory condition. Note abrasion in lower 4' of the seawall.

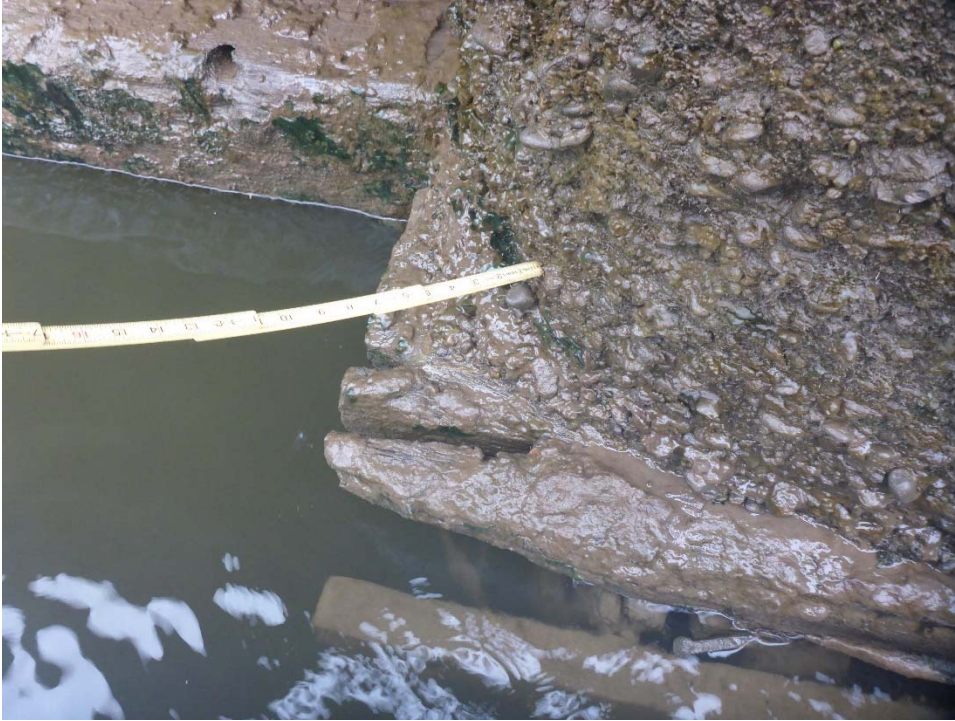
Photo 5: North face, spalling at the west corner of WD 3 measuring 48" H x 8" D with exposed and deteriorated deck. Similar deterioration was observed at each corner of the northern WDs.

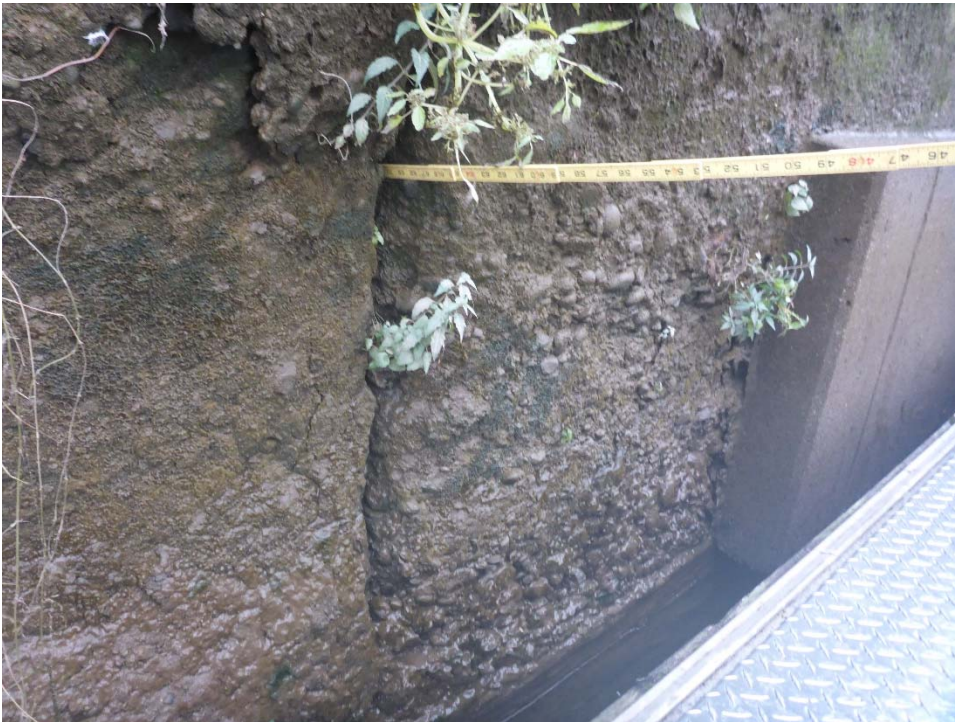
Photo 6: Typical spalling at joint measuring up to 56" H x 4" D approximately 10' west of WD 3.

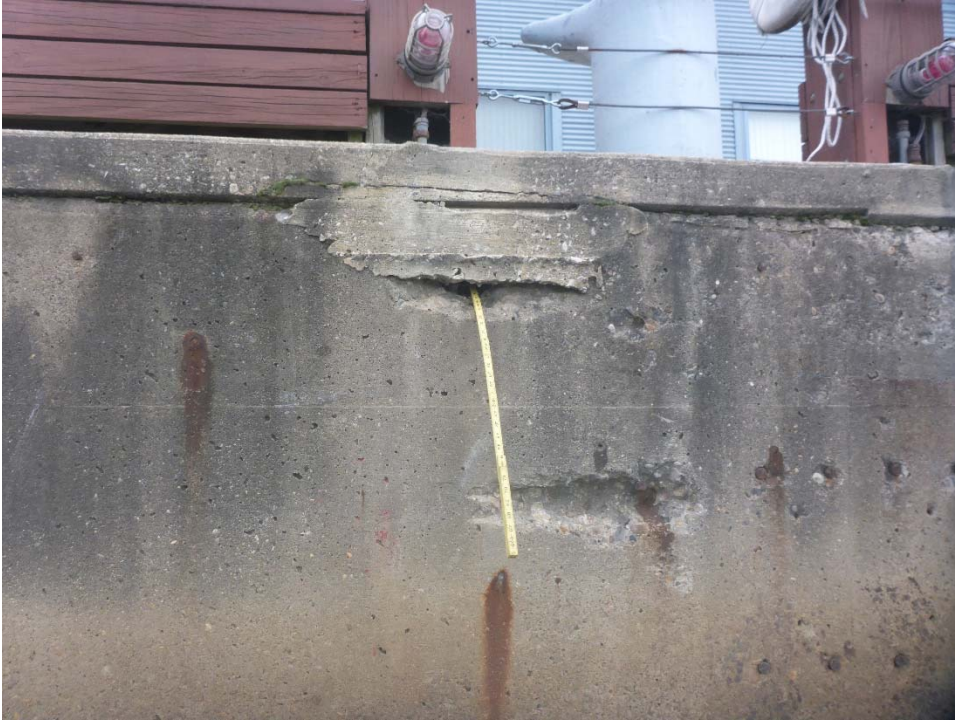
Photo 7: South face. Typical spalling with patch at top of seawall.

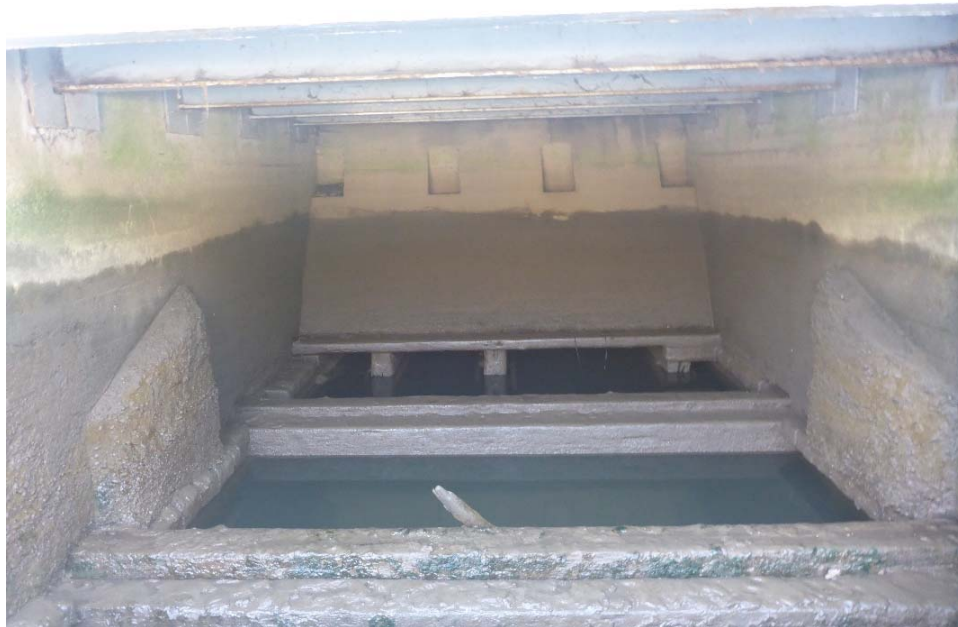
Photo 8: WD1, looking south. General layout of wharf drop. Note the steel beams spanning above and the sloped concrete back wall. Note the typical moderate abrasion that continues along the concrete walls.

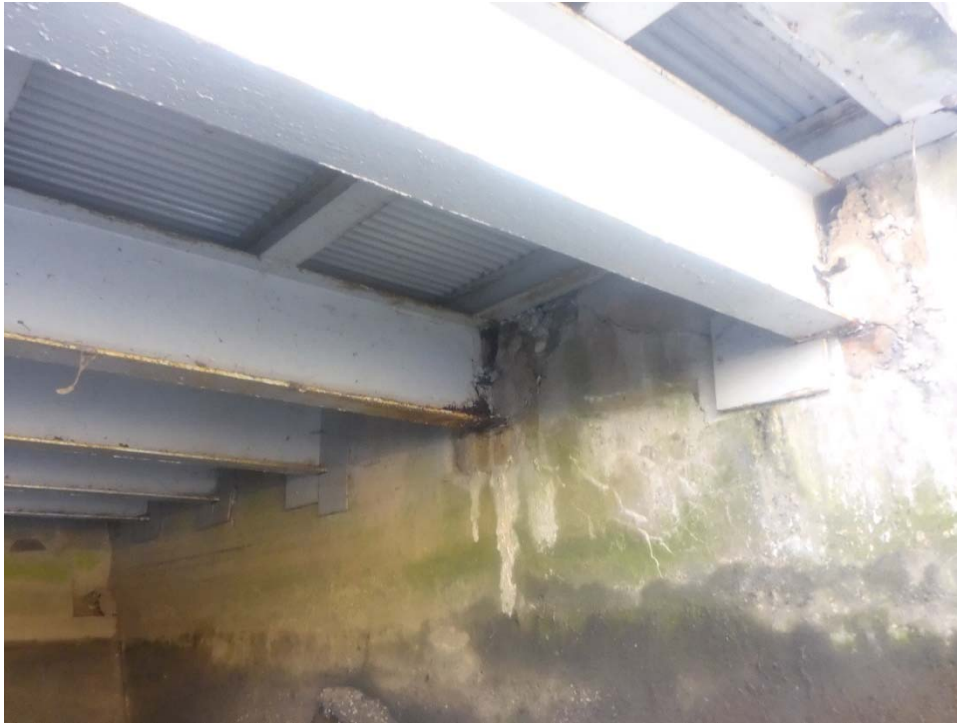
The steel beams are in satisfactory condition. Most deterioration is limited to the ends of the beams where some paint failure and minor corrosion is observed in various beams (**Photo 9**). Most of the beams have timber/plywood formwork left in place along the face of the concrete wall where they are embedded. The timber appears to be holding moisture and further increasing the rate of deterioration at the beam ends (**Photo 9**).

Photo 9: WD2, looking southwest. General layout of wharf drop 2. Note the SIP forms for the concrete deck and remnants of formwork that remain in place around the beam ends. Note that the stringers above the W18 beams are located in WD 2 only.

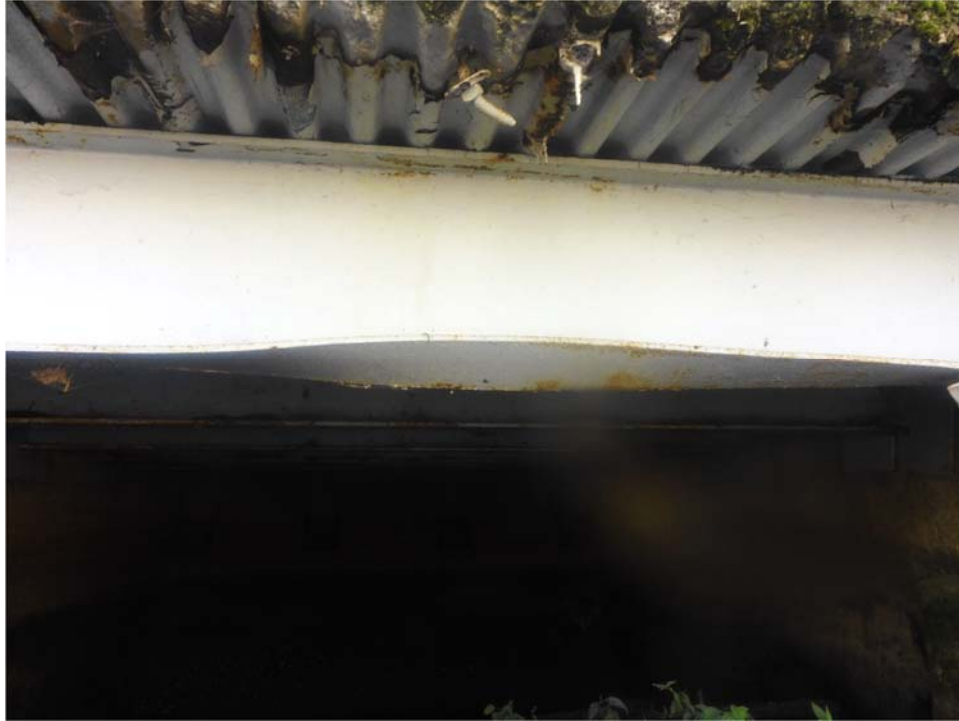
Photo 10: WD4, first beam from opening, looking south. Bottom flange was apparently struck previously. Note the deterioration in the SIP forms at the deck soffit.

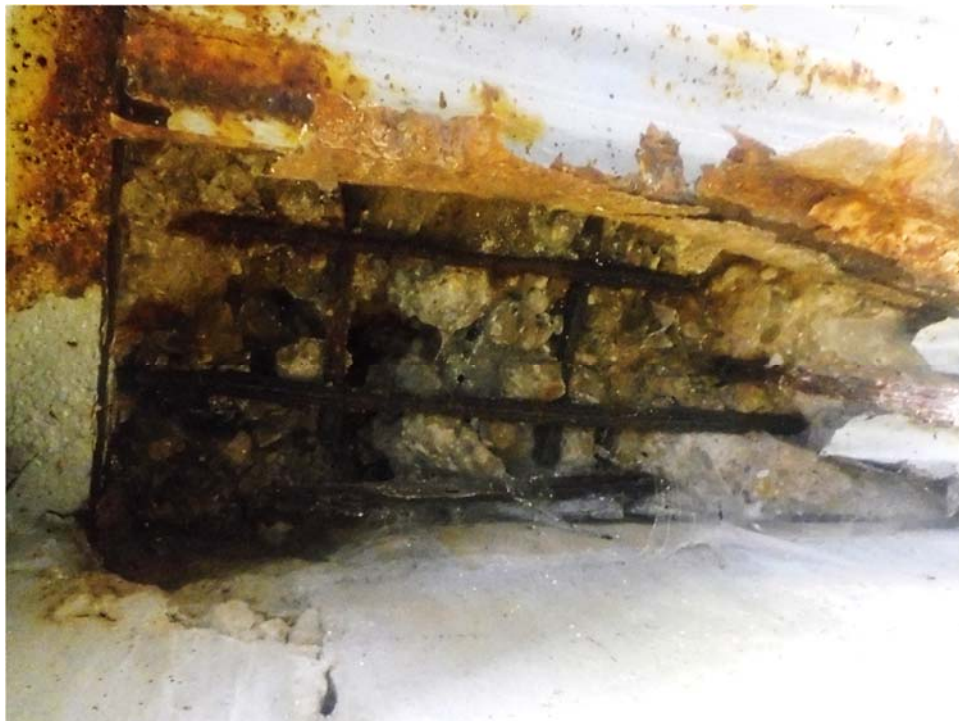
The concrete deck in Wharf Drops 1 & 3 was found to be in poor condition. There are failed sections of the SIP forms with exposed concrete and exposed layers of reinforcing with 100% section loss (**Photos 11 to 13**). The deck in Pier 4 is in satisfactory condition with deteriorated SIP forms and concrete at the soffit. The deck in Wharf Drop 2 is in good condition.

Photo 11: WD 3, east end of Beam 2 from the opening, south side of the beam, looking up. Area of 100% section loss measuring 3' L x 1'W x 9" D to the SIP forms with exposed and deteriorating concrete deck with two layers of exposed reinforcing with up to 100% section loss in the first layer and minor section loss to the second layer. Similar conditions exist on the west end.

- Wharf drops: Remove stay in place (SIP) panels and repair/replace the concrete deck at all areas with advanced deterioration in Wharf Drops 1 & 3.

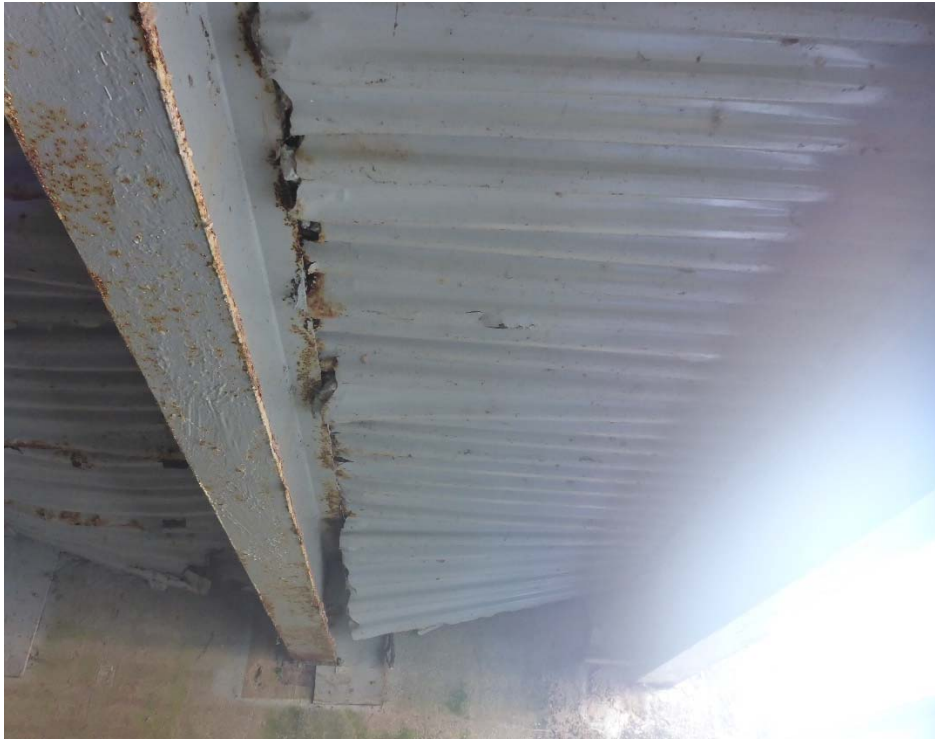
Photo 12: WD 1, Bays 1 & 2 from the opening, looking west. SIP forms have areas of 100% section loss around the perimeters and are bowing downwards.

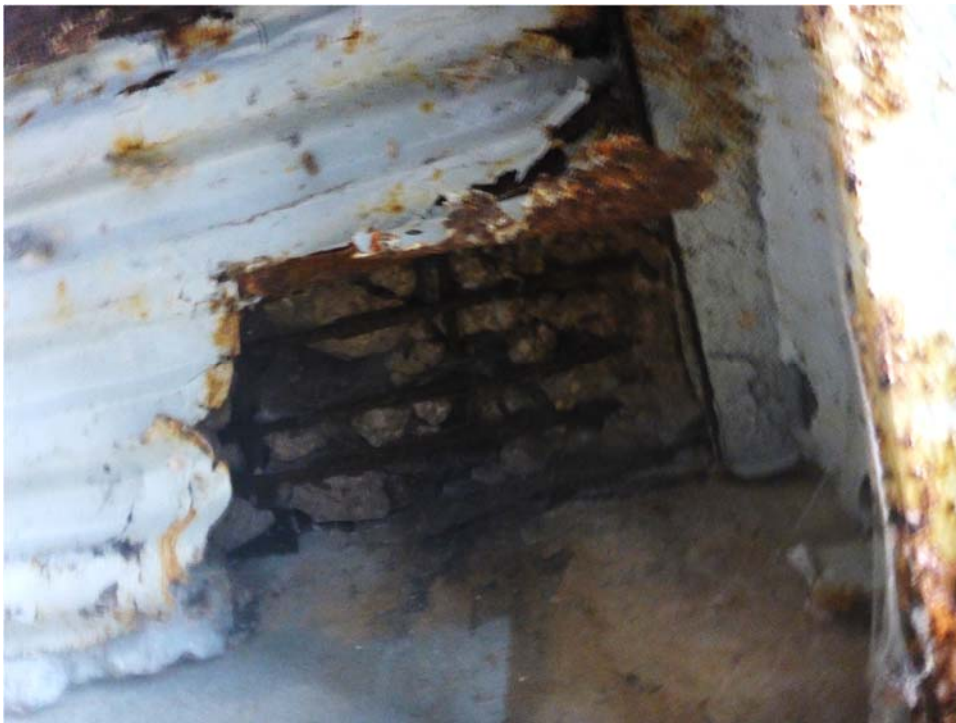
Photo 13: WD 1, northwest corner of bay 1, area of exposed and soft concrete with exposed reinforcing with up to 100% section loss.

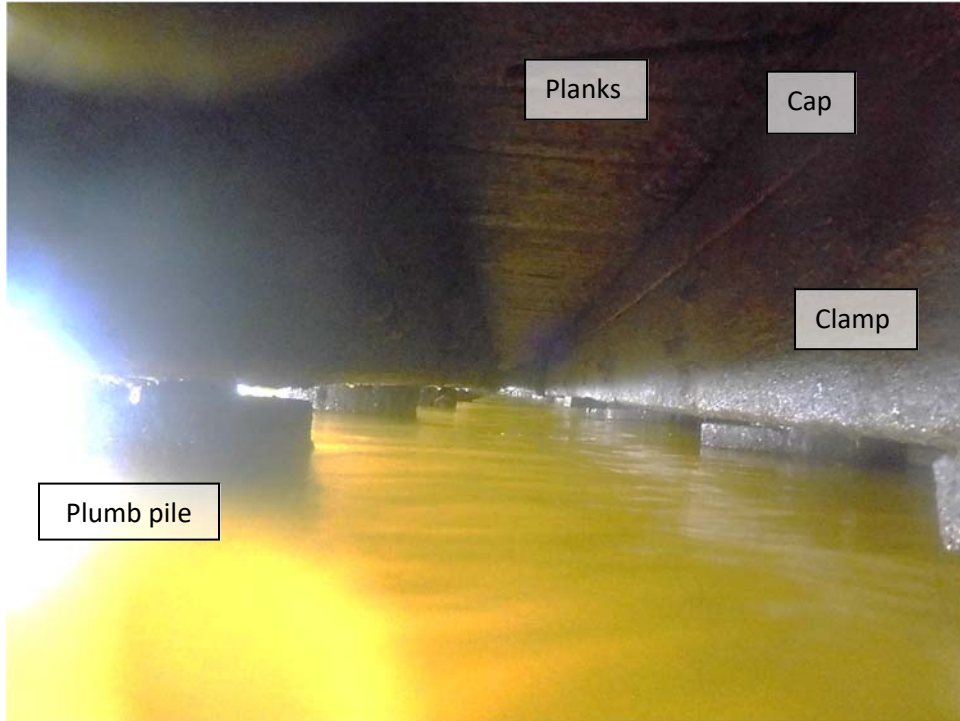
The timber piles are typically in satisfactory condition, intact and primarily bearing with minor deterioration and natural defects. The pile spacing along the bents varies throughout, between 2'-6" to 4'-3" on center. The bents are typically spaced at 5'-0" on center, with pony bents spaced at 2'-6" where installed. The timber piles also vary in size, and were typically found to be between 12" to 16" diameter. Based on the inspection approach used during this cycle, more than 300 piles were directly inspected (**Photo 14**).

The timber low deck is constructed primarily of 6”x12” timber planking that spans between bent caps in the east/west direction. The timber decking is in fair condition overall, with moderate decay and weathering typical (**Photo 14**). The boards typically exhibit up to 1” penetration with an awl.

Photo 14: Bay between Bents 1 1/2', looking south. Typical layout of timber low deck elements.

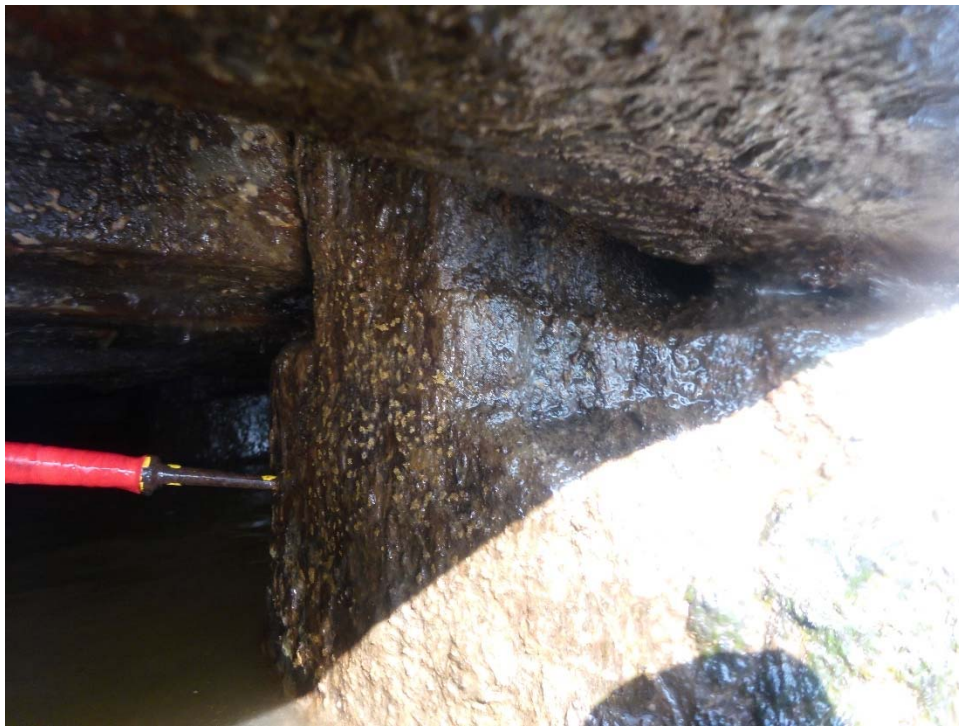
Typically, the piles were found to be relatively plumb and bearing with minor checks and splits (typical of timber elements), but no significant splits or section loss. The piles exhibit minor decay and weathering with awl penetrations up to ¾" deep throughout the length of the pile (**Photo 15**).

Photo 15: Outshore pile, East face. Typical maximum awl penetration into pile.

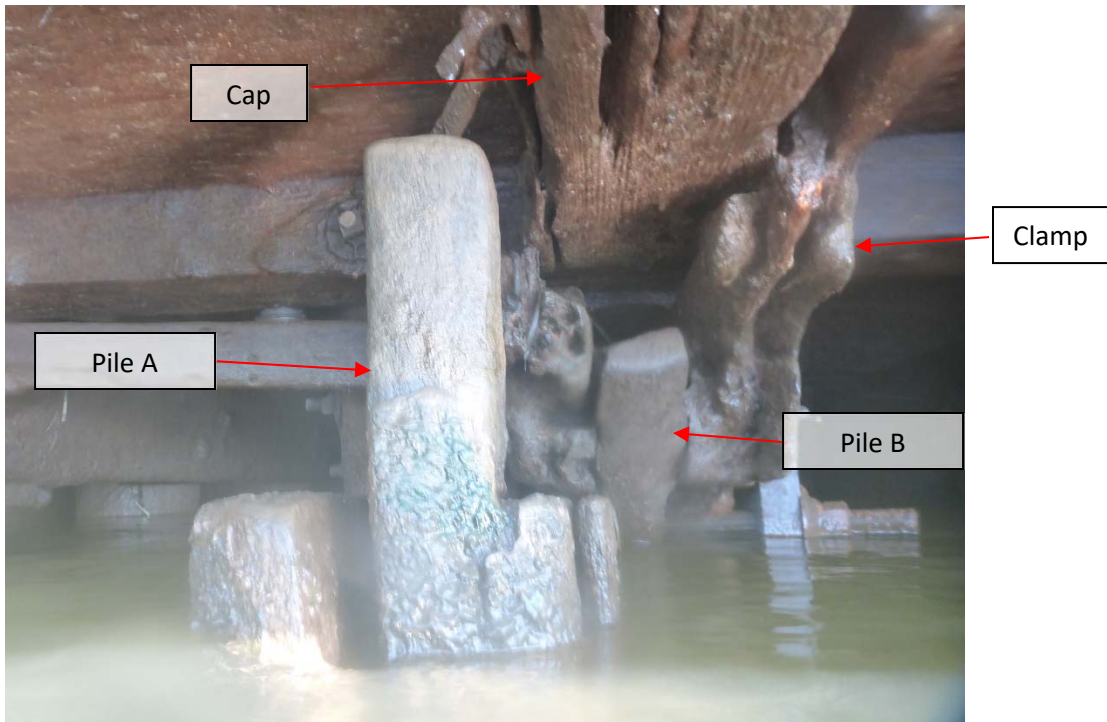
- Broken/missing piles. Piles exhibit advanced deterioration (thru-splits, crushing, decay, etc.) and are no longer functioning for load transfer. Piles (typically at the top) may be fully missing/broken off. Most of the missing or broken piles were found on the south and east faces of the pier. The most exterior piles (Piles A and B) are typically more exposed to impact damage, by either ice, debris, or vessels. Note that no broken/missing piles were found at the interior. A total of 11 broken/missing piles were identified. (**Photo 16**).

Photo 16: Bent 80S. Pile A and B are broken.

- Repair and replace deteriorated and missing timber low deck structure components including: broken, missing, split, and non-bearing piles, deteriorated and missing hardware, missing and dislodged skirt boards, and deteriorated timber clamps and pile caps. We recommend \$50,000 be set aside each year for these repairs.

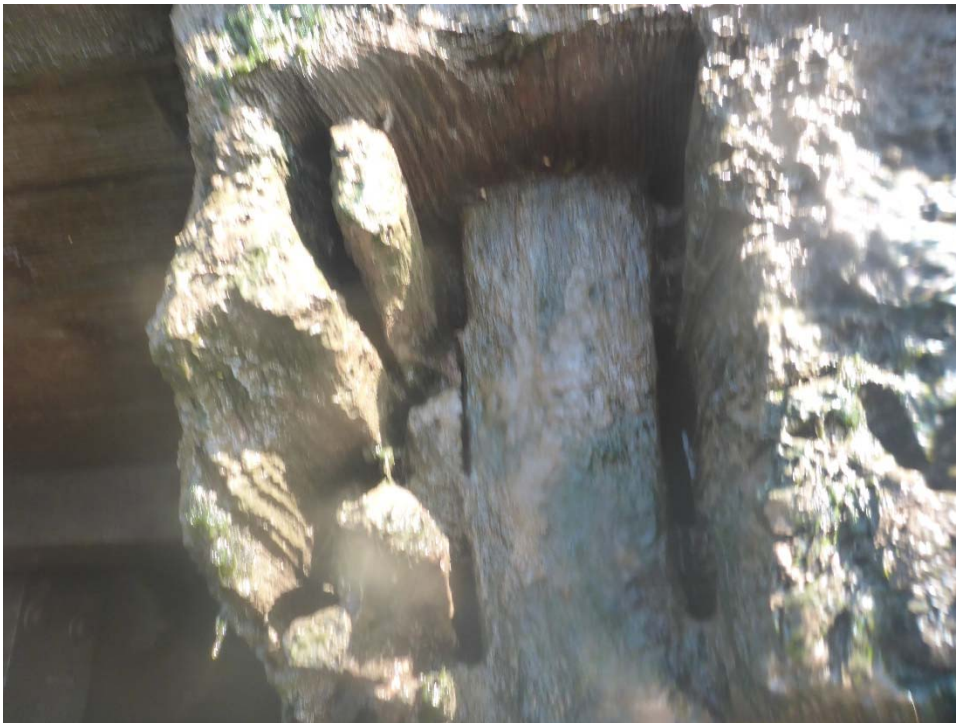
The timber caps and clamp elements were typically found to be in satisfactory condition, intact and bearing with minor deterioration and natural defects. The timber elements exhibit minor decay and weathering, with awl penetrations up to ½” deep throughout. The timber elements typically exhibit the worst conditions on the ends. A total of 1 locations of split caps or clamps were located throughout the pier. (**Photo 17**).

Photo 17: Bent 81S. Timber clamp and cap have deterioration up to 50%

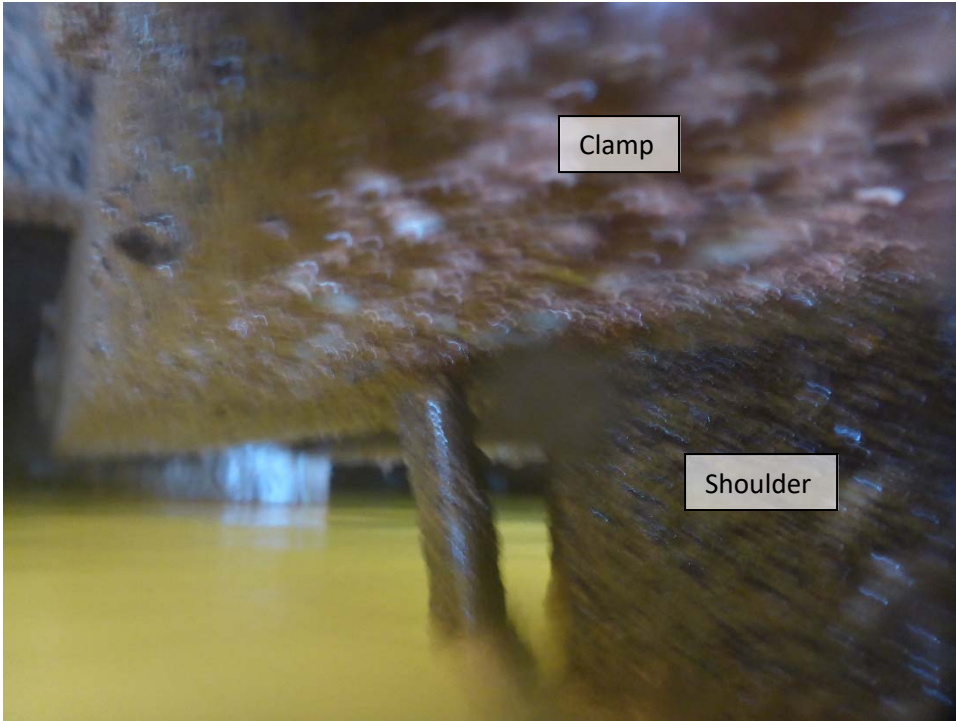
- Split piles. Some of the piles exhibit significant splitting, beyond the typical minor splitting associated with timber elements. Deep or thru-splits can reduce the load bearing capacity of a pile. Splits were typically found at the top of the pile (1' to 4' high), and often in line with the shoulder. Exterior piles are typically more susceptible to splitting than interior piles, due to effects of impact and ice damage. A total of 5 split piles were identified. (**Photo 18**).

Photo 18: Bent 69S Pile A. Minor split at pile shoulder.

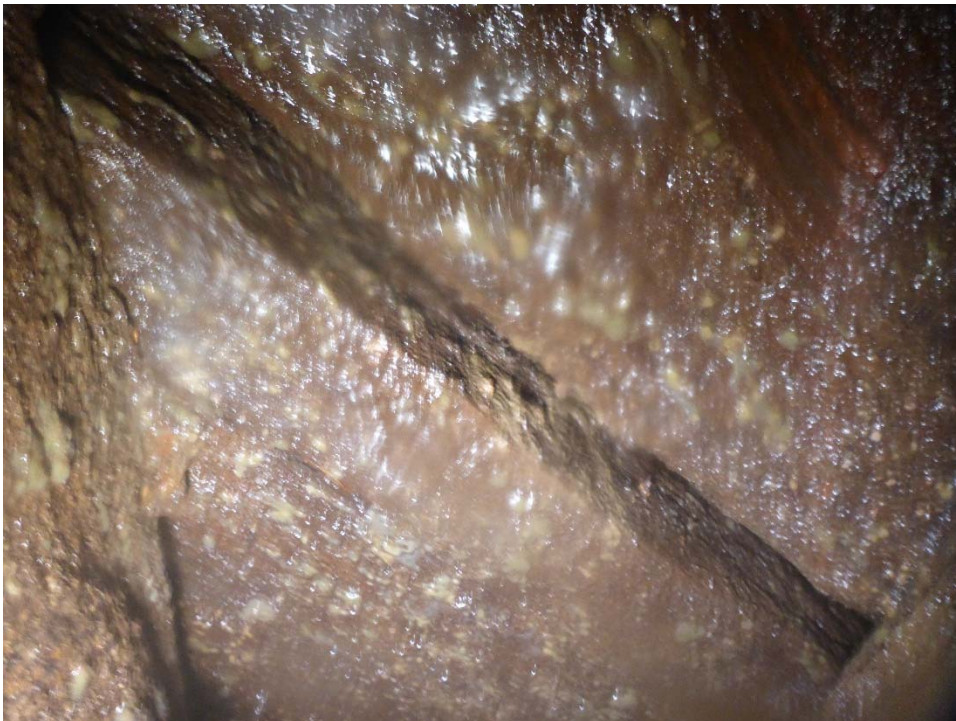
There are typically narrow gaps between the edges of the deteriorated deck boards with isolated areas of up to 1” (**Photo 19**). There was no indications of loss of fill from the gaps. Available drawings indicate that there is only one layer of timber decking. Timber low deck structures are often constructed with two layers, spanning in opposite directions, which makes them less susceptible to loss of fill due to deterioration or gaps. There were no signs of widespread sagging or broken deck boards.

Photo 19: B/W bents 95S & 96S at Pile E. Gaps in timber deck up to 1" wide with no active loss of fill.

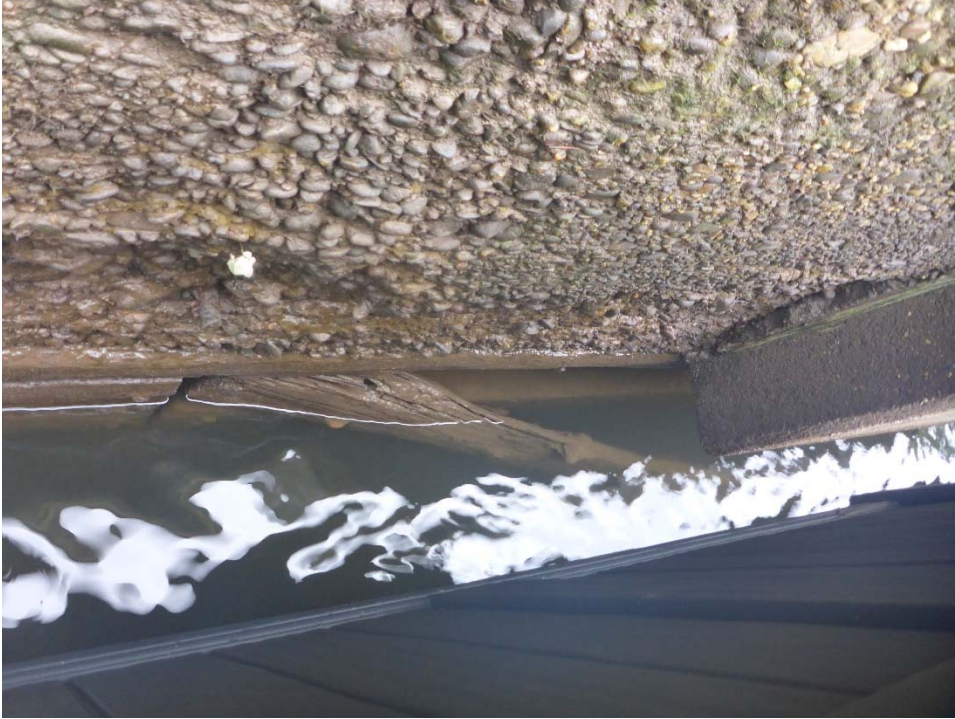
The timber skirt boards (non-structural elements) are typically in fair condition, and exhibit moderate deterioration and splitting throughout. Random skirt boards are loose or missing. From the outshore end of the south face of the pier for approximately 20 ft along the south face the skirt board is missing with exposed exterior piles. Approximately 30ft of skirt board is broken or missing on the north face (**Photo 20**). Note that the timber low deck structure in these areas is more exposed to impact damage, ice and debris. The skirt board was generally found to be in good condition along the outshore face of the pier.

Photo 20: Typical broken skirt board on the north face.

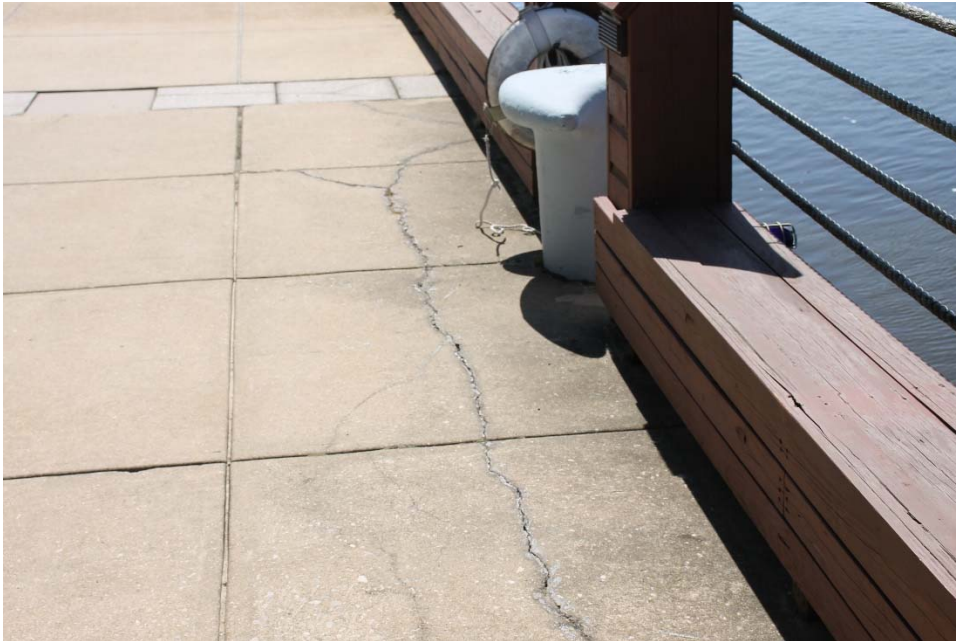
The concrete apron on the north face of the pier was not available for inspection. Several cracks up to 1/8" wide were observed in the concrete deck on the south side of the pier (**Photo 21**). The southeast corner of the pier has several cracks in the deck measuring up to 1/8" wide (**Photo 22**). The timber low deck structure was inspected thoroughly in this area to ensure the stability of the concrete deck. No evidence of loss of fill through the low deck or a deficiency in the piles were found in this area during the underwater inspection was found.

Photo21: South side of the pier, looking southeast. Typical cracking up to 1/8" W.

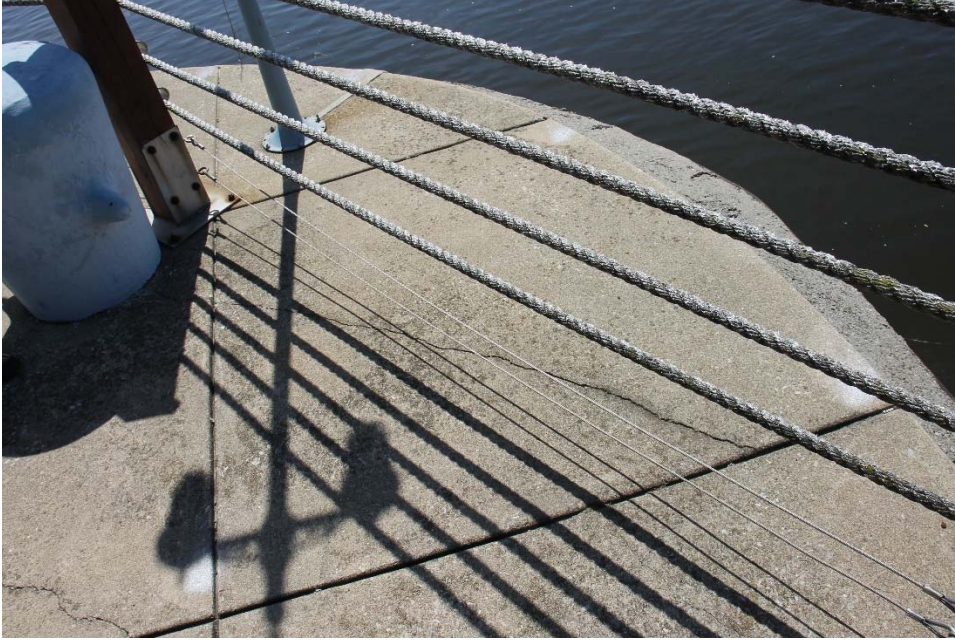
Photo 22: Southeast corner looking east. Localized cracking up to 1/8" W.
