Re: Pier 3 Condominium  
Atrium Structural and Waterproofing Rehabilitation  
WJE No. 2018.1838

In accordance with contract documents dated June 15, 2018, Pullman SST, Inc. (Pullman) and Wiss, Janney, Elstner Associates, Inc. (WJE) have completed an investigation of the elevated plaza slab and structure within the central atrium at the Pier 3 Condominium. Our investigation included a visual survey, destructive probe openings, and a structural and fire protection analysis. This report presents the findings of our investigation and recommendations to repair the noted distress.

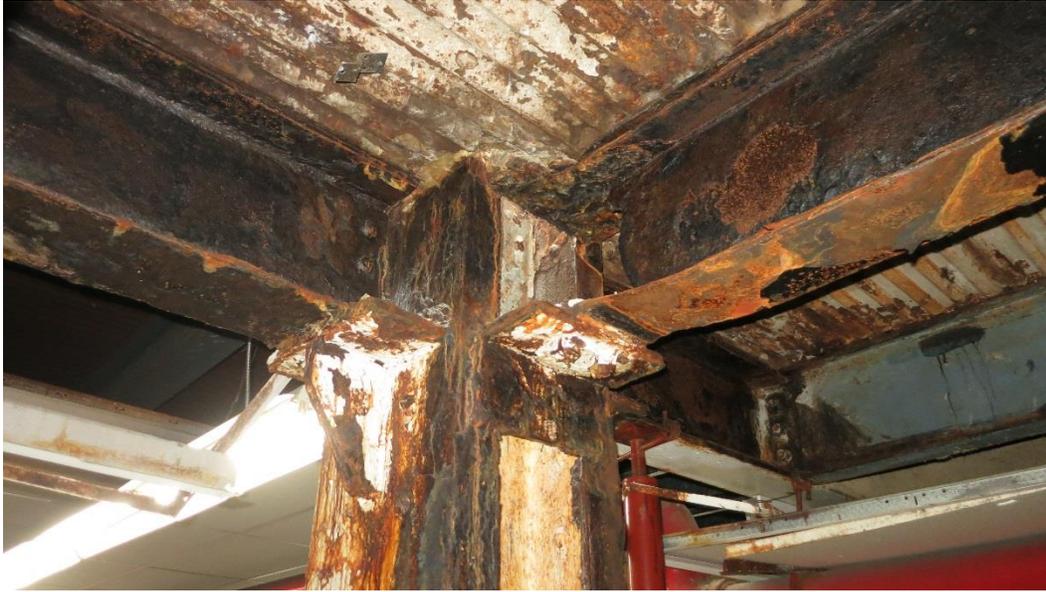
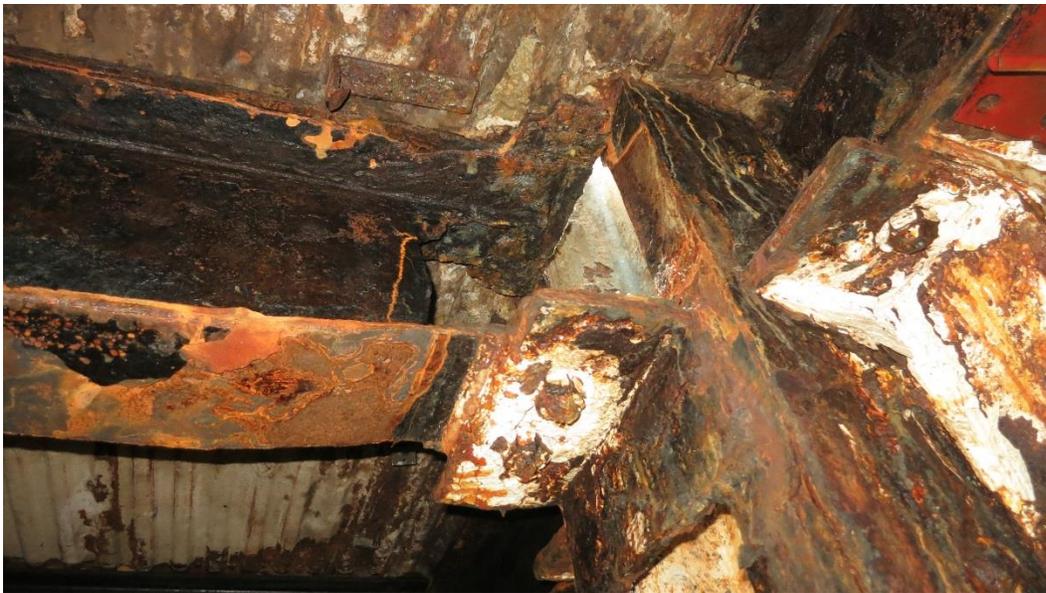
- Numerous areas of water leakage and steel corrosion were observed at the steel framing beneath the lower atrium slab. Water leakage was typically identified by stains on the drop ceiling, and was typically associated with debonded spray-on waterproofing and corrosion of steel framing. The most severe corrosion was observed at the easternmost garage/atrium column, where a persistent water leak has caused significant corrosion at the column and intersecting beams (Photos 1 and 2), including 100% section loss at one beam web. Post shores had been installed beneath beams in this area prior to our investigation. According to documents provided by Pier 3 maintenance staff, repairs to these corroded elements had previously been designed by O&S Associates in December 2017, but the repairs have not been implemented.

*Photo 1. Corrosion at east column and supported members*

*Photo 2. Corrosion at east column and supported members*

- The drop ceiling beneath the atrium slabs should be removed to allow for full visual observation of the structural members. Steel coupons should be cut from approximately 5 to 7 beams and tested to determine yield and tensile strength. Upon determination of steel strength, the number and type of steel beam repairs may be finalized. It is anticipated, based on the severity of corrosion documented, that even if the beams have a yield strength of 50 ksi steel, repairs will still be necessary in many areas. Corroded portions of steel columns and hangers likely do not require repair due to their calculated reserve capacity.

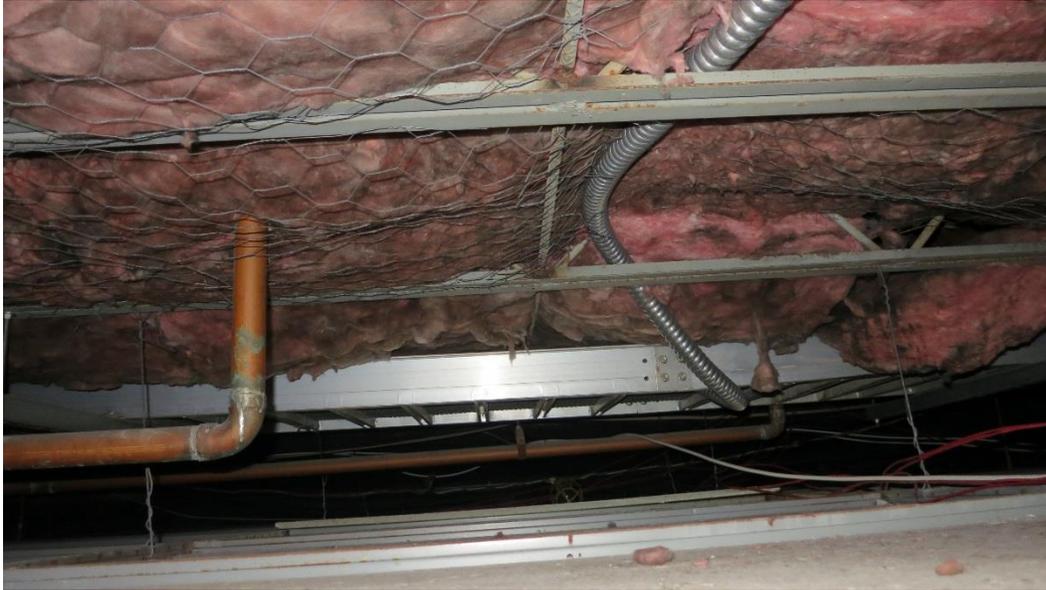
- Visual observation of exposed portions of the structural steel below the upper atrium slab and condominium units did not reveal any areas of significant corrosion (Photo 3), though the steel was typically concealed by a drop ceiling, and not all areas were observed.

*Photo 3. Cracked mortar and displaced CMU blocks at the southeast corner of the structure.*

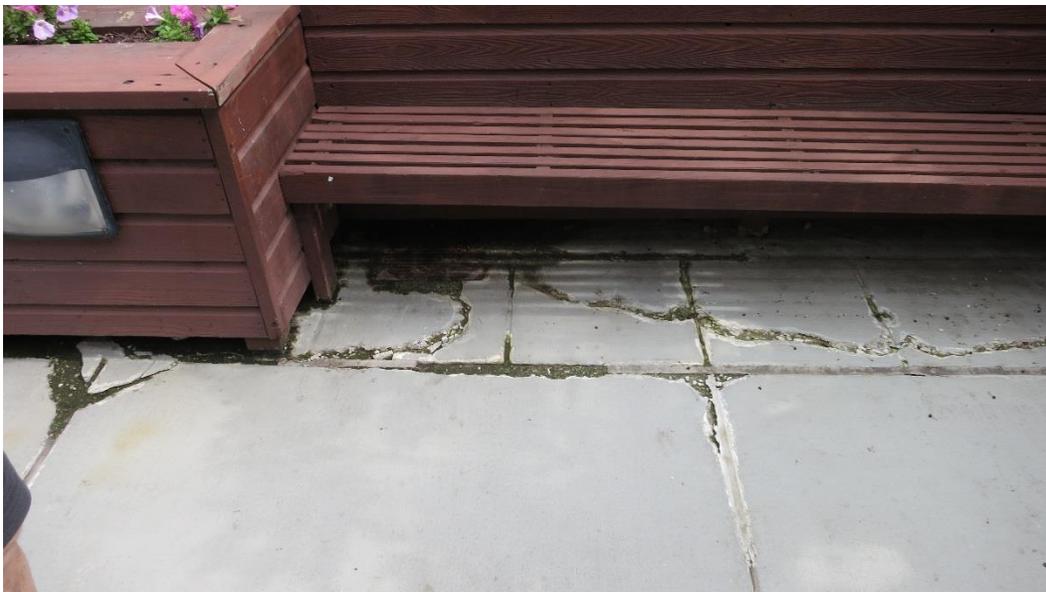
- Widespread deterioration of the lower atrium topping slab concrete and sealant joints was observed. Cracking, spalling, and scaling of concrete and debonding of sealant were observed throughout the lower atrium (Photo 4). These conditions were largely absent from the upper atrium slab, though localized areas of sealant failure and concrete deterioration at sealant joints was observed (Photo 5).

Based on observations at destructive probe locations, the structural slab at both the upper and lower atrium levels appears to be in good condition. The majority of the observed slab distress is confined to the topping slab and waterproofing itself, which has debonded from the structural slab in multiple locations. Because no drainage mat exists above the membrane and because weep holes at drains are clogged, water that penetrates the topping slab cannot sufficiently drain; this has resulted in deterioration of the topping slab, likely primarily

through freeze-thaw related distress. This deterioration is likely to continue until the topping slab and membrane are removed and replaced.

*Photo 4. Deterioration at lower atrium topping slab*

- The lower atrium topping slab and waterproofing should be removed and replaced with new waterproofing. This would require removal of the wood planter boxes, wood decks, and walls. These wood structures are already in a state of decay and are in need of repair or replacement anyway. After

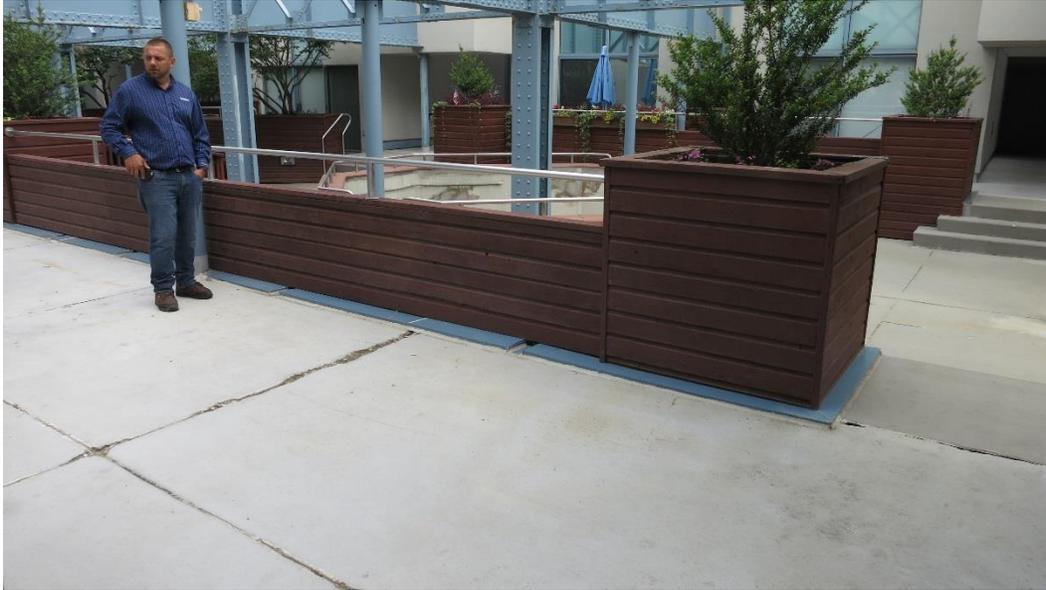
The upper atrium topping slab and membrane appears to be in better condition than the lower slab. Damage at the upper slab appears to be limited to debonding sealant at sealant joints, and some concrete spalling and scaling at joint edges. The Sika FlexCoat waterproofing system remains well-bonded. The upper atrium slab can likely be retained with localized repairs and replacement of sealant joints.

*Photo 5. Minor deterioration at joints in upper atrium slab*

- The upper atrium slab should be repaired where spalled and scaled, which is currently most significant at sealant joints. Sealant should be removed and replaced where it is failed or debonded, and repaired areas should be re-coated with the Sika FlexCoat system or an approved alternative.

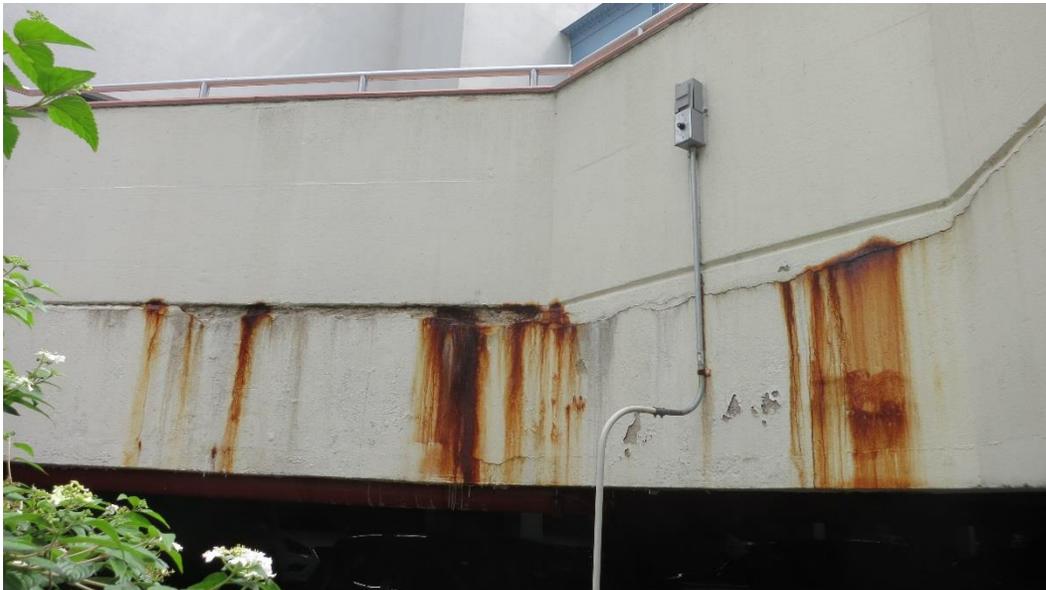
- Spalls, cracks, staining, and incipient spalls were observed at the walls of octagonal lightwell openings between the lower atrium and the parking garage (Photos 6 and 7). Numerous prior patch repairs have reported been implemented at these areas.

*Photo 6. Stains, cracks, and spalls at lightwell walls*

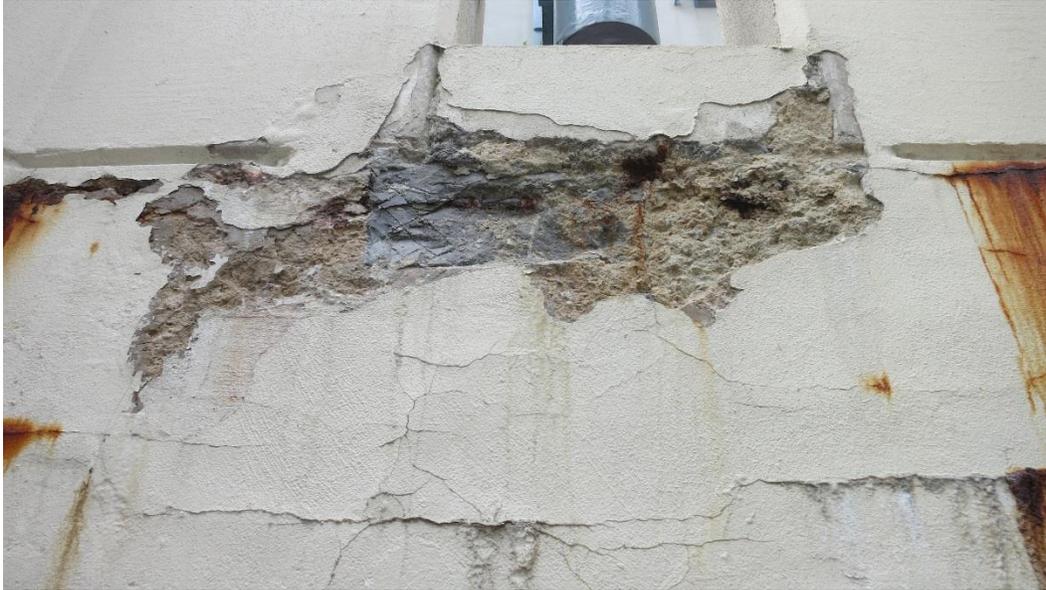
*Photo 7. Spall at lightwell wall*

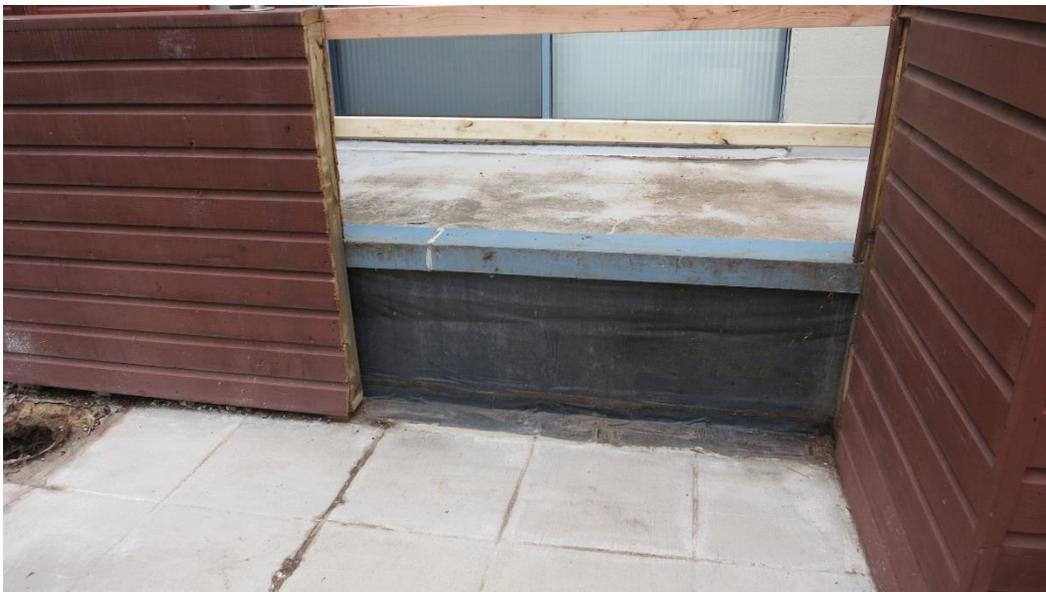
*Photo 8. Probe 1- cut open planter wall at Unit 235*

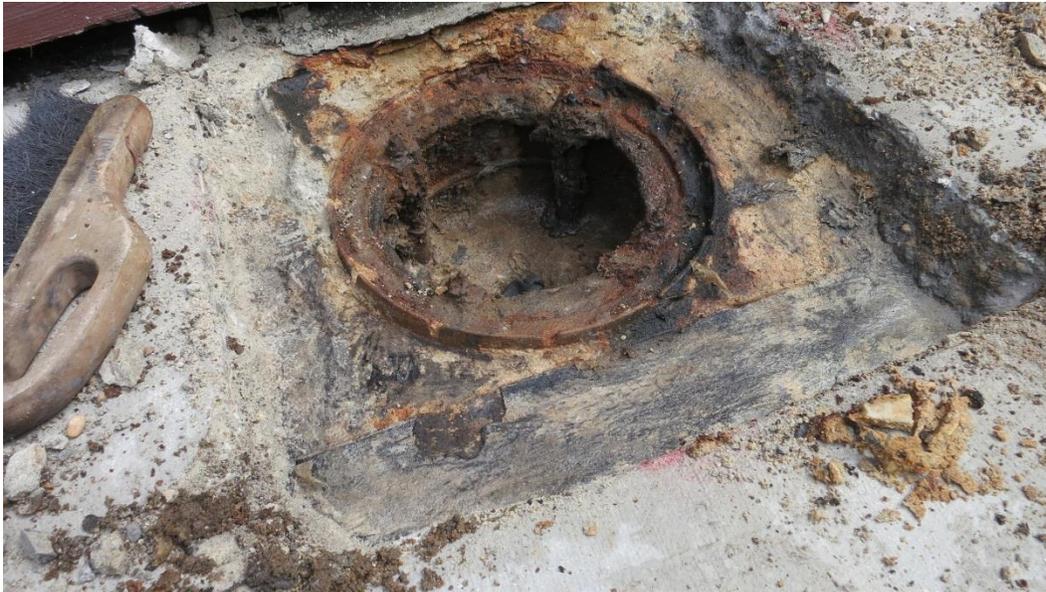
*Photo 9. Probe 1a - Cut open floor drain at Atrium lower level slab.*

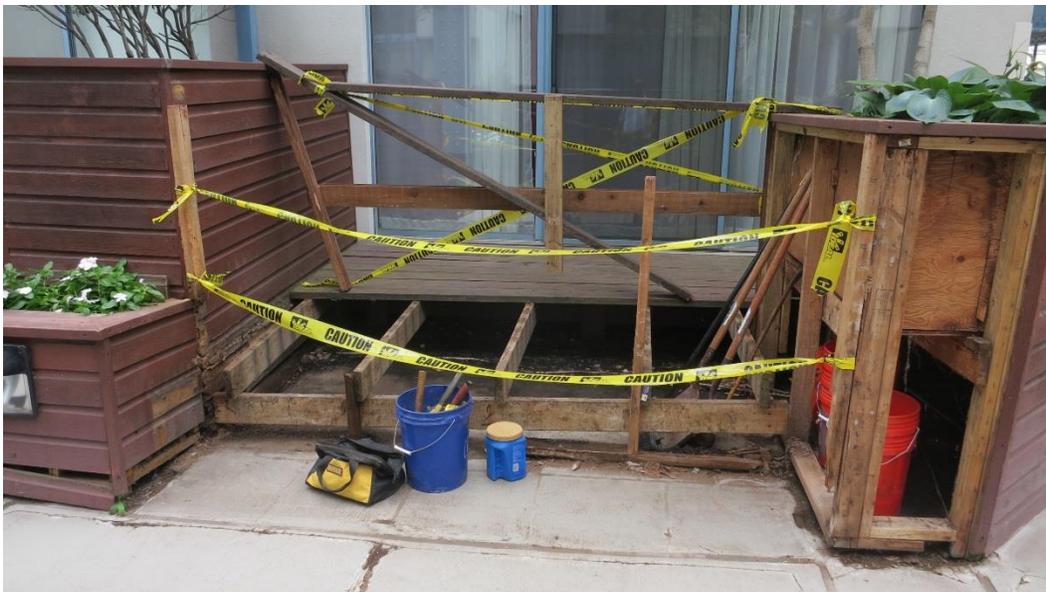
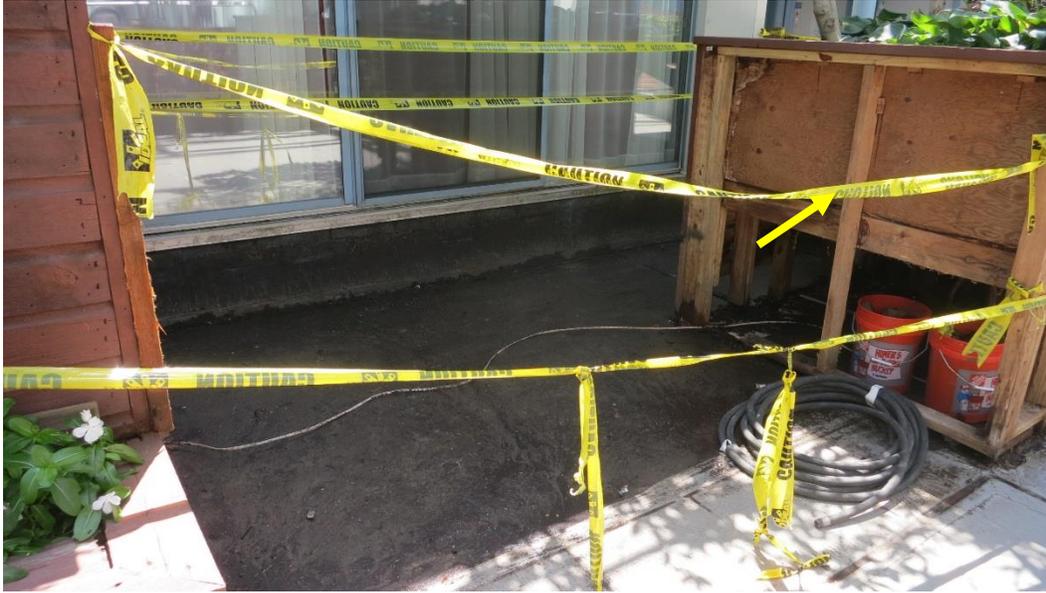
*Photo 10. Probe 2 - Partially disassembled wood planter and deck at Unit 236*

*Photo 11. Probe 2- Fully disassembled wood planter and deck at Unit 236*

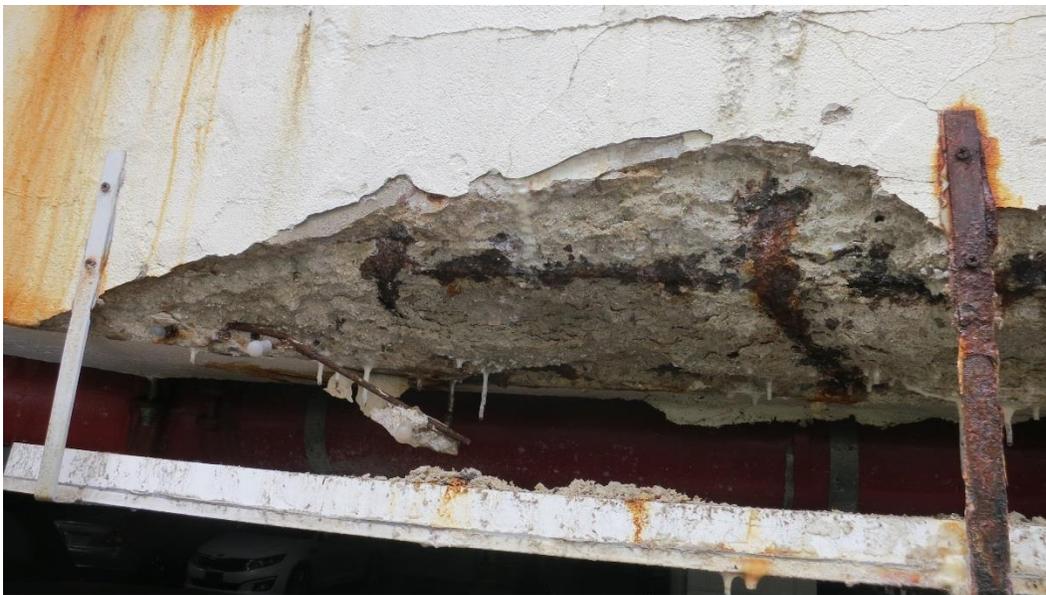
*Photo 12. Probe 3 at east lightwell.*

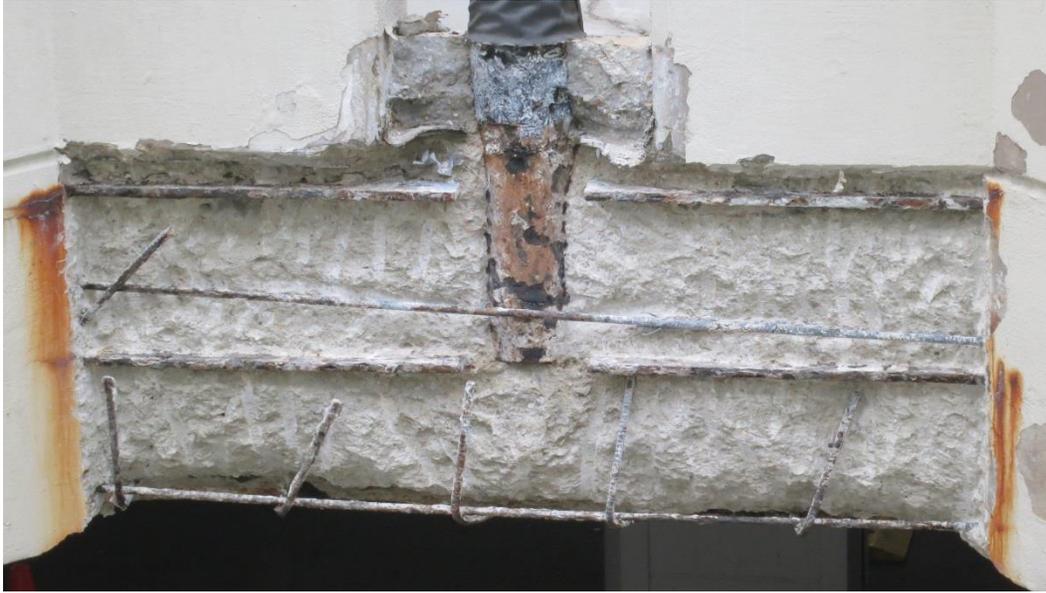
*Photo 13. Probe 4 at west lightwell*

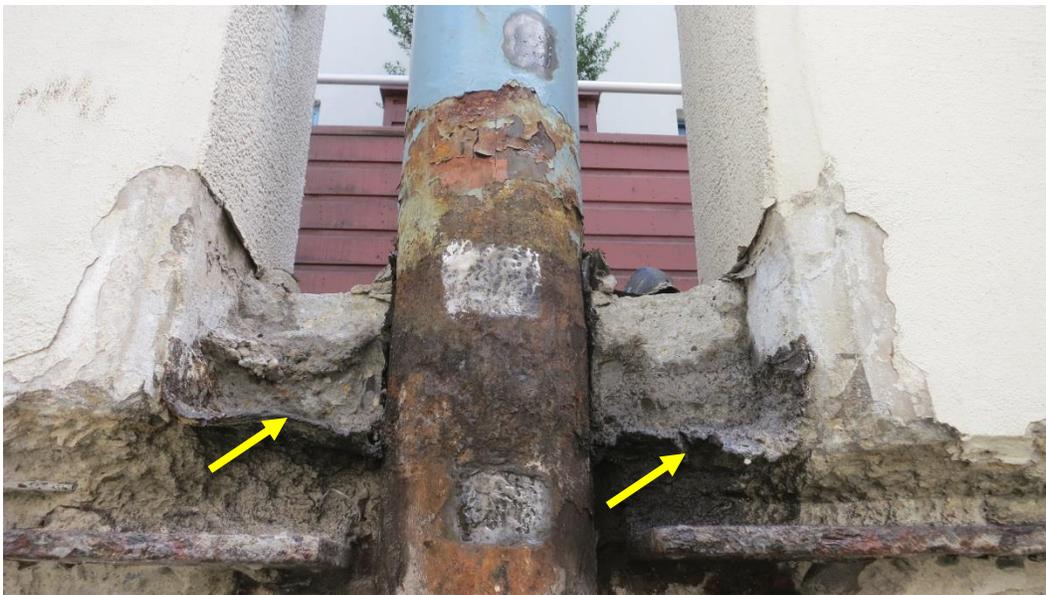
- The waterproofing membrane beneath the lower atrium slab is in poor condition and is poorly bonded to the structural slab. At octagonal lightwell openings, the membrane terminates inside the lightwell walls, with no means of drainage (Photo 24).

*Photo 24. Membrane ends inside lightwell wall with no termination.*

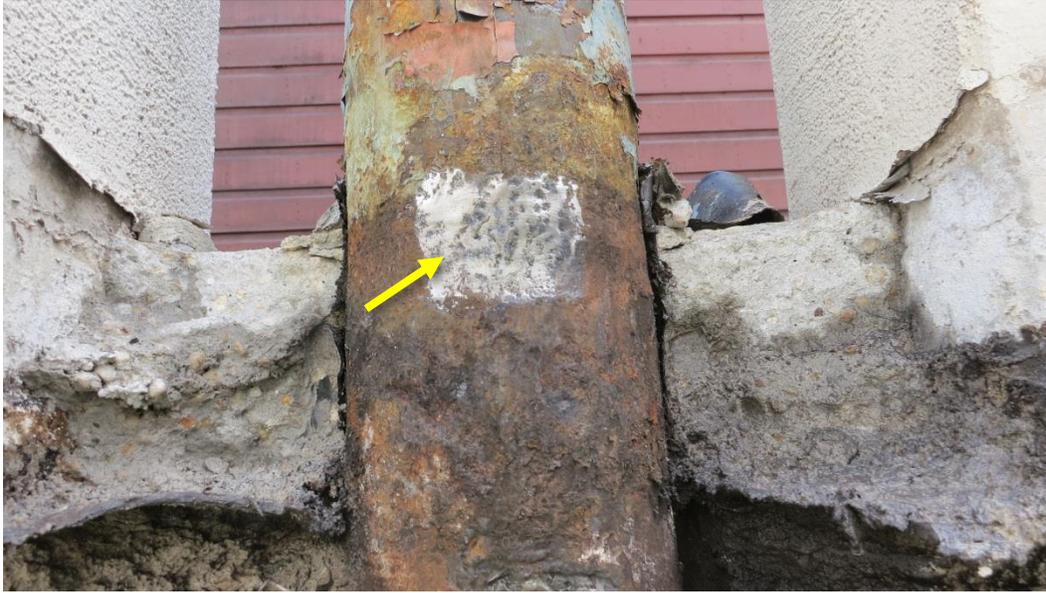
- Steel section loss was measured where corrosion was observed at steel framing, including columns, tubular hangers, and beams (Photo 25). Columns and hangers were typically found to be corroded where they pass through the topping and structural slabs, though section loss was found to be minimal. The greatest severity of section loss measured at a column was 28% at a column flange, and 11% at a column web. At a tubular hanger, the maximum measured section loss was 22%, located at a lightwell wall within the topping slab. Section loss at corroded areas of steel beams was found to vary widely, from 100% at a beam web in the highly-corroded area at the east end of the atrium/parking garage, to less than 5% at lightly-corroded members. The vast majority of steel framing below the lower atrium slab was observed to be uncorroded, with corrosion appearing to be localized and limited to areas of active or prior water leaks.

*Photo 25. Portion of hanger ground clean for thickness measurement.*

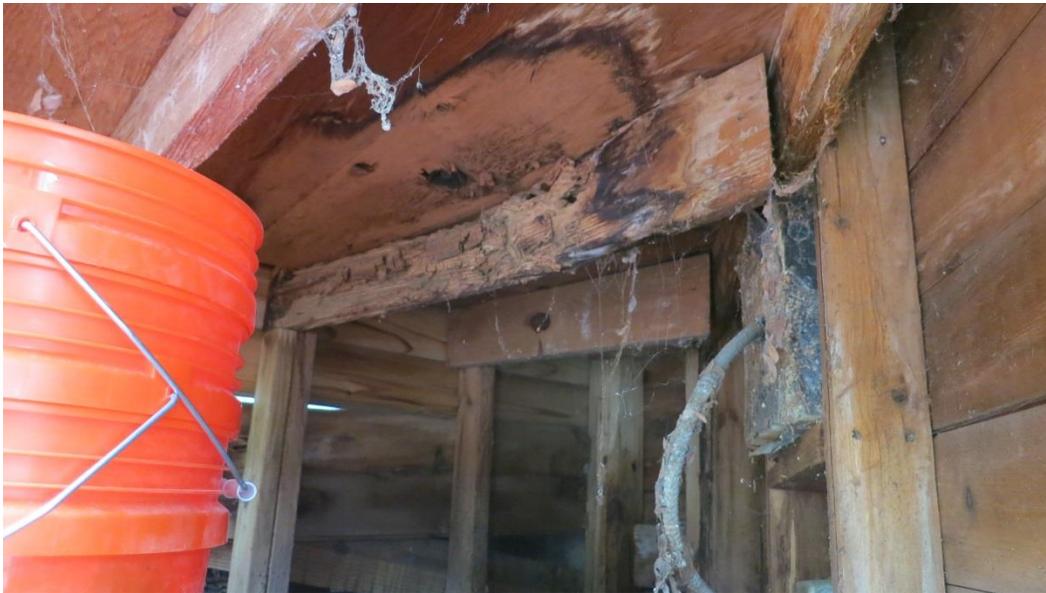
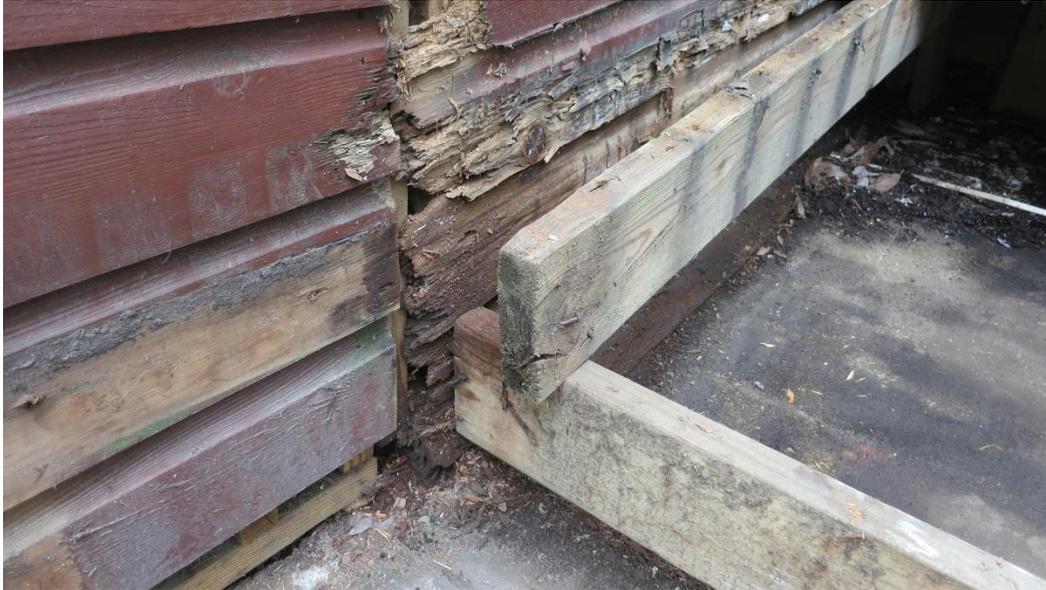
- A probe opening at the wood planter outside Unit 236 revealed significant decay of the planter framing (Photos 26 and 27), most likely caused by leaks within the planter bed. It is likely that some extent of decay is present at many if not all similar planter boxes.

*Photo 26. Deterioration of wood framing beneath planter*

*Photo 27. . Wood decay at planter*
