# HOME INSPECTION REPORT

204 Sample Circle  
Kihei, Hawaii

prepared by  
**Mark Thorman**  
*Mark Thorman Home Inspections*  
*www.MauiHomeInspections.com*  
**808-874-3456**

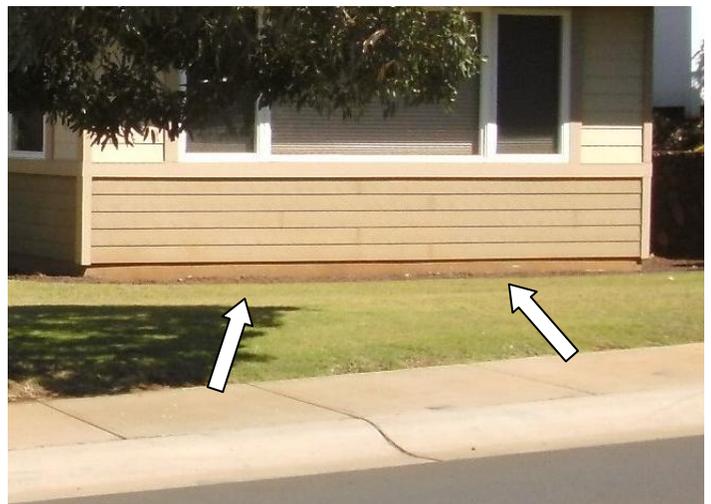
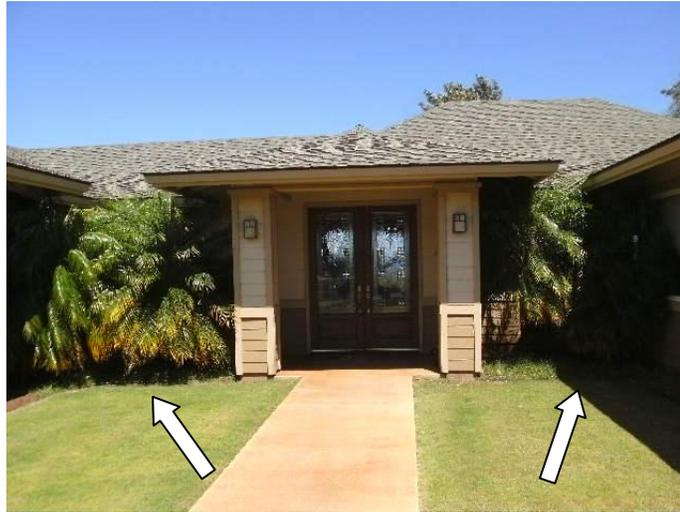
- **Evidence of poor drainage was noted at the front right section of the home and at the sides of the entry area.** The finish grade around the exterior of the home should be graded so as to drain the surface water away from the foundation, i.e. a slope of ½-inch per foot away from the home is recommended. Recommend repairs to ensure the proper soil slope away from the home to prevent moisture infiltration

under the home and consideration should be given to installing gutters at the roof above these areas to help divert the roof drainage away from the home.

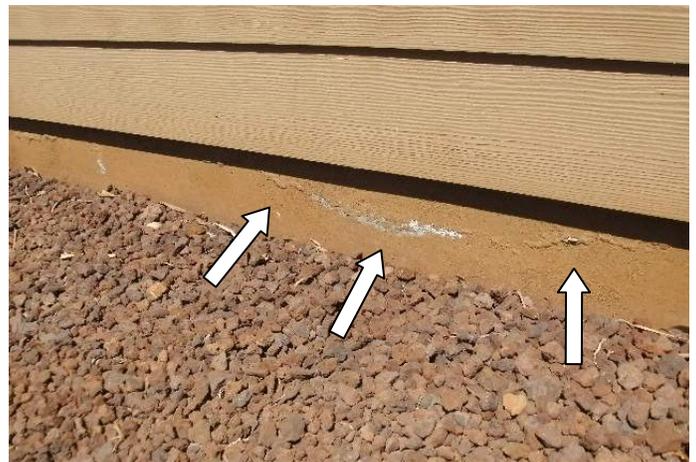
- **Efflorescence (white powdery deposits) was noted at the front right section of the foundation.** This appears to be a result of the poor exterior drainage (See Grading and Drainage) at this area. While no structural damage was noted to the foundation, I recommend repairs to the drainage to prevent future damage.

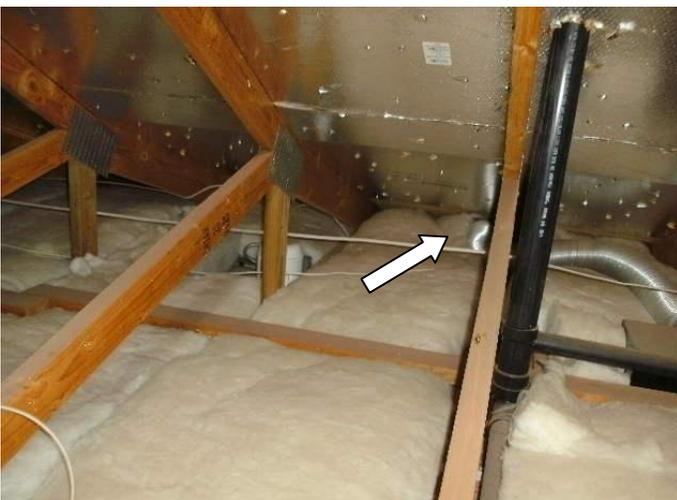
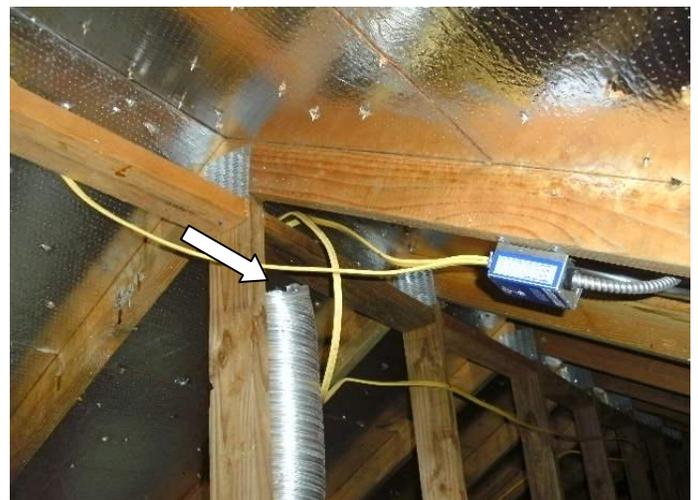
- **The exhaust fans of the right hallway bathroom and master bedroom bathroom were noted to vent directly into the attic.** Recommend providing exterior vent terminations by installing the proper exterior vent hood to prevent moisture build-up in the attic area.

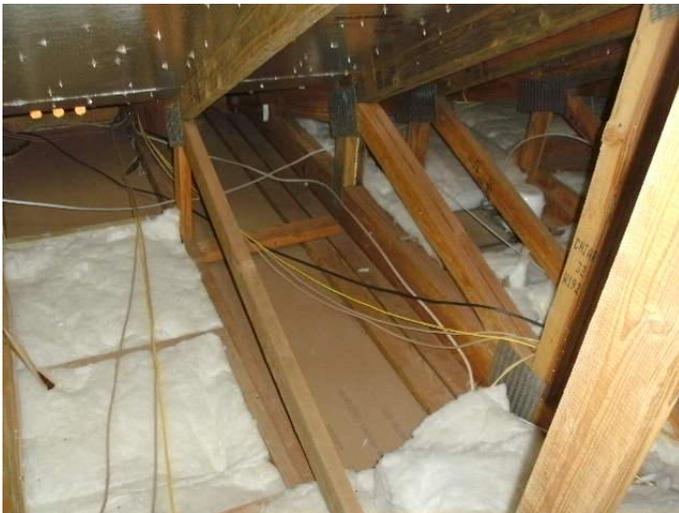
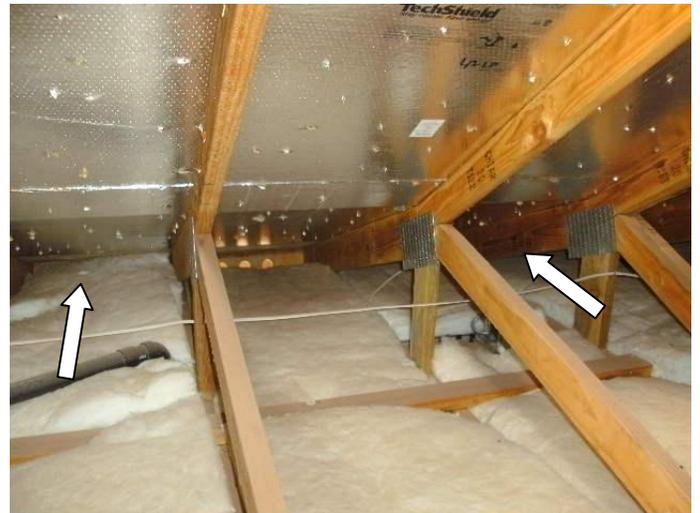
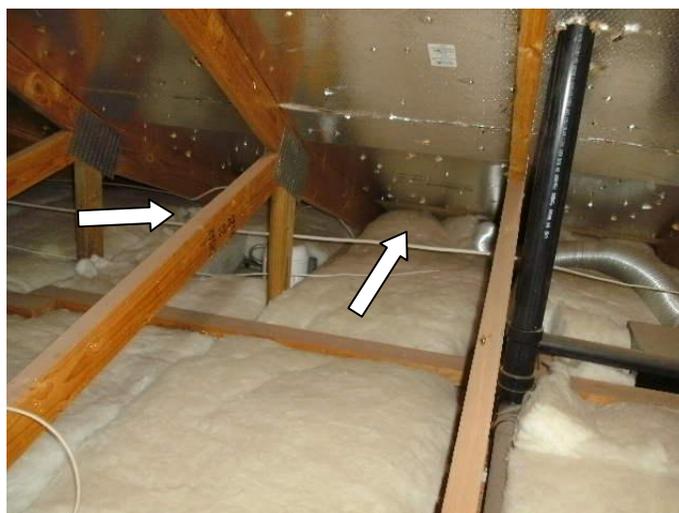
- **Poor coverage of the attic insulation was noted at the right side of the attic above the family room area.** Recommend ensuring an even layer of insulation.
- **The insulation was noted to block approximately 80 percent of the eave vent openings.** Attics are required to be adequately vented to minimize heat and moisture build-up in the attic area. Recommend pulling the insulation back from the eave vent openings or installing a cardboard baffle at the vents to allow circulation.

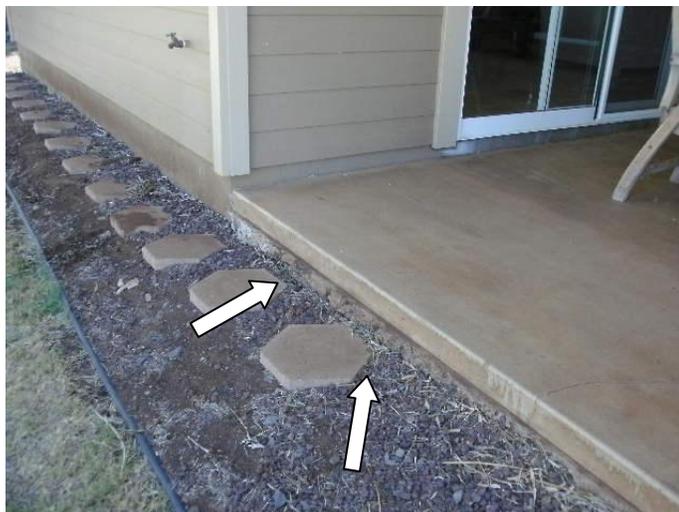
- **Slight erosion was noted at the soil at the back of the lanai.** Recommend adding additional soil around and under the affected area to ensure proper support.

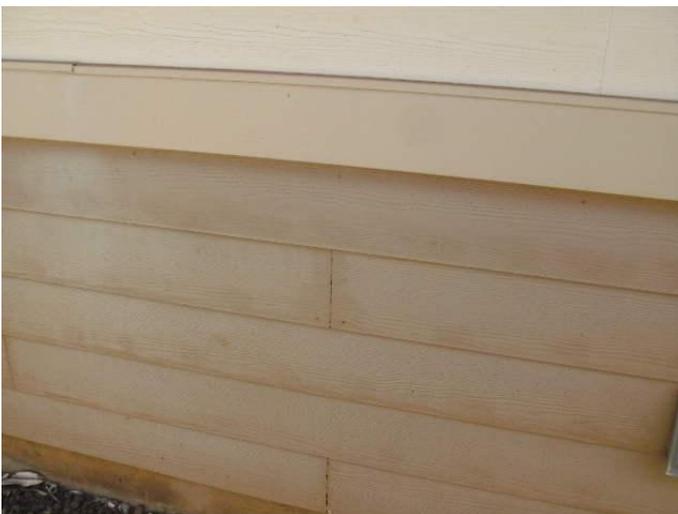
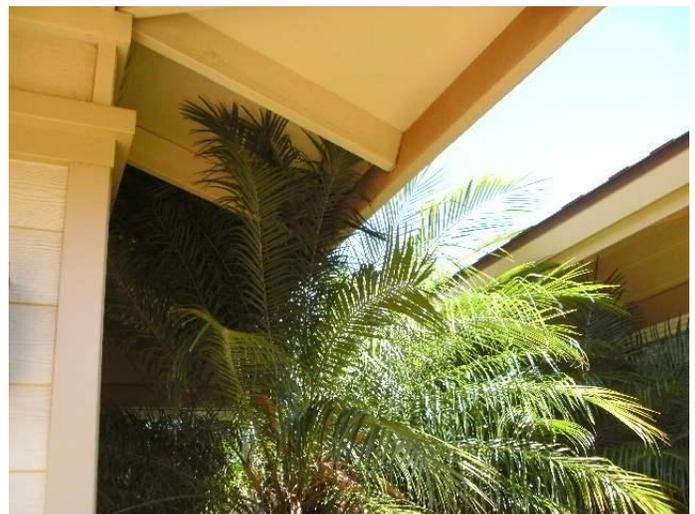
- **Some of the butt joints at the siding at the left side of the home were noted to be in need of caulking.** Recommend ensuring the integrity of the caulking as part of a regular maintenance program.
- **Vegetation was noted against the front of the home.** Recommend keeping the vegetation trimmed away from the home to prevent damage to the siding and trim.

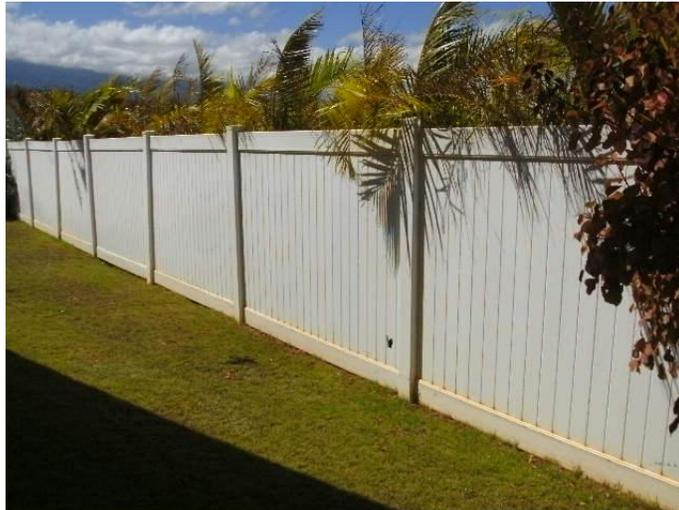
- **A hole was noted in the fence at the left side of the property.** Recommend patching the hole on an as needed basis.

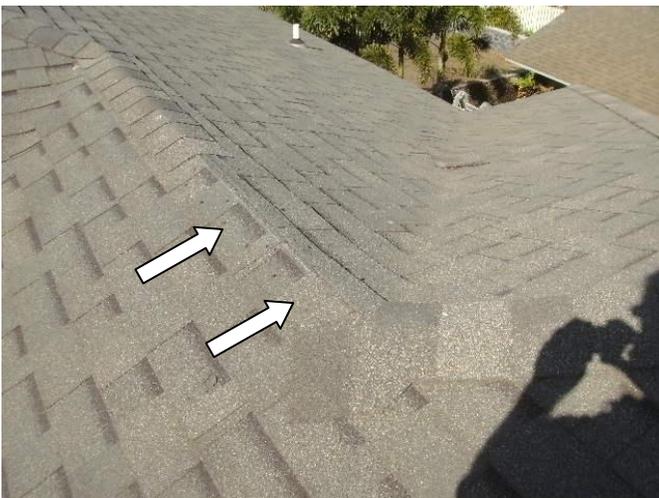
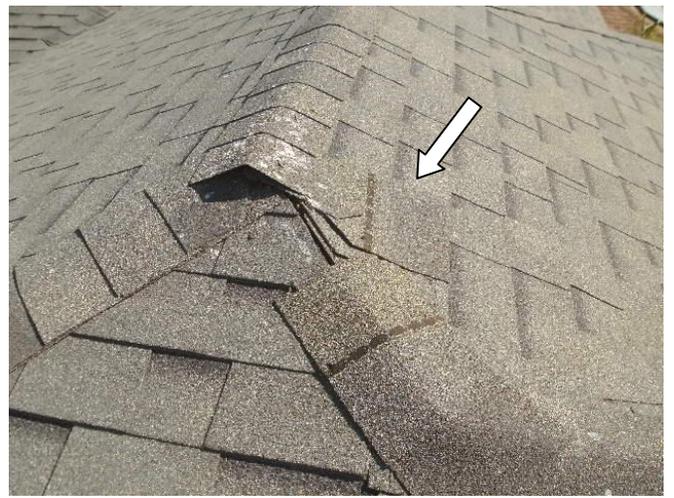
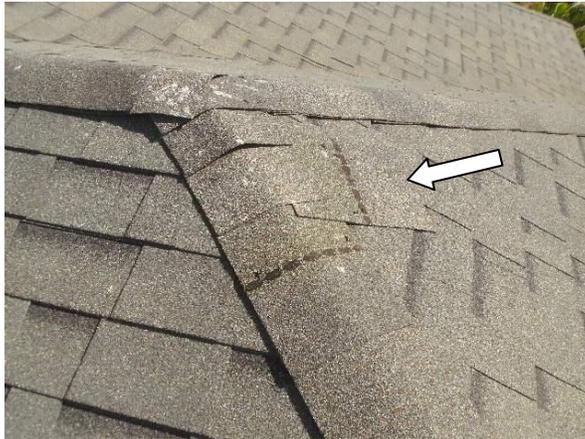
- **Loose, damaged and missing ridge cap was noted at the second floor roof.** Recommend repairs to prevent moisture infiltration.

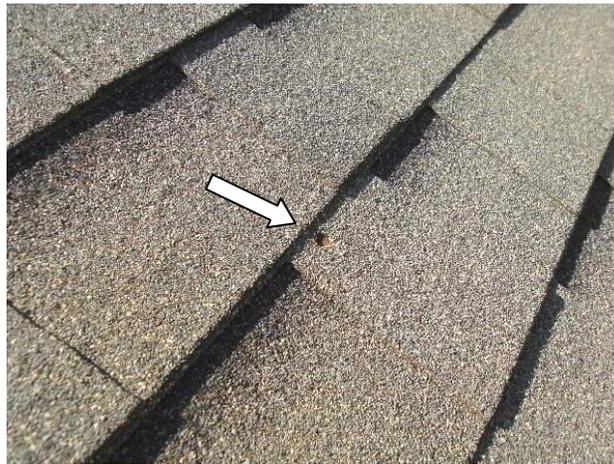
- **An exposed nail was noted at the back of the roof.** Recommend sealing the exposed nail with roofing cement to prevent moisture infiltration.

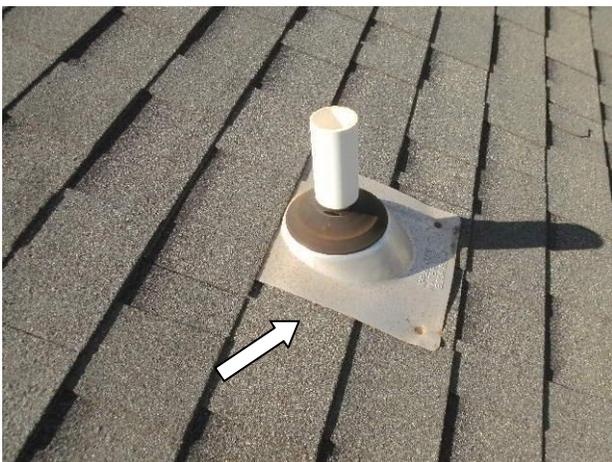
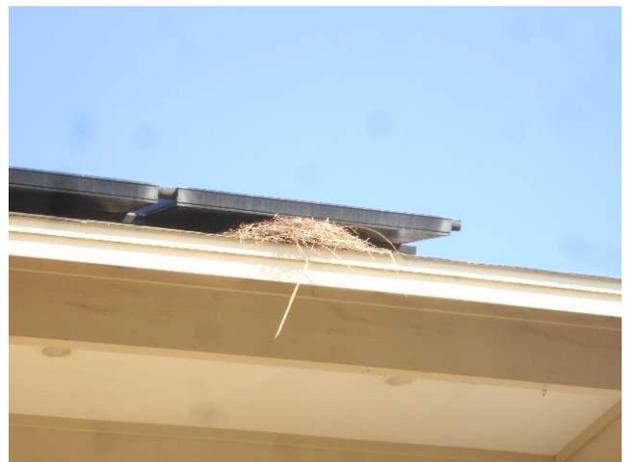
- **Improper installation of the vent pipe flashing was noted,** i.e. the roofing material should cover at least half of the flashing. Recommend repairs to prevent moisture infiltration.
- **A bird's nest was noted at the front of the second floor roof.** Recommend removing the nest.

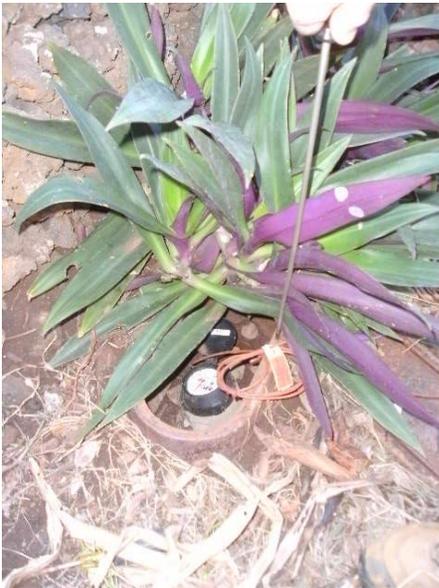
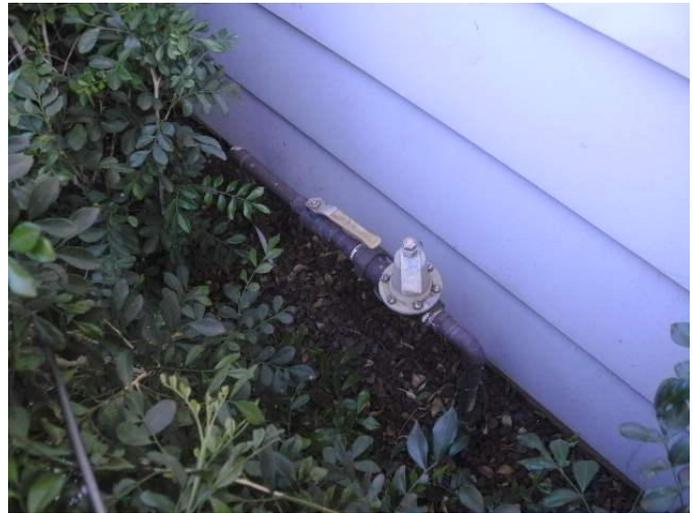
**Comments:** A pressure regulator located at the shutoff valve at the left side of the home controls the pressure to 90 p.s.i.

- **A pressure regulator located at the main shutoff valve controls the pressure to 90 p.s.i..** This is considered to be slightly high water pressure. Recommend adjusting the pressure regulator to bring the p.s.i. down to 80 or below in order to prolong the longevity of the plumbing fixtures.

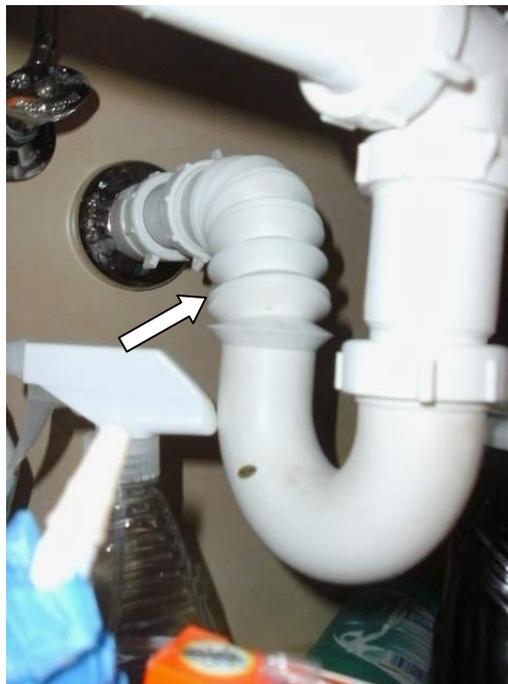
- **Improper piping was noted at the downstairs right side bathroom sink waste line, i.e. flex piping.** Flex pipe tends to collect debris which may lead to slow draining and clogging of the waste line. Recommend replacing the flex piping with solid piping.

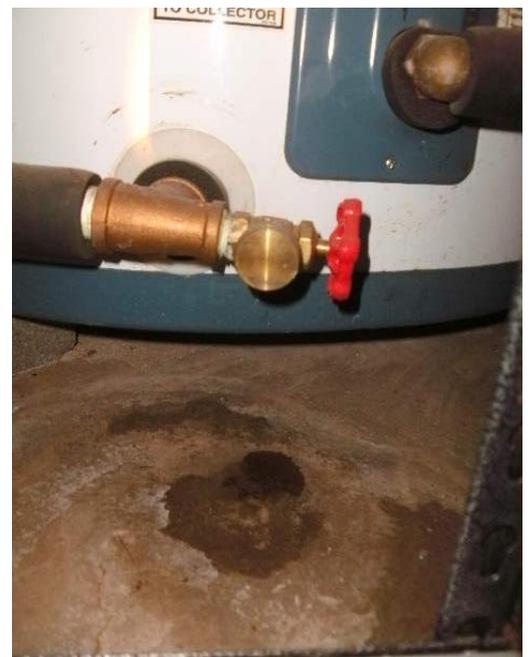
- **A leak was noted at the drain valve of the water heater.** Recommend repairs to prevent the leak.

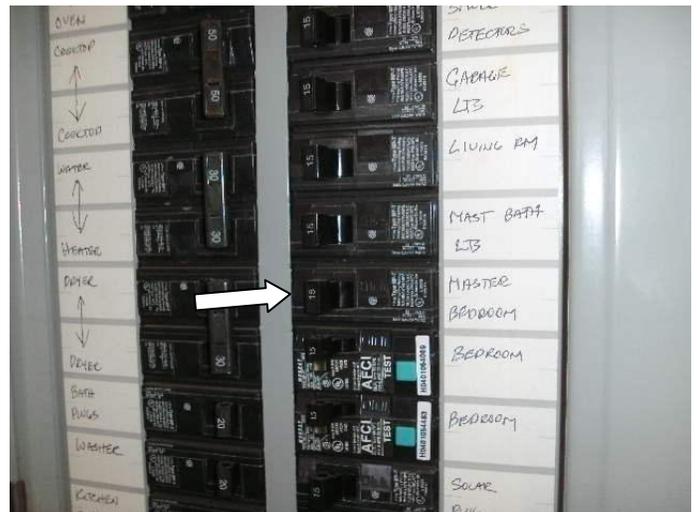
- **The outlets in the master bedroom are not protected by an AFCI (Arc Fault Circuit Interrupter) circuit breaker.** This age of home requires AFCI protected outlets in all of the bedrooms to minimize the potential risk of a fire from defective appliances and wiring. Recommend installing the appropriate AFCI breaker.

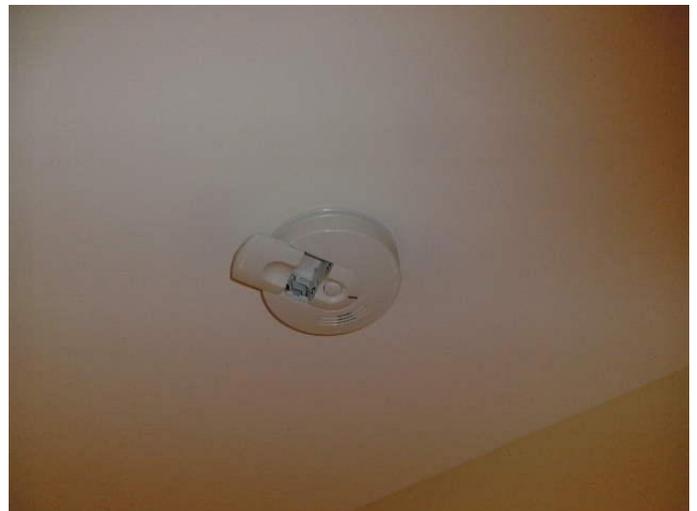
- **The smoke detector in the laundry hallway is missing its battery.** While the smoke detector was functional because it is also connected to the wiring of the home, a new battery should be installed to protect the home in the event of a power outage.

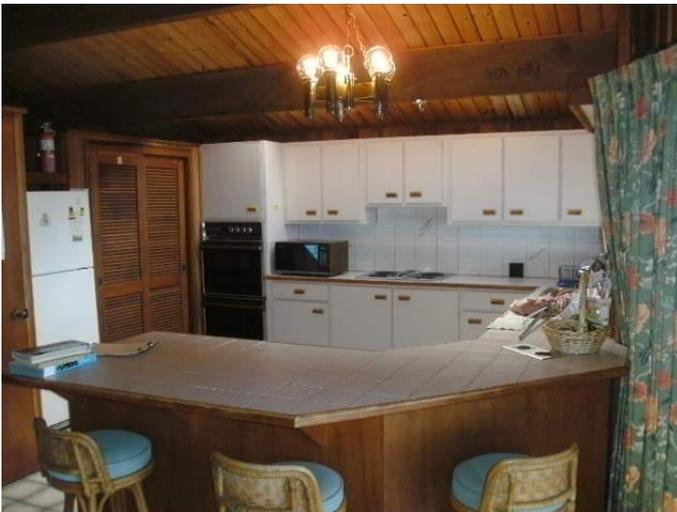
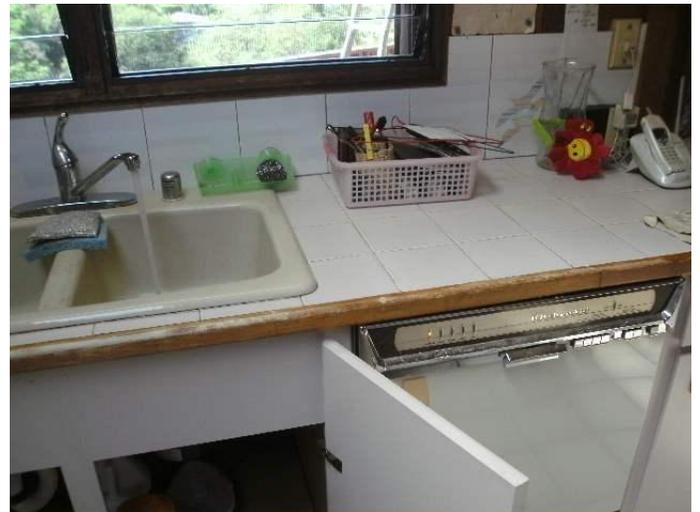
- **A few cracked tiles were noted at the counter and caulking is needed at the counter-to-backsplash connection.** Recommend replacing the cracked tiles and keeping the areas sealed to prevent moisture infiltration.

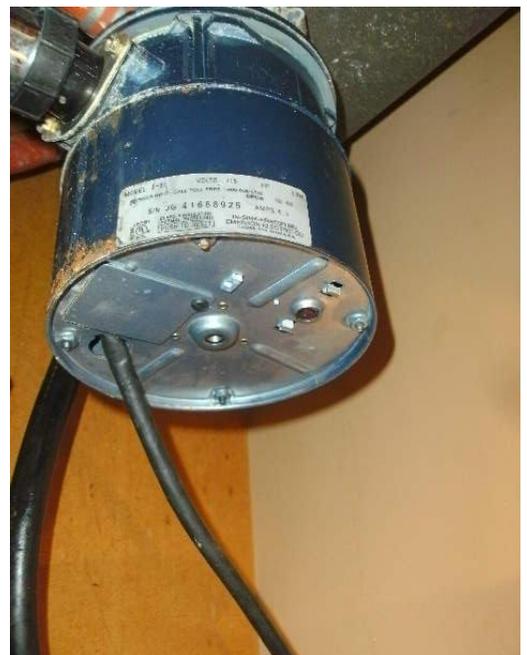
- **There is no wire clamp at the bottom of the garbage disposal.** Recommend installing a wire clamp in order to protect the wires from accidental damage.
- **Corrosion was noted at the interior rotary plate and at the exterior of the garbage**

**disposal.** While functional, the unit should be considered to be near the end of its useful life and the unit may need to be replaced in the near future.

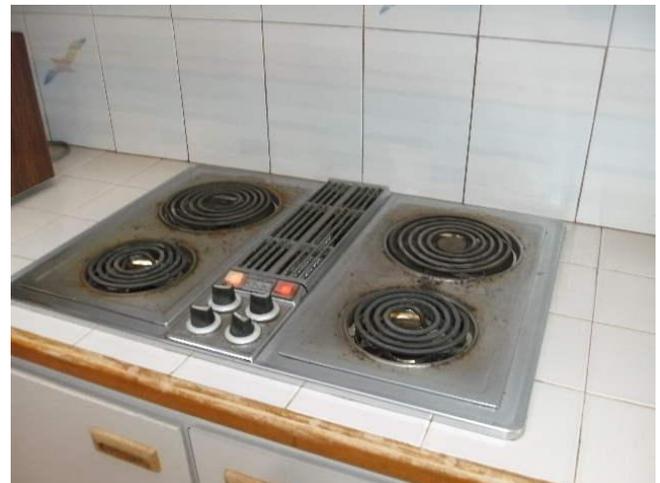
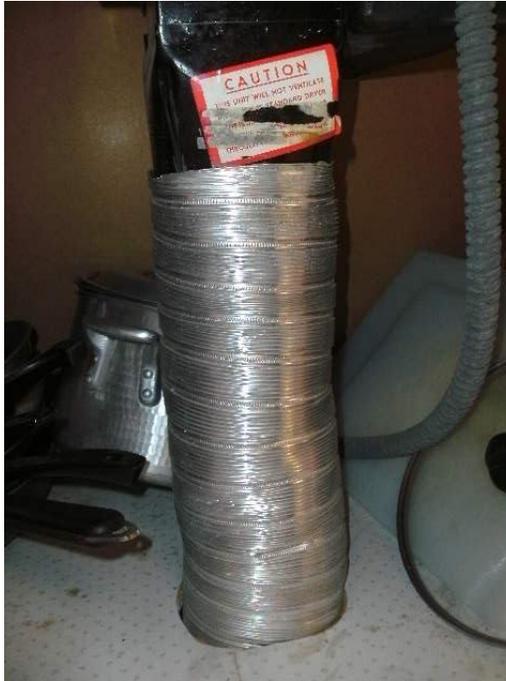
- Improper vent piping was noted at

**the downdraft vent piping**, i.e. flex piping. Flex pipe tends to collect grease and debris which is *a potential fire hazard*. Recommend replacing the flex piping with rigid sheet metal piping.

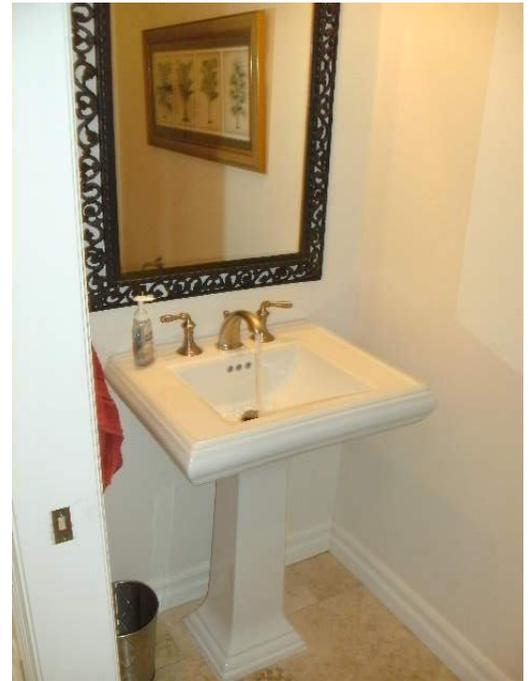
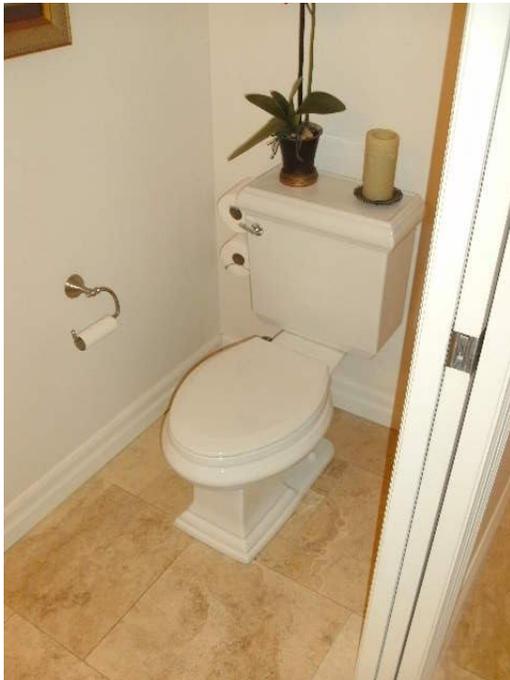
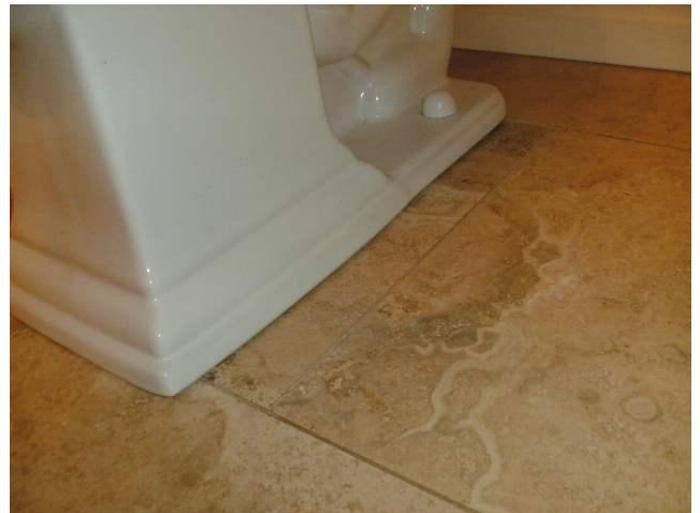
- **Recommend caulking or grout at the base of the toilet.** Recommend caulking or grout at the base of the toilet to prevent moisture infiltration and debris from entering under the toilet and to better secure the unit.

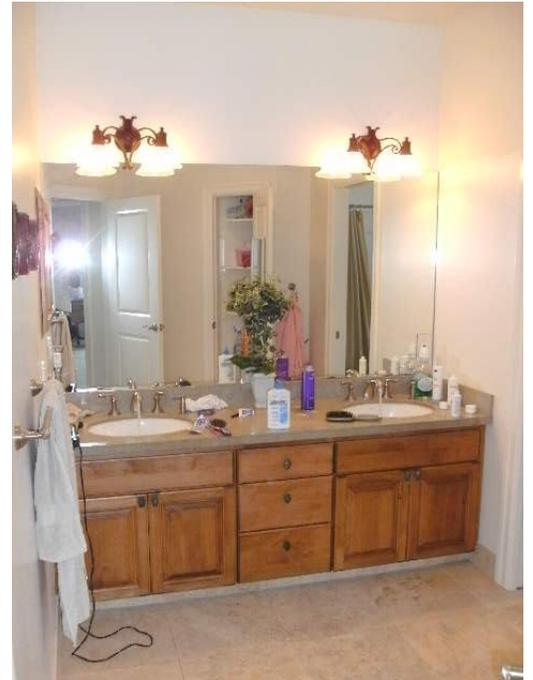
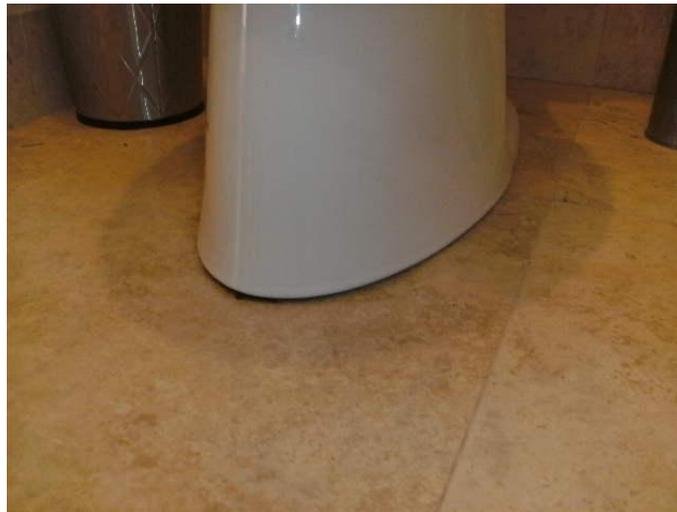
- **The toilet was noted to be loose at the floor.** Recommend installing a new wax ring, caulking the base and ensuring a secure attachment of the toilet to the floor in order to prevent moisture infiltration into the sub-floor.

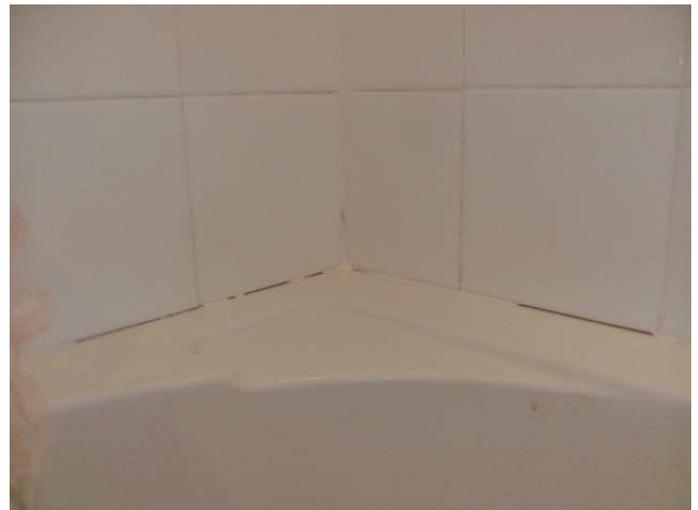
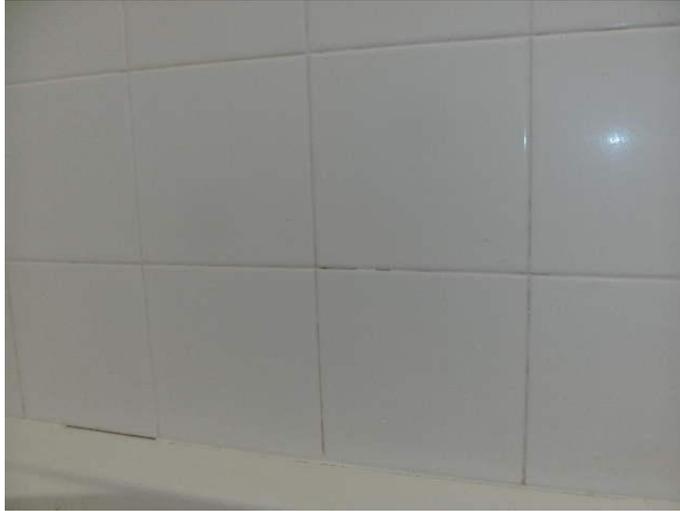
- **Loose and missing grout and caulking was noted at various areas of the shower walls.** Recommend ensuring the integrity of the caulking and grout at all water related areas and this should be considered part of a regular maintenance program.

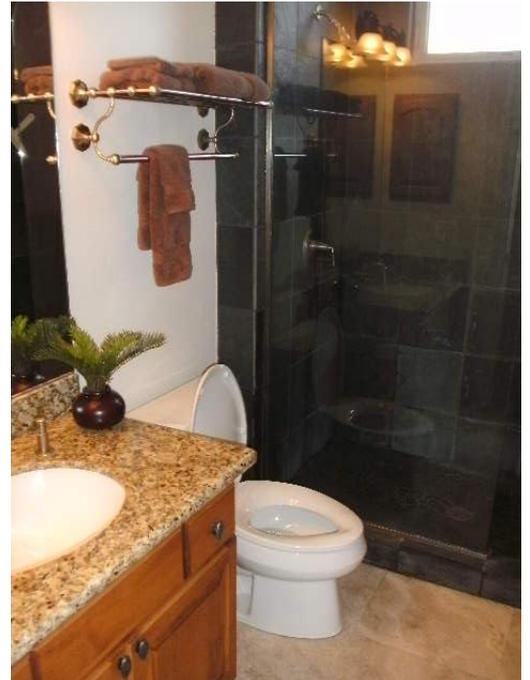
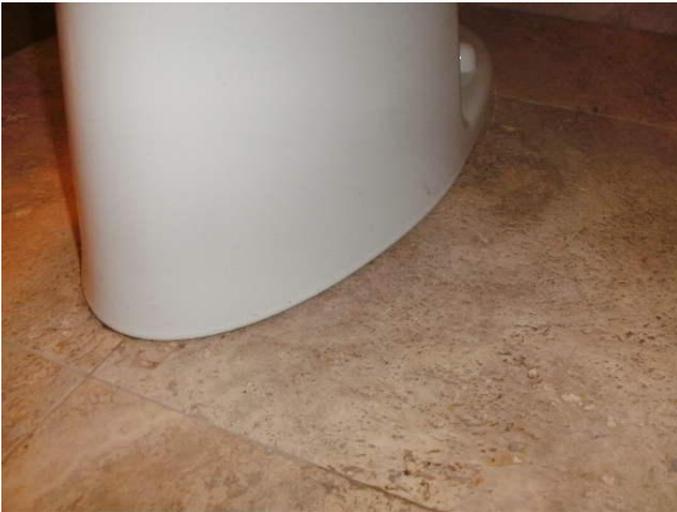
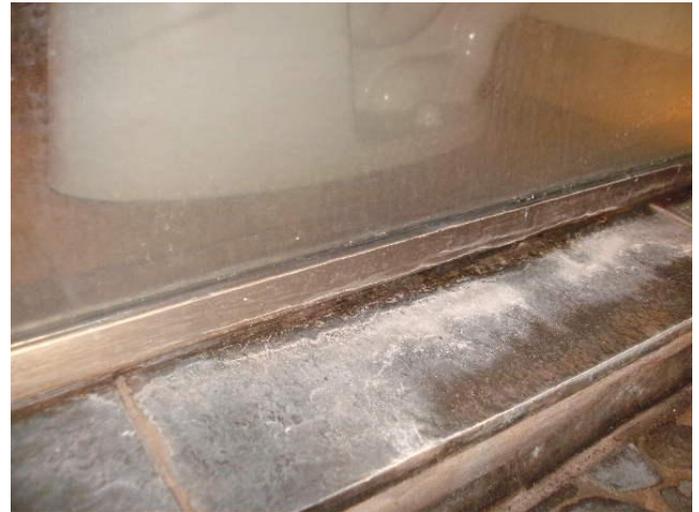
- **The toilet was noted to be loose at the floor.** Recommend installing a new wax ring, caulking the base and ensuring a secure attachment of the toilet to the floor in order to prevent moisture infiltration into the sub-floor.
- **Recommend caulking at the bottom of the shower glass panel.** Recommend ensuring the integrity of the caulking and grout at all water related areas and this should be considered part of a regular maintenance program.

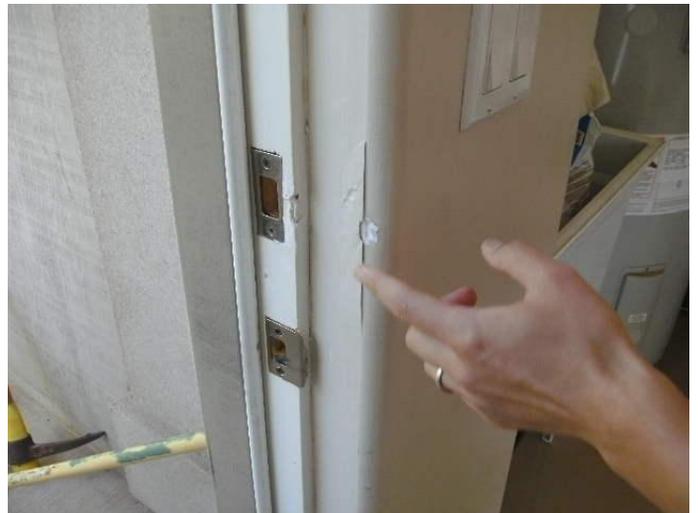
- **Cosmetic damage was noted at the drywall at the exterior side door.** Recommend patching the area as a cosmetic concern.

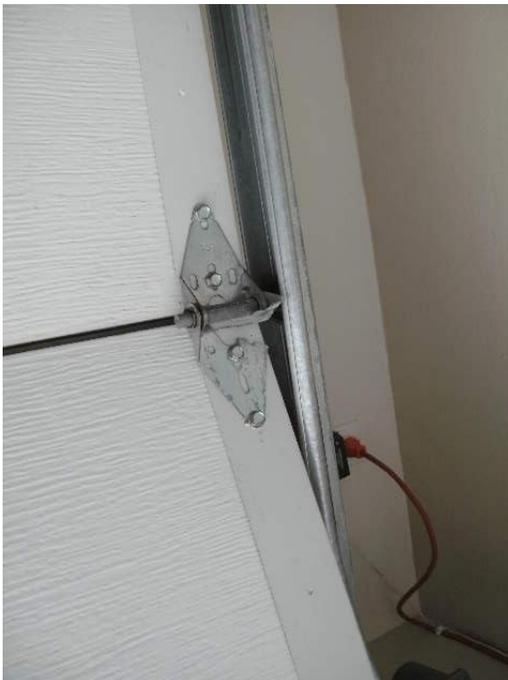
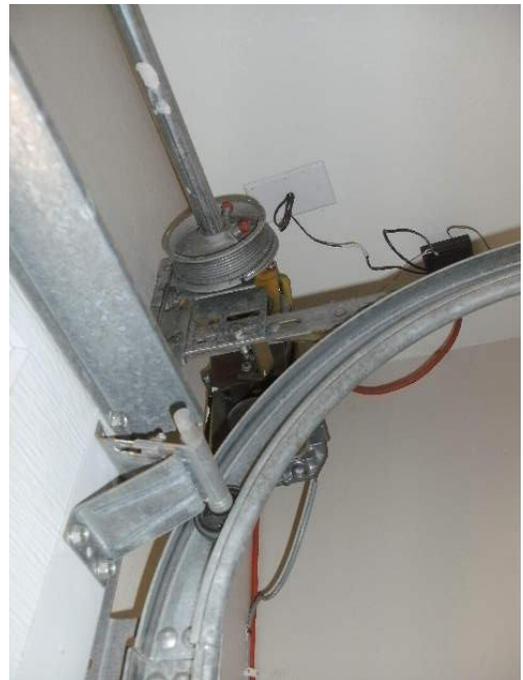
- **Several defects were noted at the garage vehicle door and opener, i.e. (a) a damaged hinge was noted at the right side door, (b) the manual over-ride release lever was noted to be bolted in place, (c) a loose bolt was noted at the door opener bracket, (d) there are no photo-eye sensors for an automatic reverse feature (required on all U.S. openers) and (e) the size of the door exceeds the recommended door size for this opener (not to exceed 160 sq. ft.).** Recommend repairs to the door and recommend the proper installation of the opener as per the ZAP installation instructions at [http://www.acd-usa.com/PDF/800R\\_Installation\\_Manual.pdf](http://www.acd-usa.com/PDF/800R_Installation_Manual.pdf).

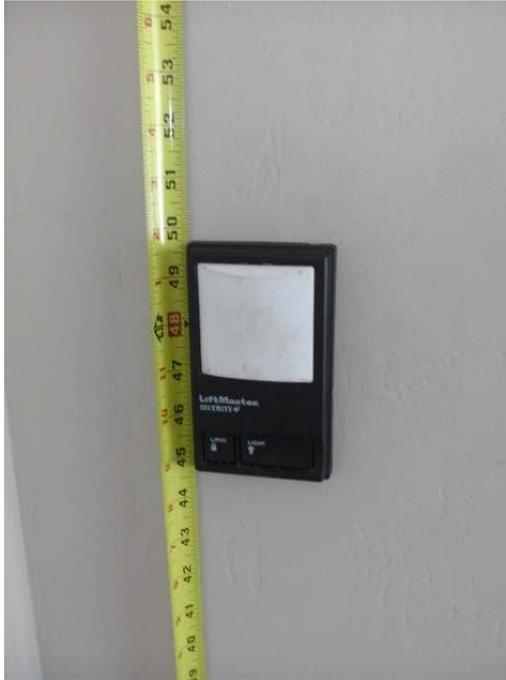
- **The garage door opener control buttons are installed too low at 48 inches above the garage floor.** The manufacturer of this opener and the Consumer Product Safety Commission recommends that the button be installed at a height of at least 60 inches to prevent access to the button from small children.
