HOME INSPECTION REPORT

123 Sample Circle

Kihei, Hawaii

Mark Thorman Home Inspections

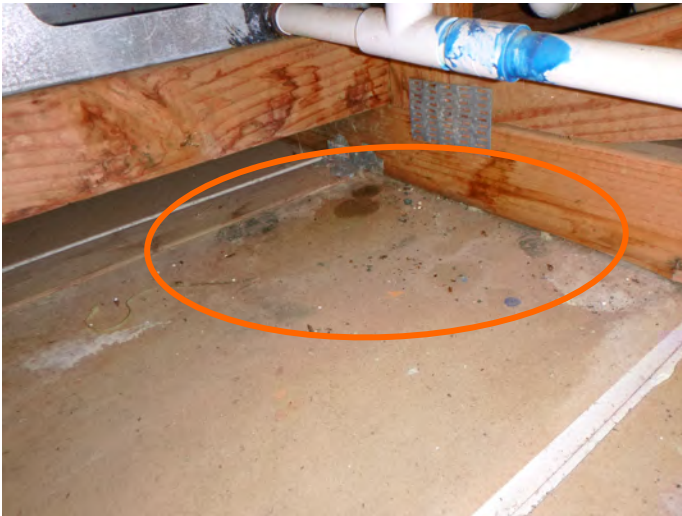
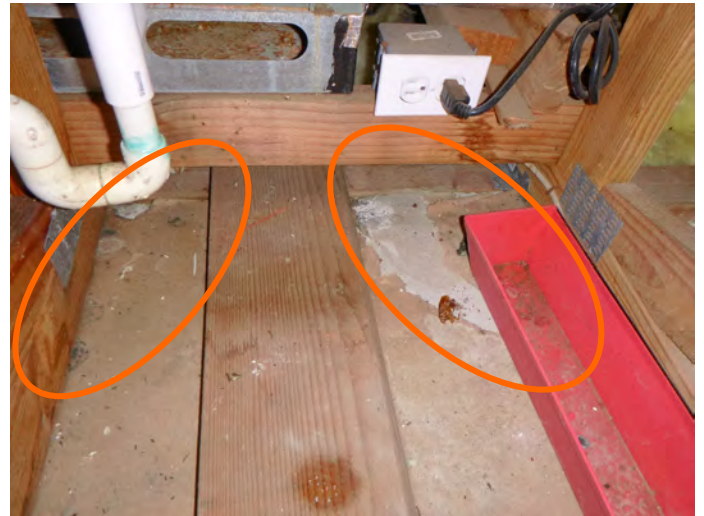
- **A mold/mildew-like substance was noted at the attic side of the ceiling drywall under the air conditioning system air handler.** This appears to have been caused by a past leak at the air handler (See Air Conditioning section of this report). While determining the presence or type of mold/mildew is outside the scope of this inspection, due to the health issues related to mold/mildew in the home, I recommend additional attention be given to this area. The EPA (Environmental Protection Agency) and the CDC (Center for Disease Control) recommends removal of mold/mildew with water and detergent and replacing the affected materials that have absorbed the mold/mildew. Contact a licensed contractor experienced and certified in mold remediation.

3. **A mold/mildew-like substance was noted at the attic side of the ceiling drywall under the air conditioning system air handler.** This appears to have been caused by a past leak at the air handler (See Air Conditioning section of this report). While determining the presence or type of mold/mildew is outside the scope of this inspection, due to the health issues related to mold/mildew in the home, I recommend additional attention be given to this area. The EPA (Environmental Protection Agency) and the CDC (Center for Disease Control) recommends removal of mold/mildew with water and detergent and replacing the affected materials that have absorbed the mold/mildew. Contact a licensed contractor experienced and certified in mold remediation.

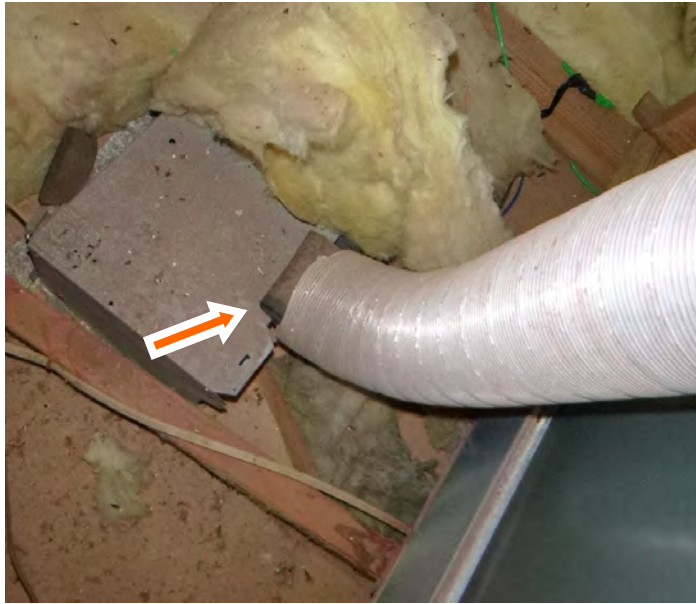
- **The bedroom #1 bathroom exhaust fan was noted to vent directly into the attic.** The vent tubing was noted to have become disconnected from the fan housing. Recommend repairs to ensure a proper connection.

4. **The bedroom #1 bathroom exhaust fan was noted to vent directly into the attic.** The vent tubing was noted to have become disconnected from the fan housing. Recommend repairs to ensure a proper connection.

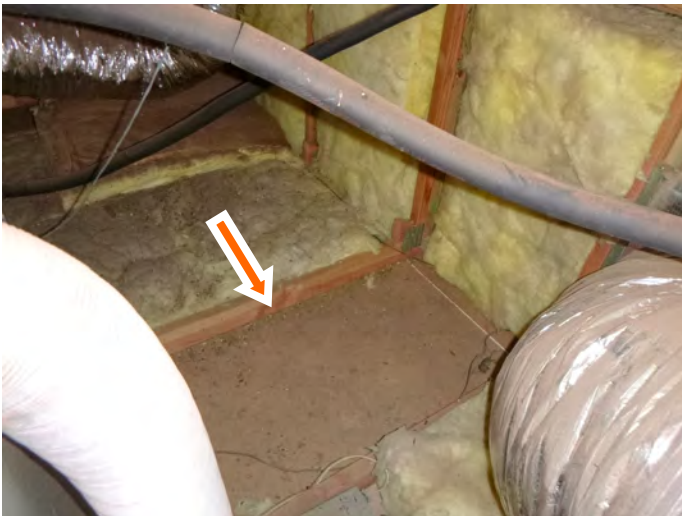
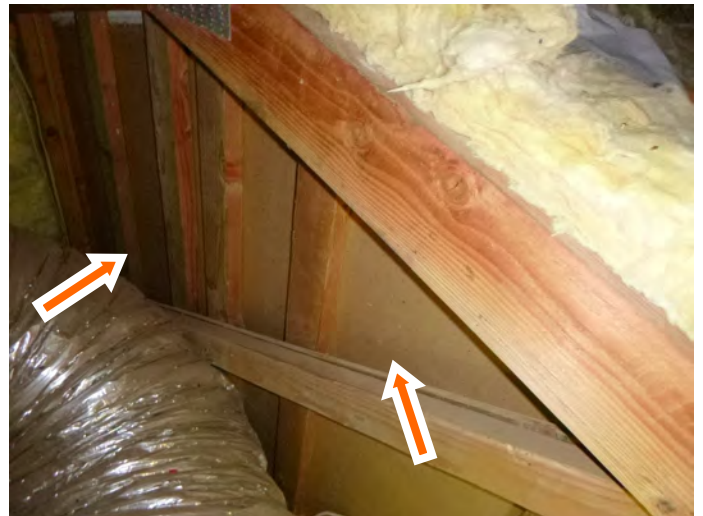
- **Poor coverage of the attic insulation was noted**, i.e. several pieces of insulation were noted to have been relocated and there is no insulation at the vaulted walls of the master bedroom. Recommend completing the insulation as an energy saving concern.

5. **Poor coverage of the attic insulation was noted**, i.e. several pieces of insulation were noted to have been relocated and there is no insulation at the vaulted walls of the master bedroom. Recommend completing the insulation as an energy saving concern.

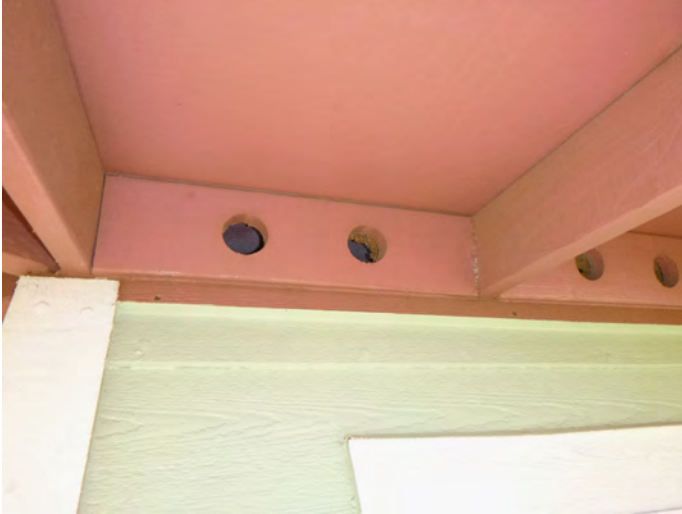
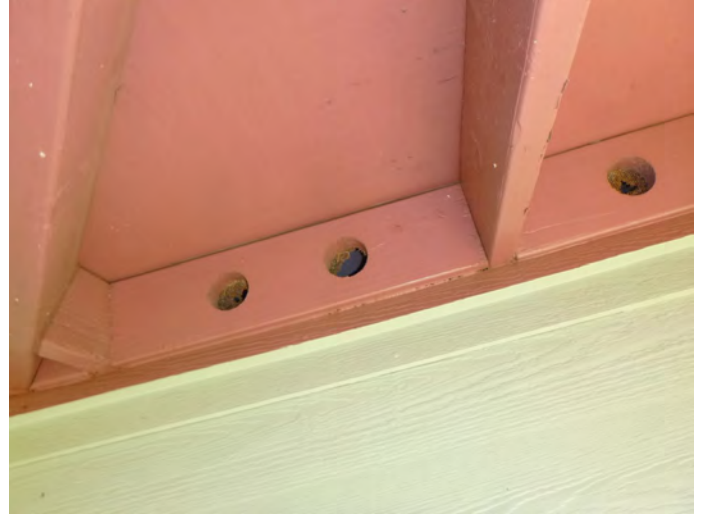
- **Several eave vent screens were noted to be missing or damaged. Recommend installing new screens in order to prevent birds from entering and nesting in the attic.**

6. **Several eave vent screens were noted to be missing or damaged.** Recommend installing new screens in order to prevent birds from entering and nesting in the attic.

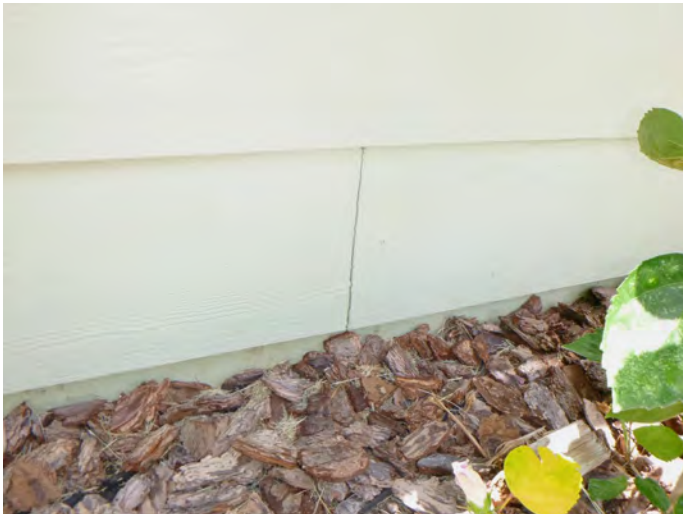
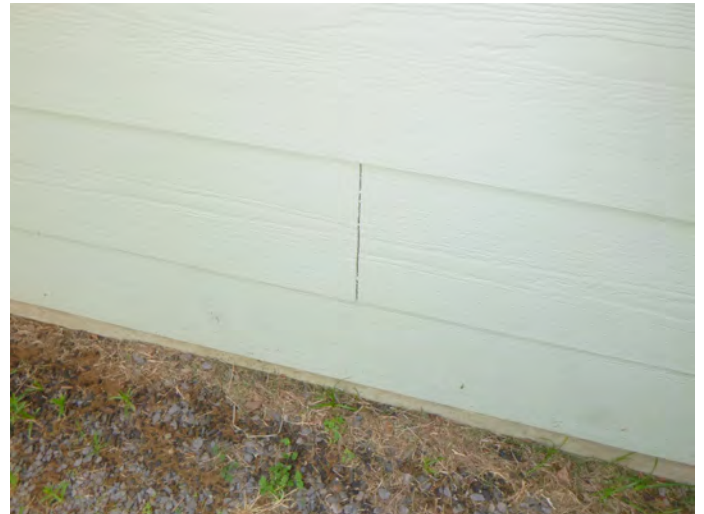
- **Several of the siding butt joints of the home were noted to be in need of caulking.** Recommend ensuring the integrity of the caulking as part of a regular maintenance program.

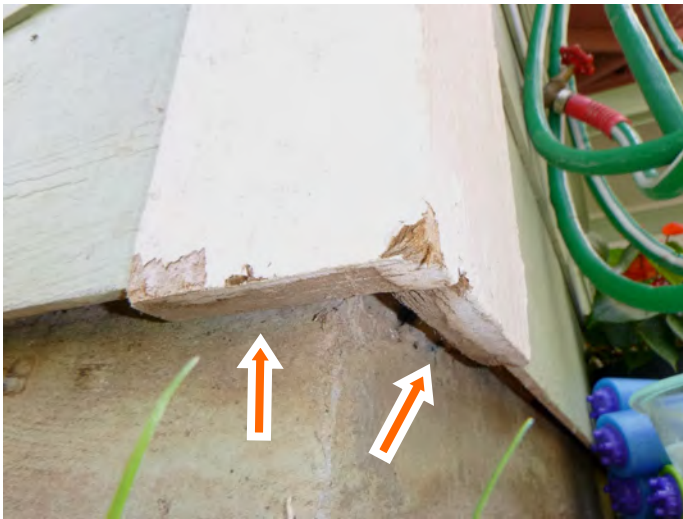
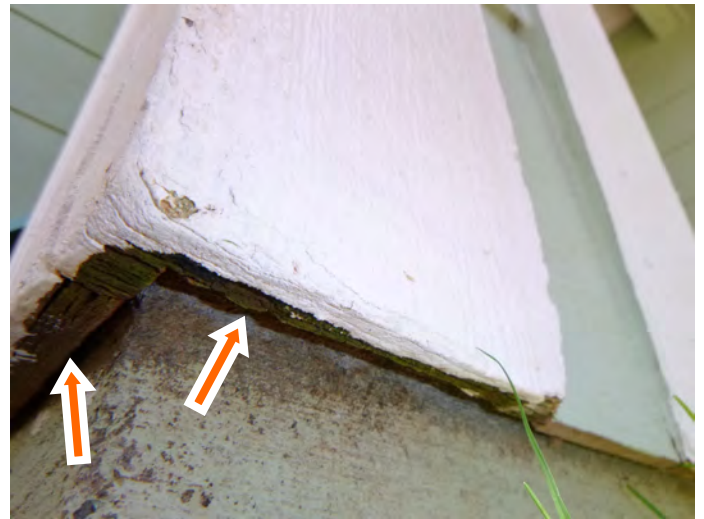
- **The cut ends at the bottoms of the corner and door trim are not properly sealed.** The trim of this home is a fibrous wood product that is susceptible to moisture damage when exposed. The manufacturer of this product, MiraTEC, recommends to “1. Prime and paint all raw and field cut ends of MiraTEC trim which will be exposed to the weather. Use a high quality exterior primer and paint formulated for use on composite wood and 2. Coat all surfaces including the bottom edge.” Recommend sealing the ends to prevent moisture damage to the trim.

trim of this home is a fibrous wood product that is susceptible to moisture damage when exposed. The manufacturer of this product, MiraTEC, recommends to “1. Prime and paint all raw and field cut ends of MiraTEC trim which will be exposed to the weather. Use a high quality exterior primer and paint formulated for use on composite wood and 2. Coat all surfaces including the bottom edge.” Recommend sealing the ends to prevent moisture damage to the trim.

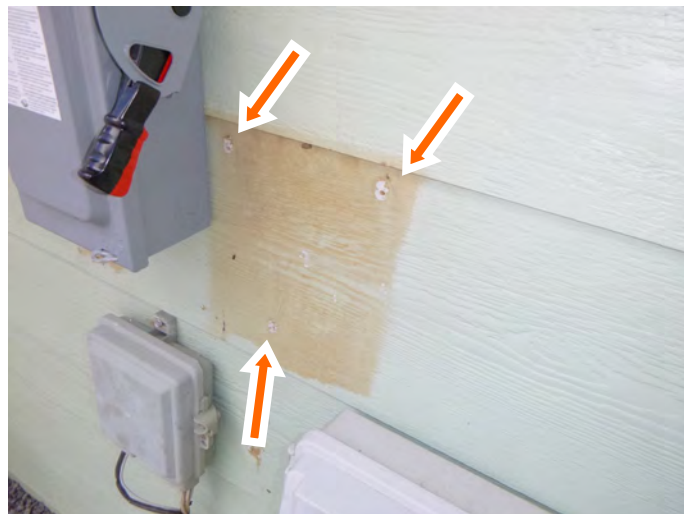
- **Holes were noted in the exterior siding at right side of the garage.** Recommend sealing the holes (caulking) to prevent moisture infiltration.

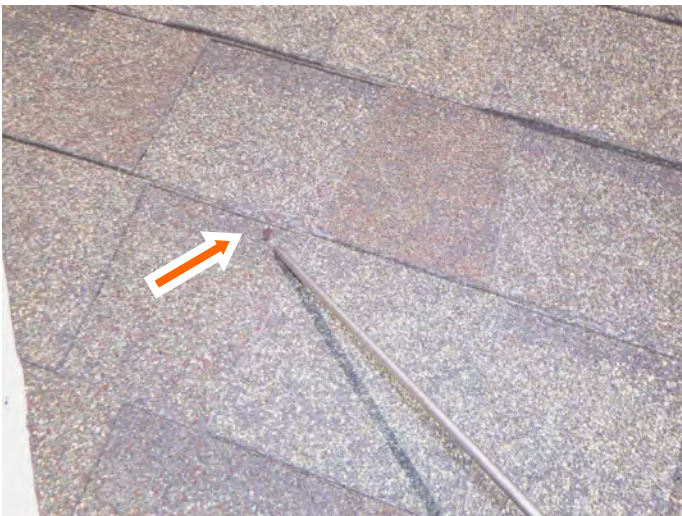
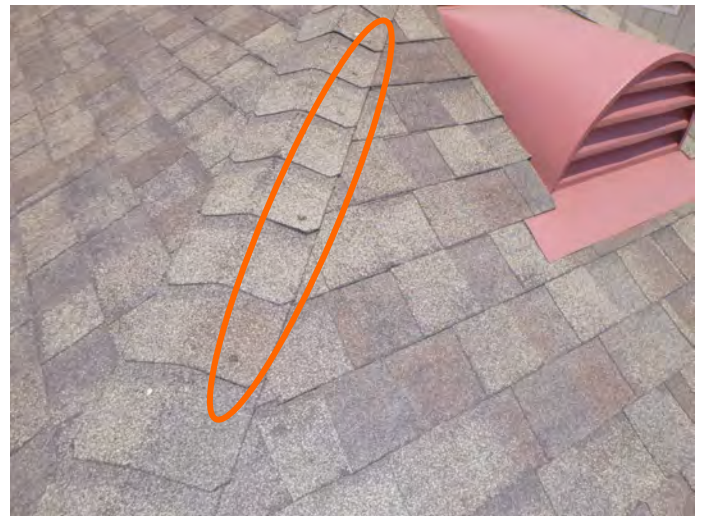
- There are several exposed nail heads and numerous raised nail heads popping through the roof shingles and ridge caps. The raised nails appear to be a result of crooked and under-driven nailing. Recommend removing the raised nails and sealing the holes and exposed nail heads with roofing cement in order to prevent moisture infiltration. Contact a licensed roofing contractor for further evaluation and repairs.

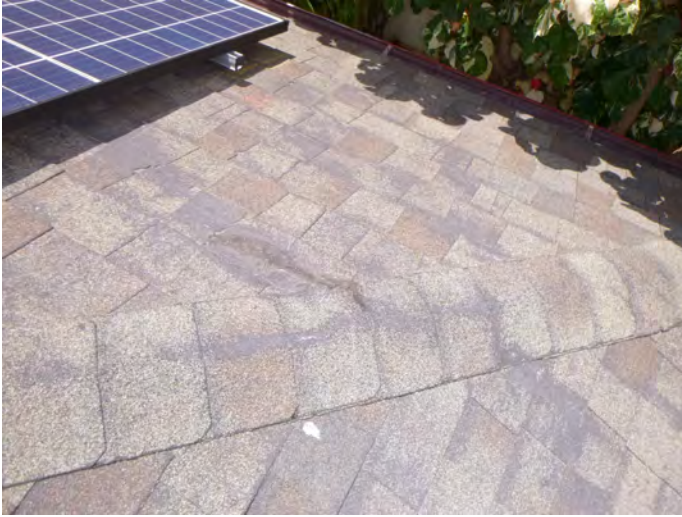
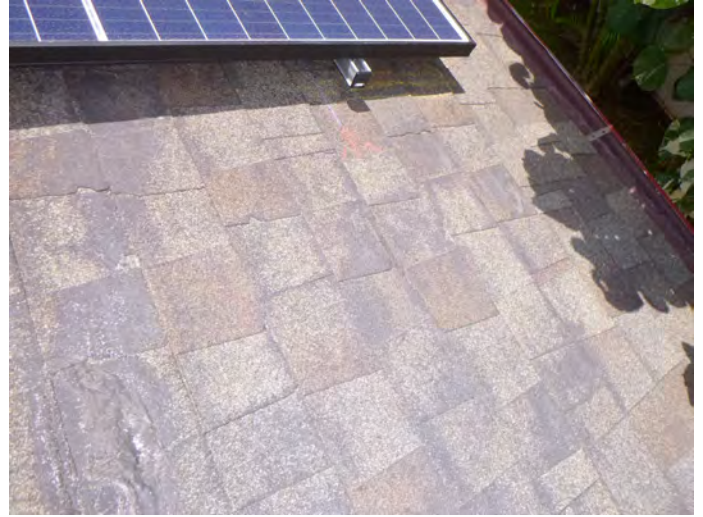
- **Several damaged shingles were noted at the back left corner of the roof.** This appears to be the result of past vegetation that was in contact with the roof. Contact a licensed roofing contractor for further evaluation and repairs.

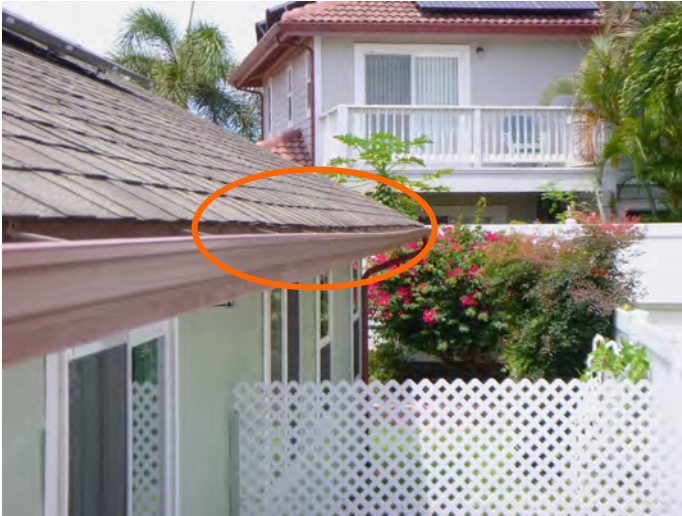
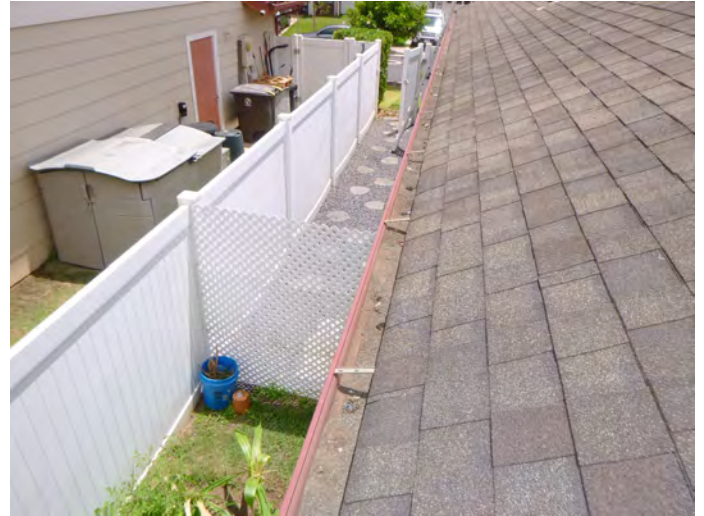
- **Evidence of poor drainage was noted at the gutter at the right side of the home, i.e. there is debris and a large dip in the gutter. Recommend removing the debris and adjusting the gutter to ensure a slight downward slope toward the downspout or the installation of an additional downspout at the low sections of the gutter to better control roof drainage.**

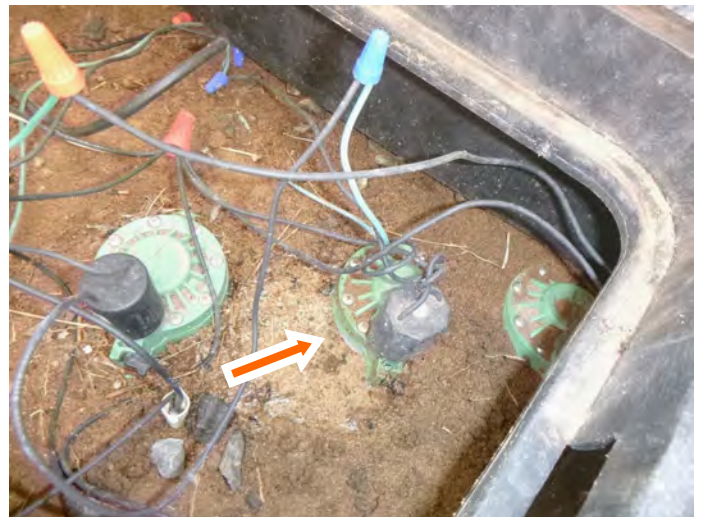
- A leak was noted at one of the landscaping sprinkler valves at the right side of the home. While the inspection of the landscaping sprinkler system is outside the scope of this inspection, I recommend repairs to prevent leaks.

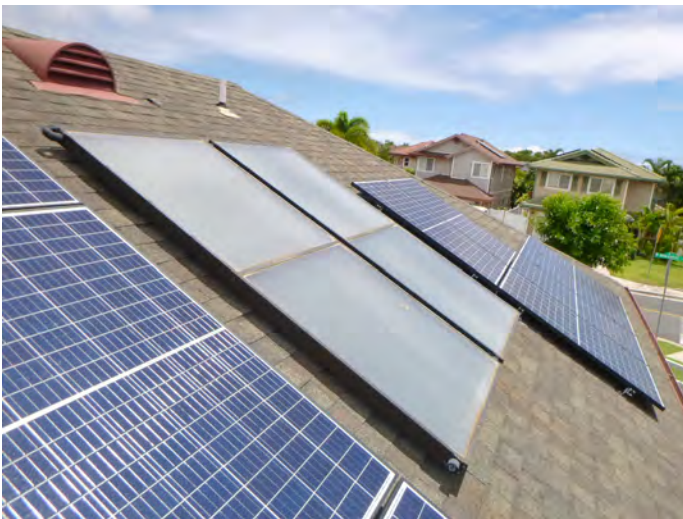
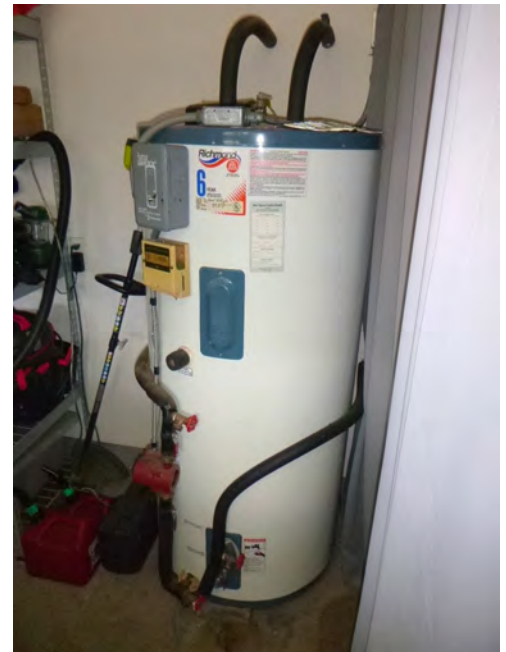
Comments: The overall condition of the water heating system was noted to be fair with typical wear and corrosion noted, although:

- While the water heating system was noted to be functional, based on the age of the system (13 years old) and the amount of corrosion noted, this system is considered to be nearing the end of its useful life. Repairs or replacement of the system may be required in the near future.

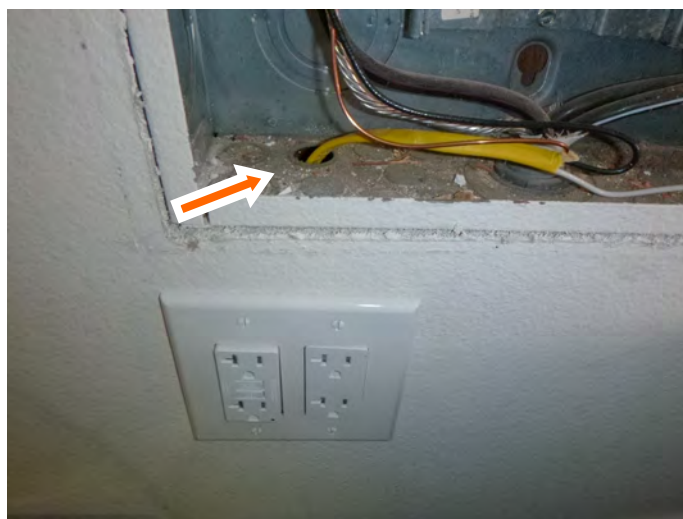
- The wires entering at the bottom of the garage panel are missing the bushing/wire clamp and the breaker is not labeled. Bushings/wire clamps are important, as they protect the wires from damage that may occur at the area where the wires enter the panel. Recommend installing a bushing or wire clamp and labeling the circuit.

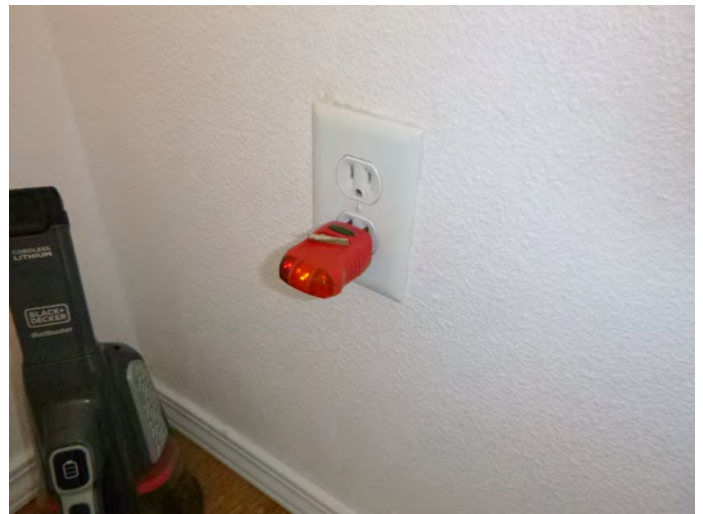
- **Reverse polarity was noted at most of the outlets in bedrooms #1 and #2.** Reverse polarity, simply put, means the wires are hooked up backwards. The outlets will appear to function normally, although injury can result when using defective appliances. Repairs are recommended to ensure that the hot and neutral wires of the power

supply circuit are connected to the corresponding hot and neutral wires of the appliance. Contact a licensed electrical contractor for further evaluation and repairs.

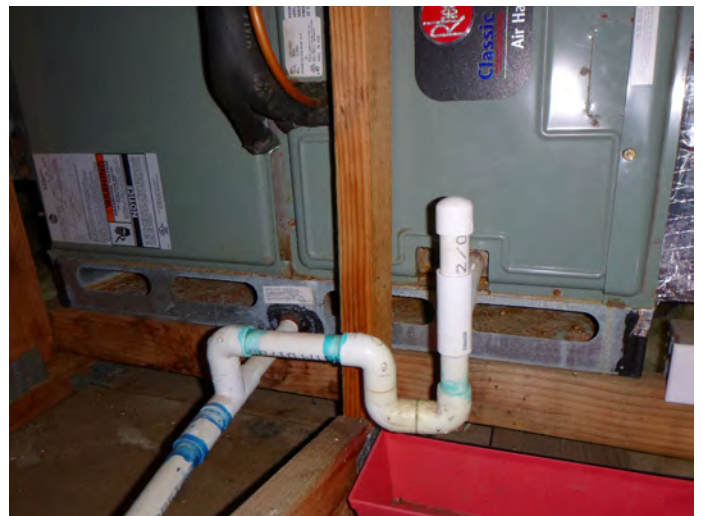
- Evidence of repairs was noted to the air handler drainage system, i.e. moisture stains and a mold-like substance was noted at the drywall under the air handler. Recommend obtaining information from the seller as to the reason for and the extent of the repairs performed.

2. **Evidence of repairs was noted to the air handler drainage system**, i.e. moisture stains and a mold-like substance was noted at the drywall under the air handler. Recommend obtaining information from the seller as to the reason for and the extent of the repairs performed.

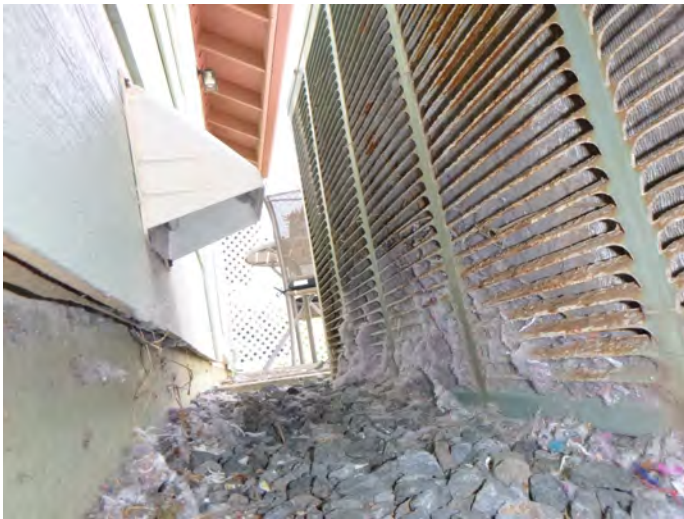
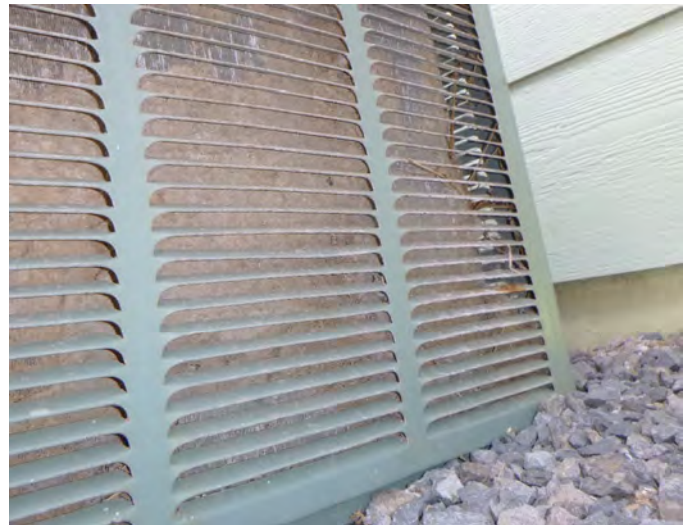
- **The secondary drain pan under the air handler does not have its own independent drain line installed**, i.e. air handlers installed in attics are required to have a secondary drain pan with an independent drain line diverted to an exterior conspicuous location (usually above a window). Recommend installing an independent drain line for the secondary pan. Contact a licensed HVAC contractor for further evaluation and repairs.
- **Excessive clothes dryer lint was noted at the condenser coils**. This is due to the poor location of the clothes dryer exterior vent hood. Recommend removing the lint from the coils and relocating the dryer vent hood away from the condenser. Contact a licensed HVAC contractor for further evaluation and repairs.

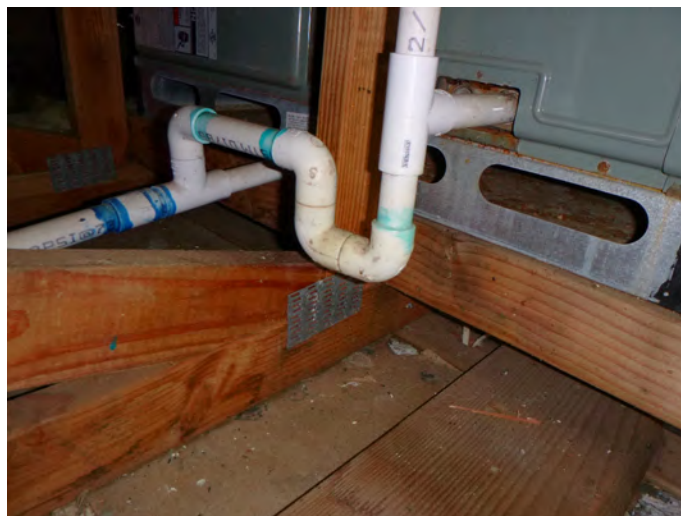
- **There is no insulation on the condensation drain line of the air handler**. Recommend installing insulation on the drain line, as condensation on the drain line was noted to be dripping onto the drywall below the unit.

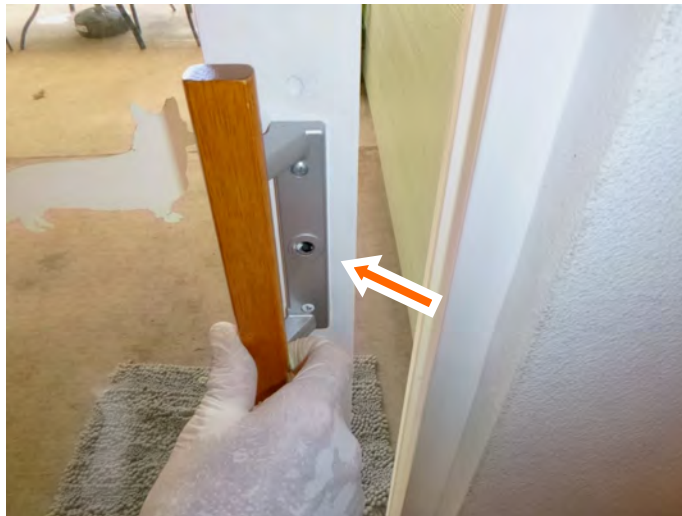
- **The door latch lever at the lanai sliding glass door was noted to be missing.** Recommend installing a new latching mechanism.

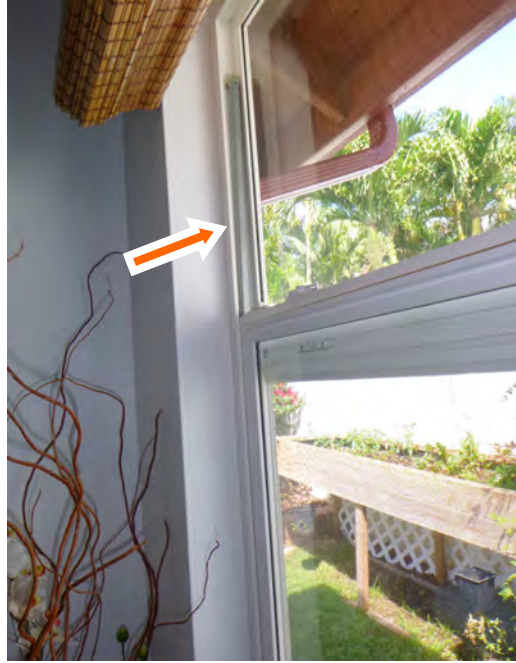
- **The balancing mechanism at the right side master bedroom window was noted to be disconnected from the sash.** Recommend reconnecting the mechanism and further evaluation of the window be made at that time.

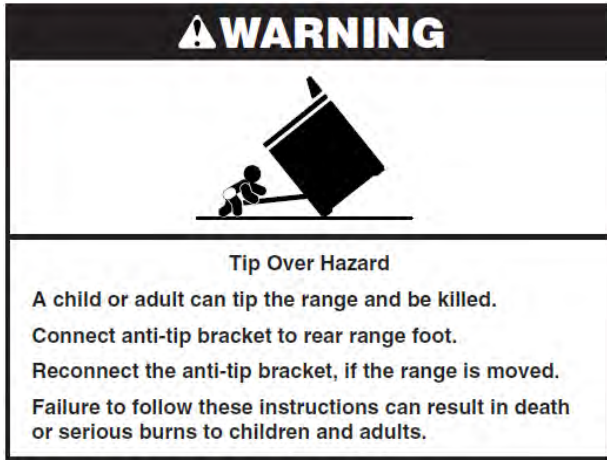
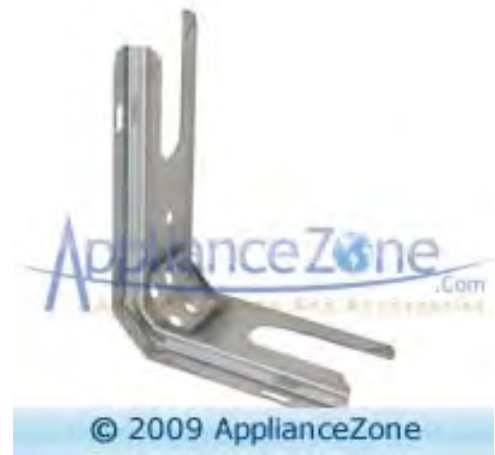
- **The range is not equipped with an anti-tip device.** Without properly installed anti-tip hardware provided by the manufacturer, a free-standing or slide-in kitchen range can tip forward accidentally if the oven door is used as a step stool or makeshift seat, which may result in serious injury or death.

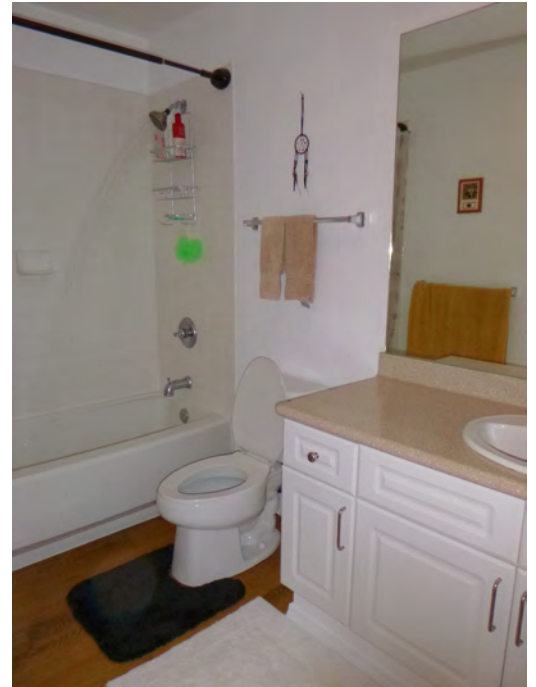
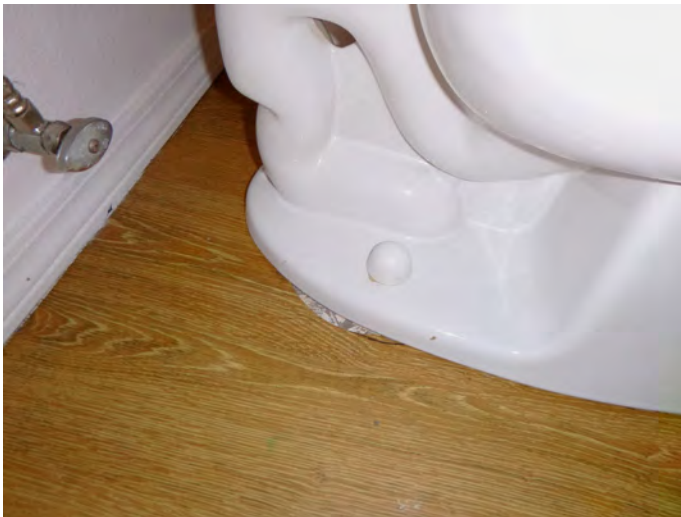
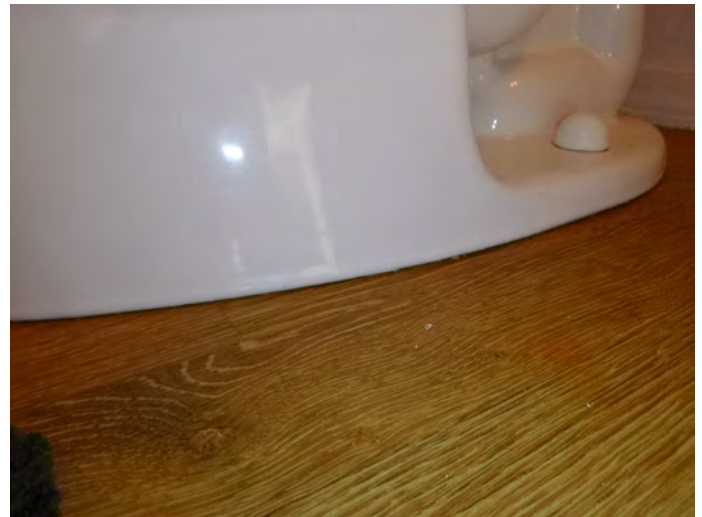
- **Recommend caulking at the base of the toilet.** Recommend caulking at the base of the toilet to prevent moisture infiltration and debris from entering under the toilet and to better secure the unit.

- **The drain stopper at the bathtub was noted to be missing.** Recommend installing a drain stopper.
- **Hard water deposits were noted in the toilet bowl.** Recommend removing the deposits, as the toilet bowl walls should have a smooth surface to ensure proper flushing.

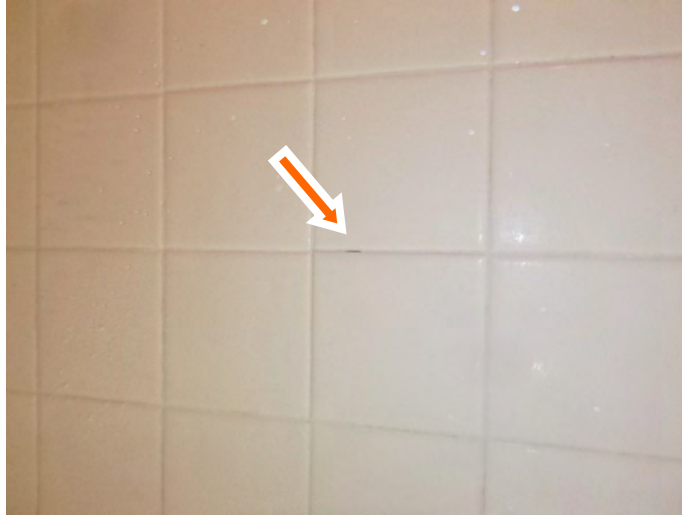
- **A small hole was noted between the tiles at the back of the shower walls.** Recommend installing additional grout or caulking and I recommend ensuring the integrity of the caulking and grout at all water related areas as part of a regular maintenance program.

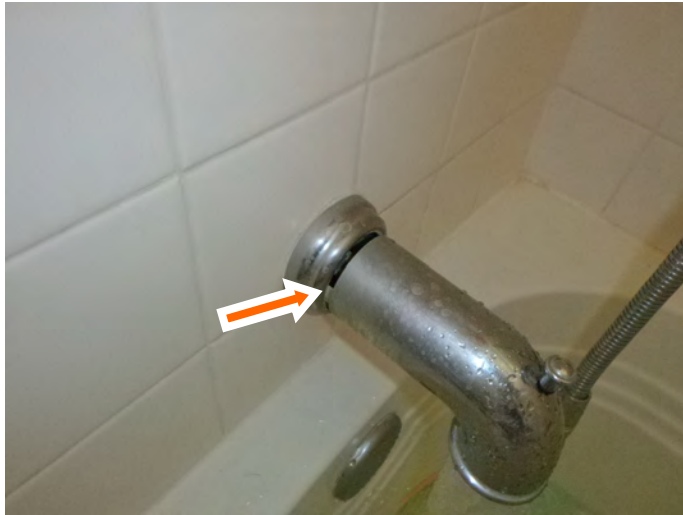
- **The drain stopper at the bathtub was not functional.** Recommend installing a new drain stopper.
- **The bathtub spigot was noted to be loose.** Recommend ensuring a secure attachment of the spigot.

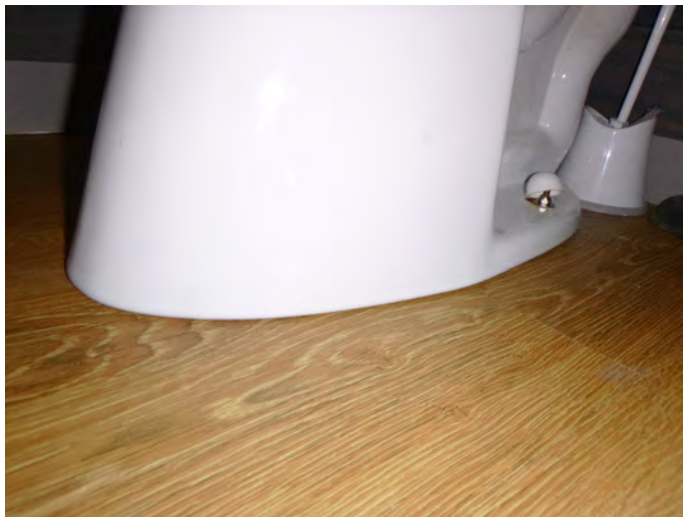
- **The toilet was noted to be loose.** Recommend caulking the base and ensuring a secure attachment of the toilet to the floor in order to prevent moisture infiltration into the sub-floor.

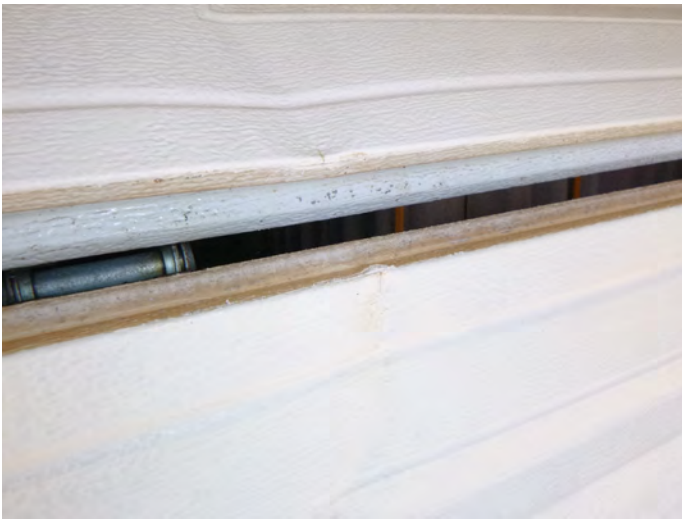
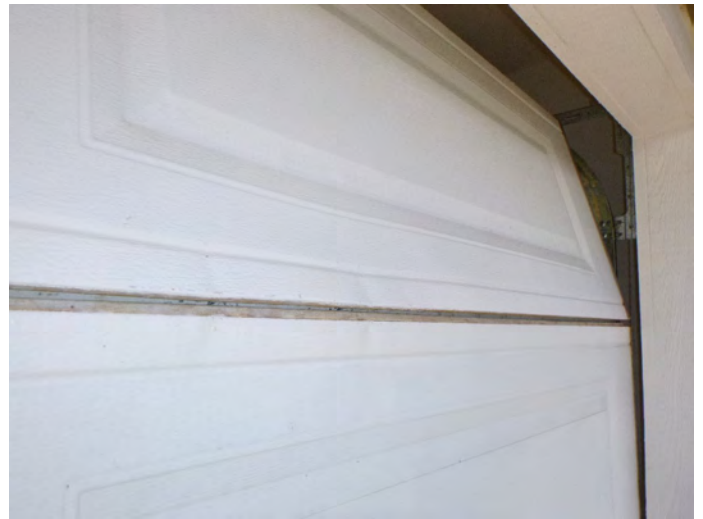
- **Minor damage and hair line cracks were noted at the bottom two panels.** While the door was functional, I recommend periodic inspection of the panels.

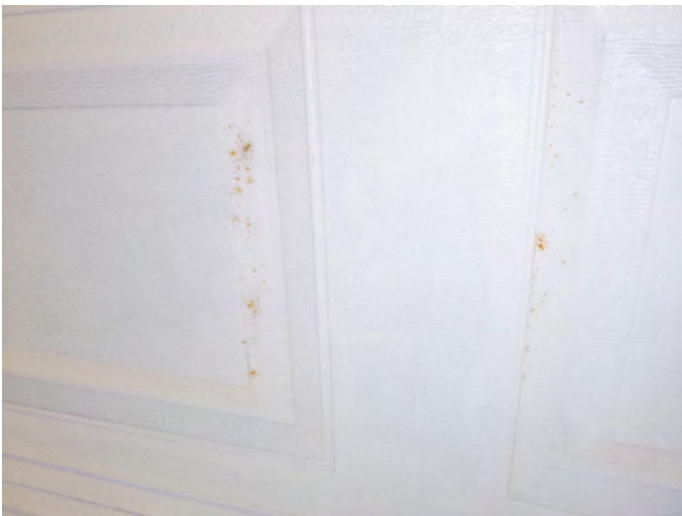
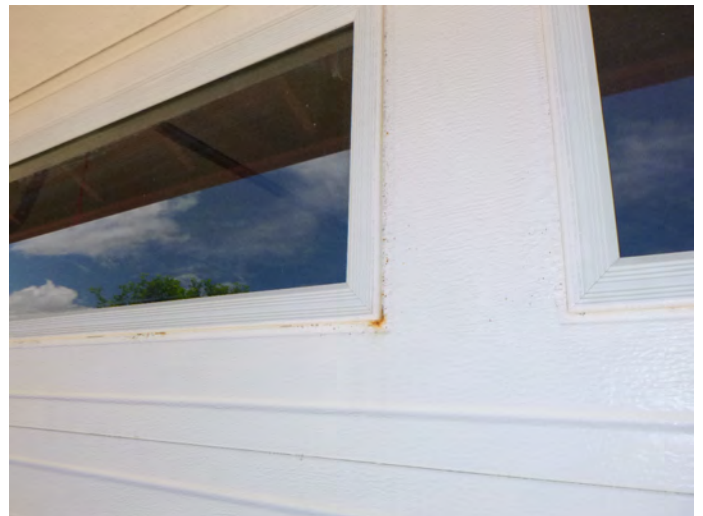
- **Surface corrosion was noted at the exterior of the garage vehicle door.** Recommend lightly sanding the affected areas and painting with a rust resistive paint.
