Foundation Design, P.C.

Reference: Yellow Mills Road Solar Farm
466 Yellow Mills Road, Farmington, New York
Geotechnical Evaluation, 4618.0 (Revised)

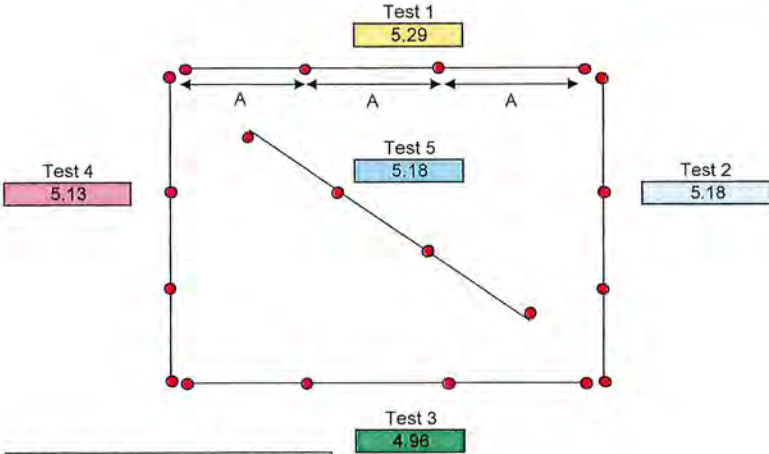
Electrode Spacing (A) 10 ft Electrode depth (B) 0.5 ft

rho calculation $\rho = 191.5AR$

Test	Test Reading R	Soil Resistivity ρ
1	5.29	10130.4
2	5.18	9919.7
3	4.96	9498.4
4	5.13	9823.95
5	5.18	9919.7

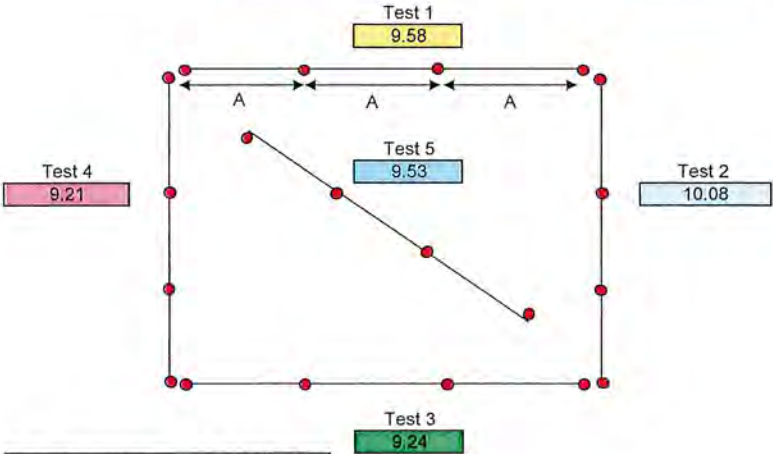
Test Location Yellow Mills Road Solar, Farmington, New York P-23 Test Date 06.21.19
 Address 466 Yellow Mills Road, Farmington, New York
 Model AEMC 4620 Operator Name: J. Goggin

Electrode Spacing (A) 10 ft Electrode depth (B) 0.5 ft

rho calculation $\rho = 191.5AR$

Test	Test Reading R	Soil Resistivity ρ
1	9.58	18345.7
2	10.08	19303.2
3	9.24	17694.6
4	9.21	17637.2
5	9.53	18250
