7/17/19 F. Kabat Planning Board Letter

List of Exhibits

RE: Solar Farm Development, Fox & Yellow Mills Road, Town of Farmington, NY
Trip Generation Letter/Intersection Crash Analysis Letter

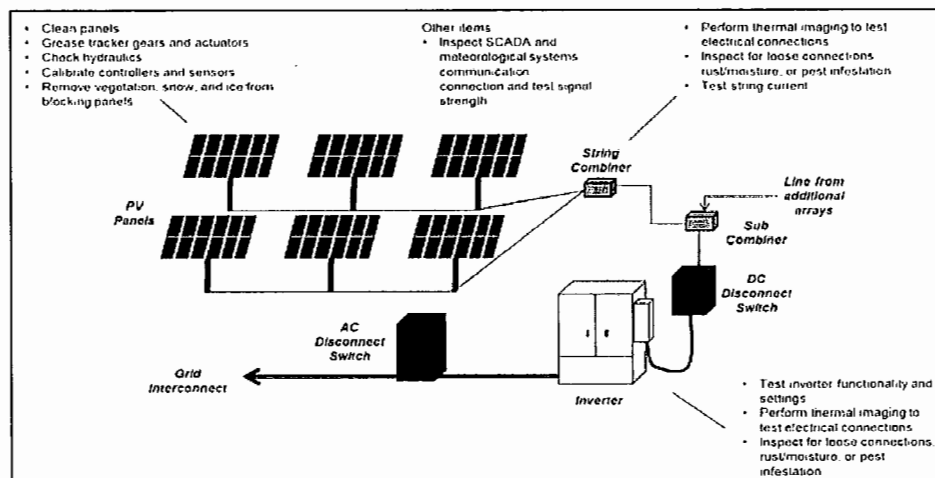
Figure 11. Highlights of the Solar Facility Maintenance

- **Modules Cleaning:** Module cleaning will be performed during preventive maintenance hours or extraordinary snow storms.
- **Scheduled Project Maintenance:** There will be the need to periodically inspect the modules (removal snow, ice, grass, vegetation) and make necessary alignment adjustments (i.e. tighten fasteners) or replace damaged modules to prevent breakdowns and production losses. Project components will go through maintenance checklist once or twice per year.

- Checking wire connections
- Testing voltage/current at any part
- Inspecting components for moisture
- Confirming settings on the inverter
- Transformer maintenance
- Resealing of system components

- **Corrective Maintenance:** Corrective maintenance will occasionally be required due to uncontrollable circumstances such as severe weather or premature failure of components. These unscheduled repairs will be undertaken in a manner to minimize impacts to the continued operation of the Solar Facility.
- **Monitoring Management:** uses real-time data to oversee Project parameters.

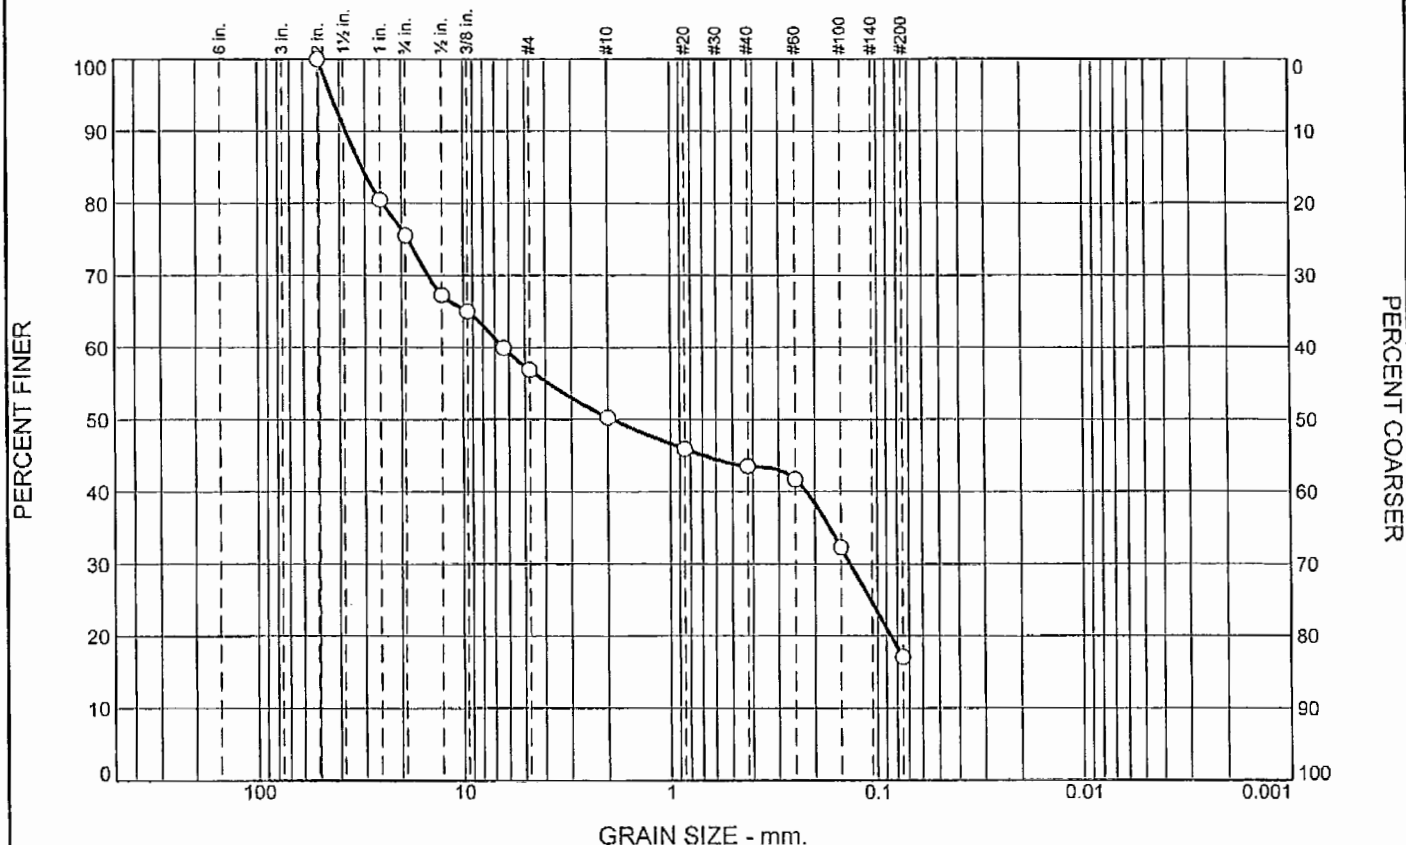
Particle Size Distribution Report

% +3"	% Gravel		% Sand			% Fines	
	Coarse	Fine	Coarse	Medium	Fine	Silt	Clay
0	24	19	7	6	27	17

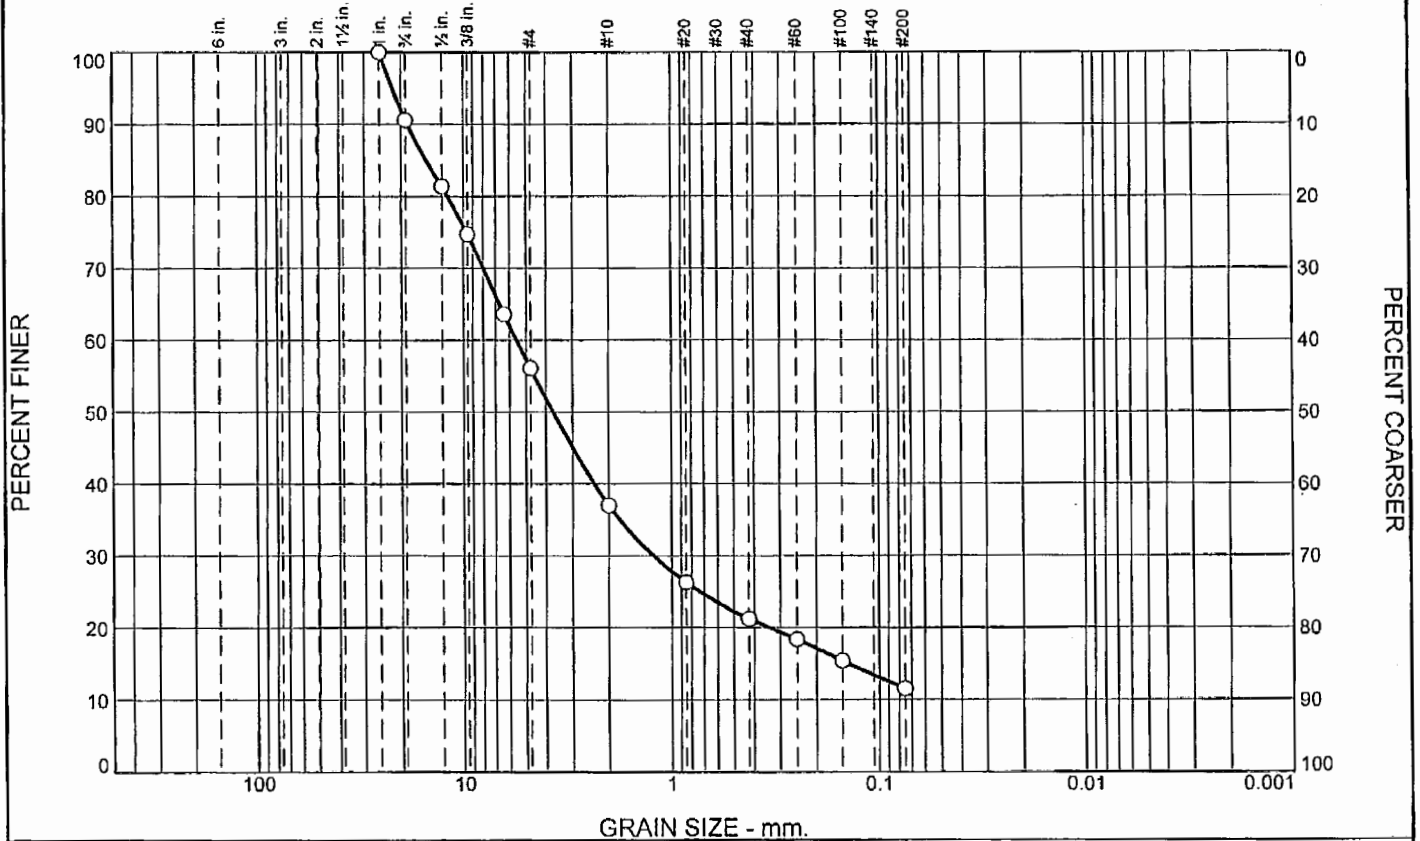
Particle Size Distribution Report

% +3"	% Gravel		% Sand			% Fines	
	Coarse	Fine	Coarse	Medium	Fine	Silt	Clay
0	9	35	19	16	10	11

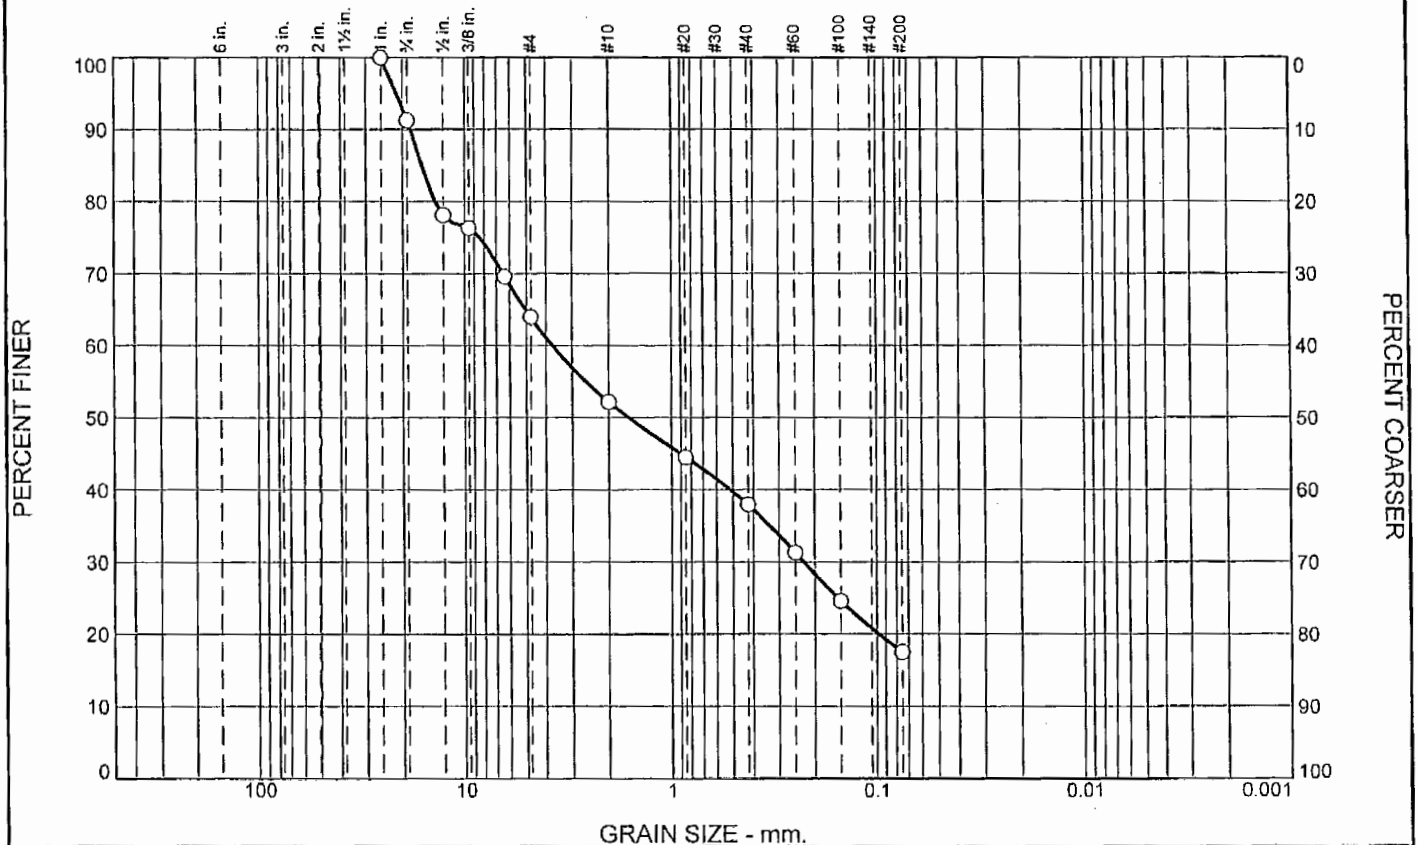
Particle Size Distribution Report

% +3"	% Gravel		% Sand			% Fines	
	Coarse	Fine	Coarse	Medium	Fine	Silt	Clay
0	9	27	12	14	21	17

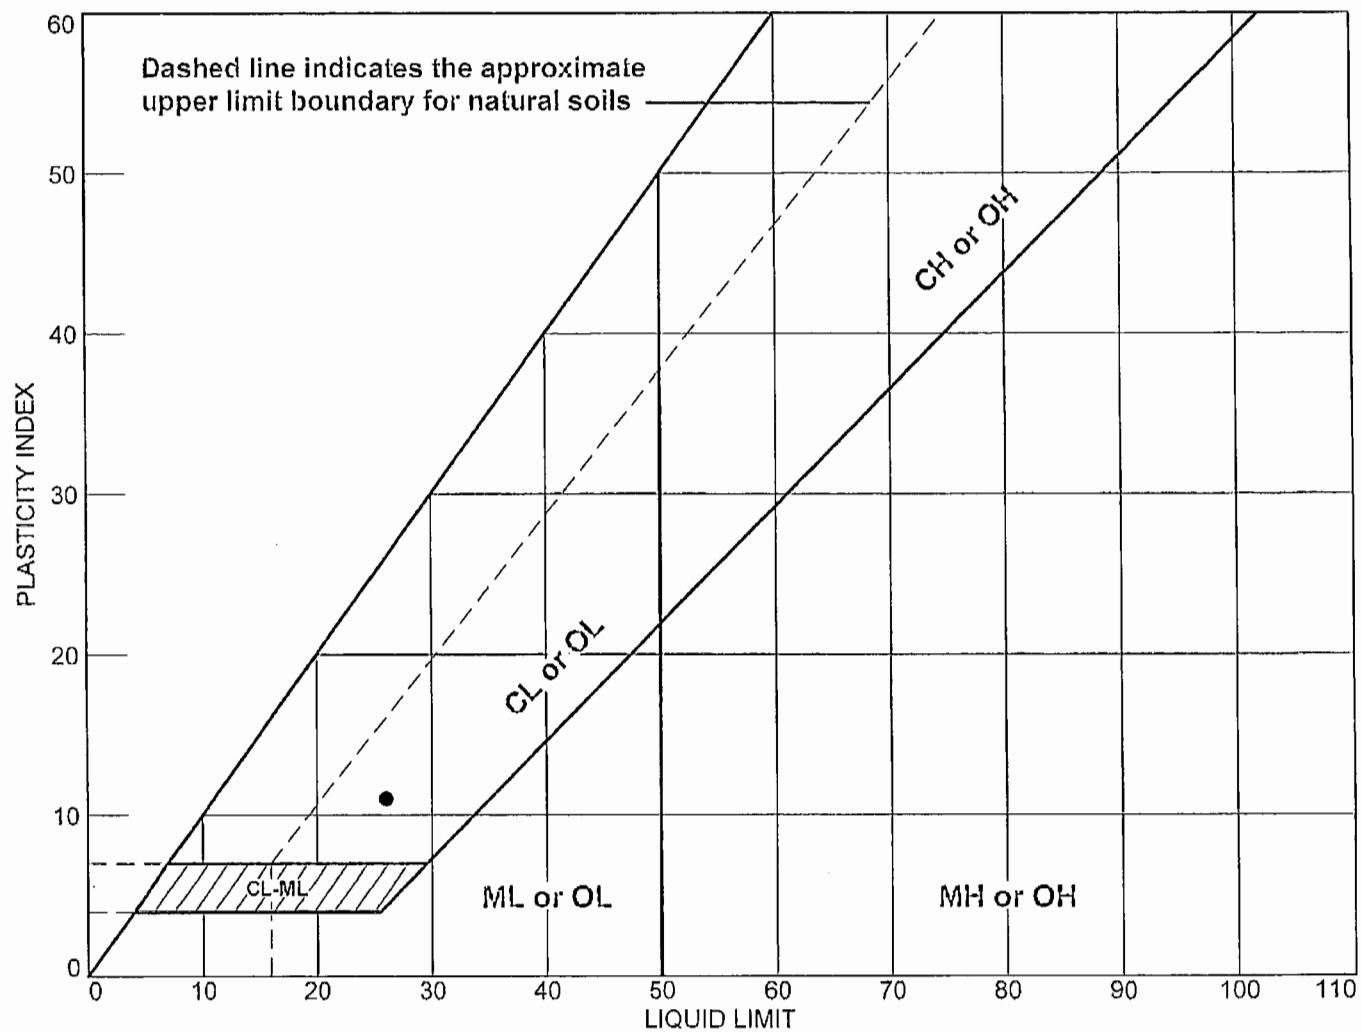
LIQUID AND PLASTIC LIMITS TEST REPORT

SOIL DATA								
SYMBOL	SOURCE	SAMPLE NO.	DEPTH	NATURAL WATER CONTENT (%)	PLASTIC LIMIT (%)	LIQUID LIMIT (%)	PLASTICITY INDEX (%)	USCS
•	P-10	S-2	2'-4'	24.9	15	26	11

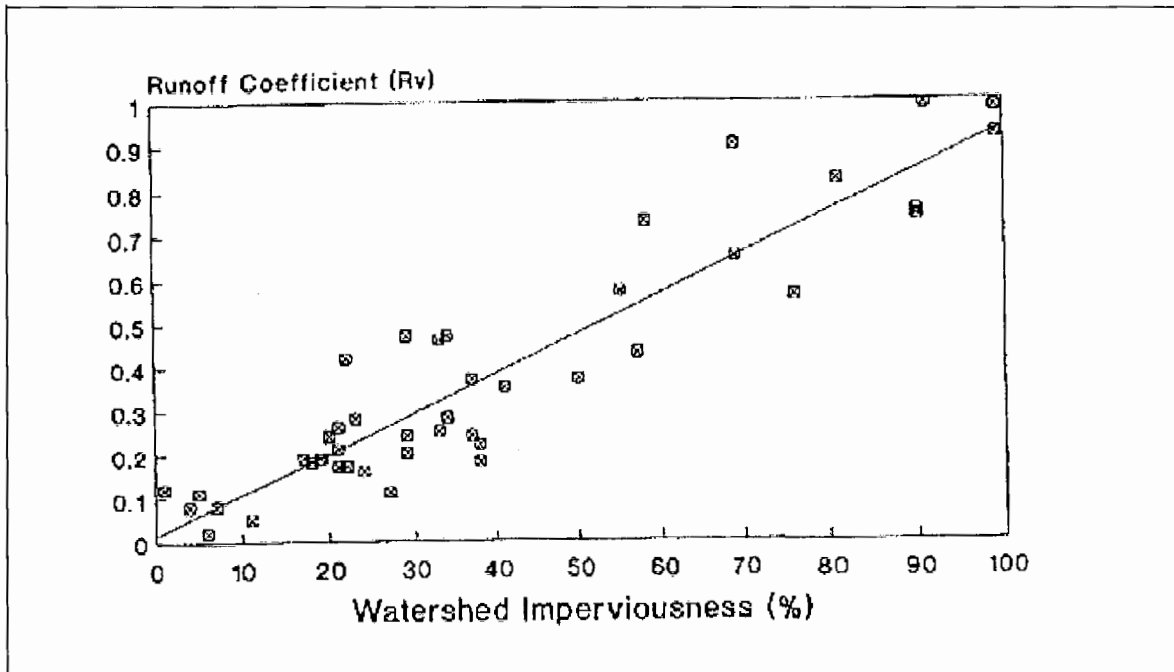
Figure 2.2 Relationship Between Impervious Cover and Runoff Coefficient (Schueler, 1987)

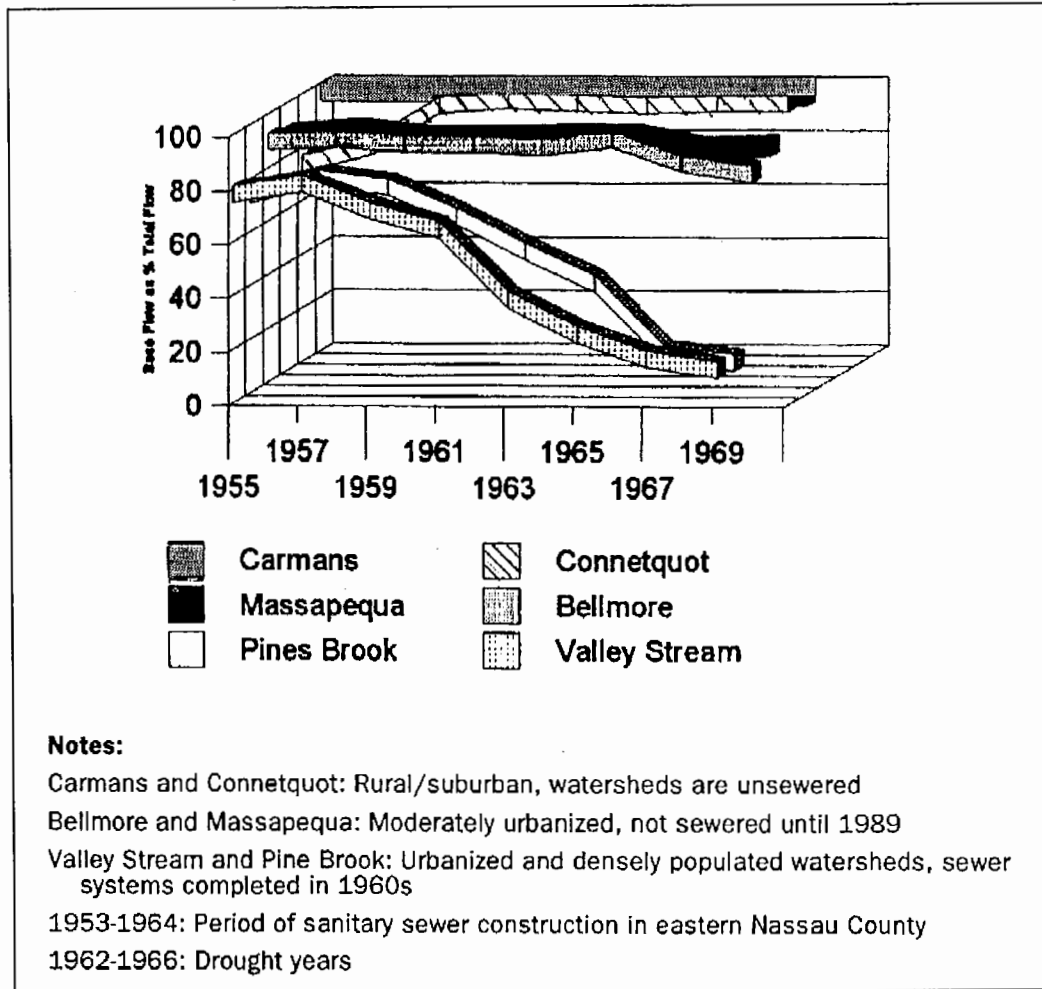
Figure 2.3 Declining Baseflow in Response to Development

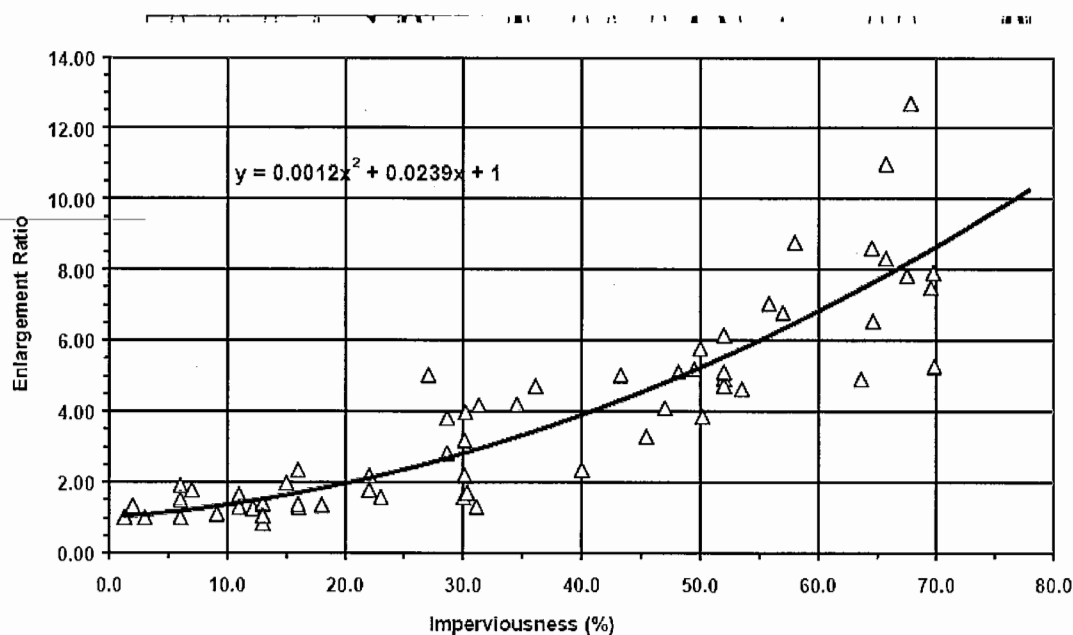
Figure 2.5 Relationship Between Impervious Cover and Channel Enlargement

Channel enlargement in response to watershed development has been observed for decades, with research indicating that the stream channel area expands to between two and five times its original size in response to upland development (Hammer, 1972; Morisawa and LaFlure, 1979; Allen and Narramore, 1985; Booth, 1990). One researcher developed a direct relationship between the level of impervious cover and the “ultimate” channel enlargement, the area a stream will eventually reach over time (MacRae, 1996; Figure 2.5).

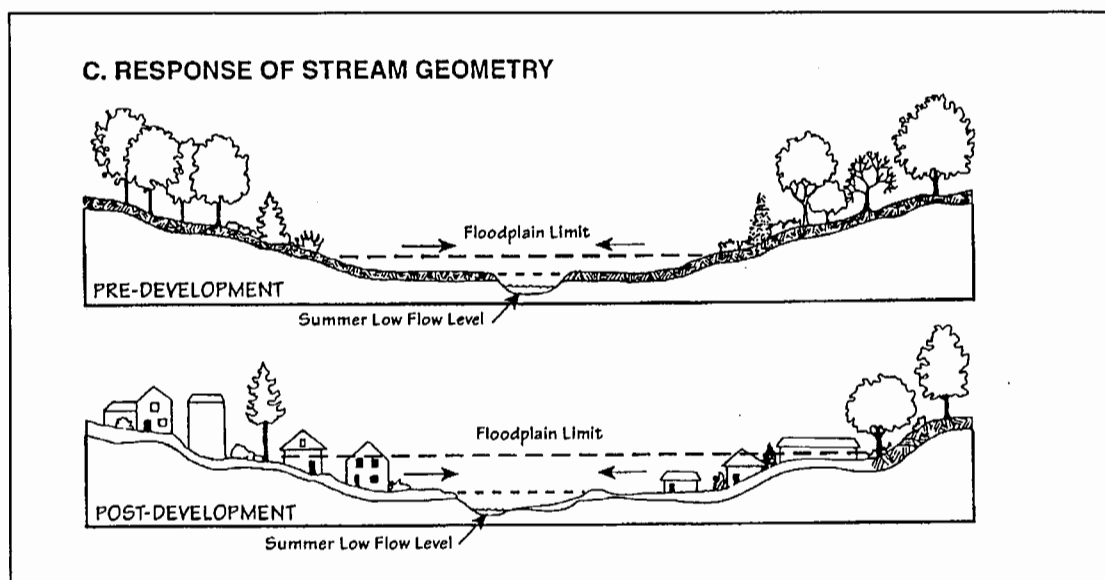
Figure 2.7 Floodplain Expansion with New Development

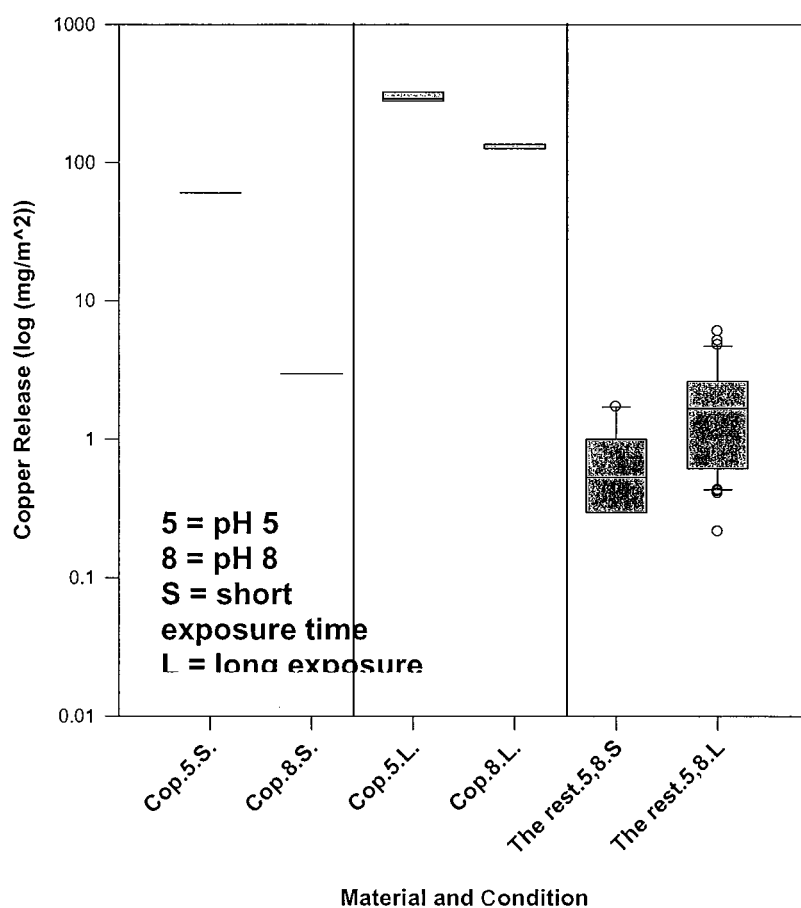
Copper Release. Controlled pH.

Group box plot for copper release in mg/m² for materials immersed in pH 5 and pH 8 waters (Ogburn 2013).

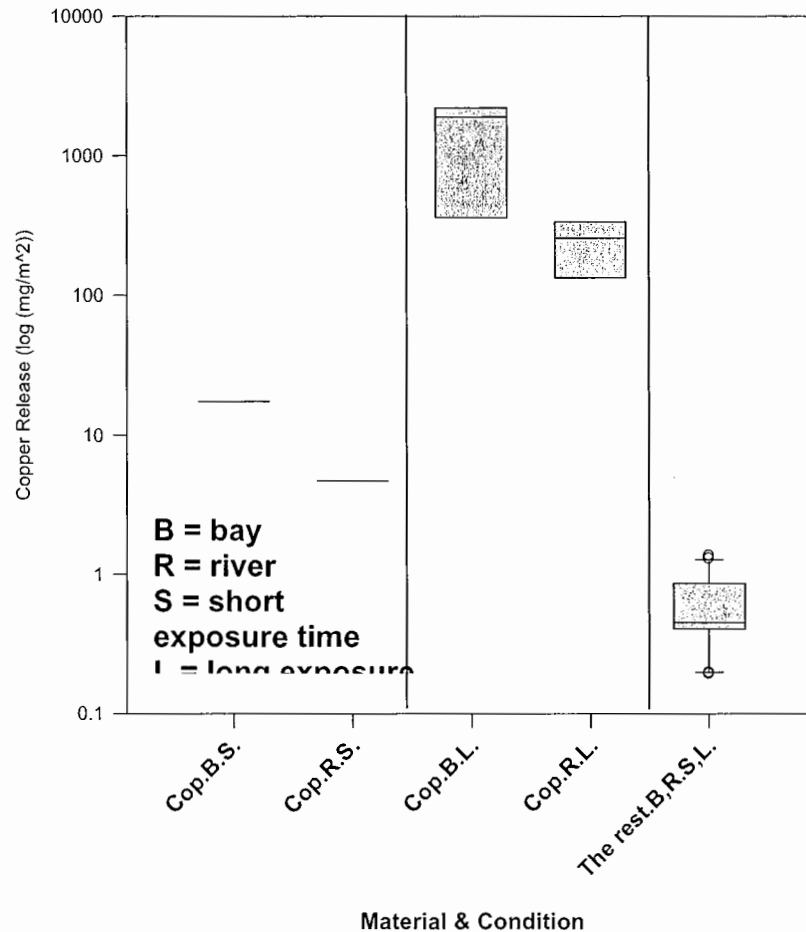
Copper Release. Natural pH.

Group box plot for copper release in mg/m^2 for materials immersed in bay and river waters (Ogburn 2013).

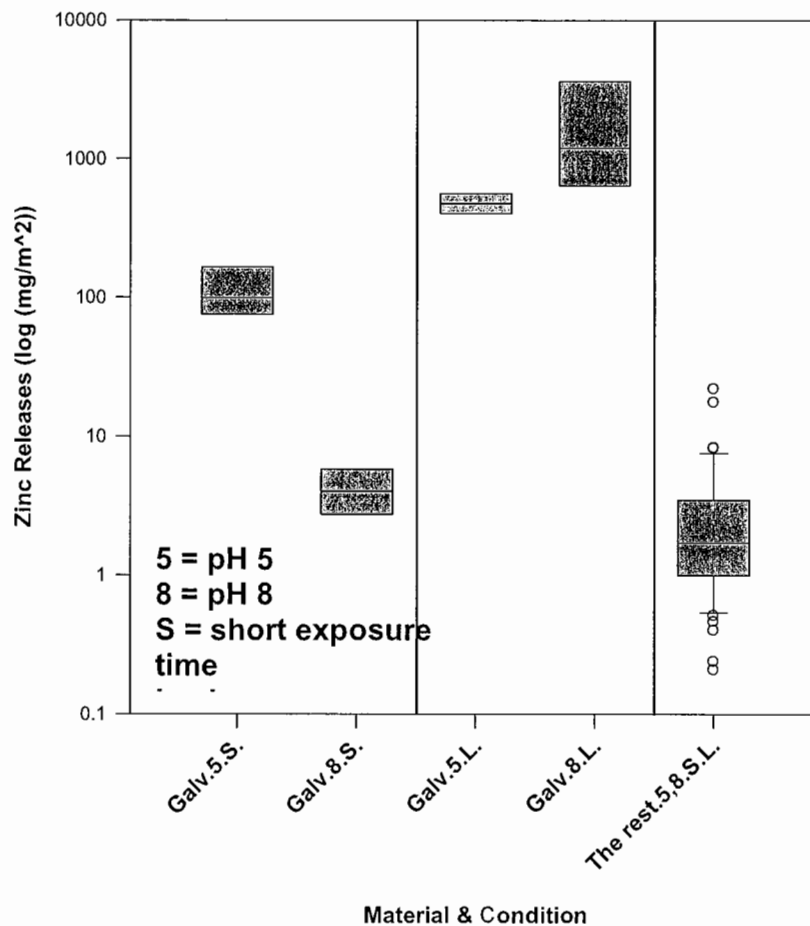
Zinc Releases. Controlled pH

Group box plot for zinc release in mg/m^2 for materials immersed in pH 5 and pH 8 waters (Ogburn 2013).

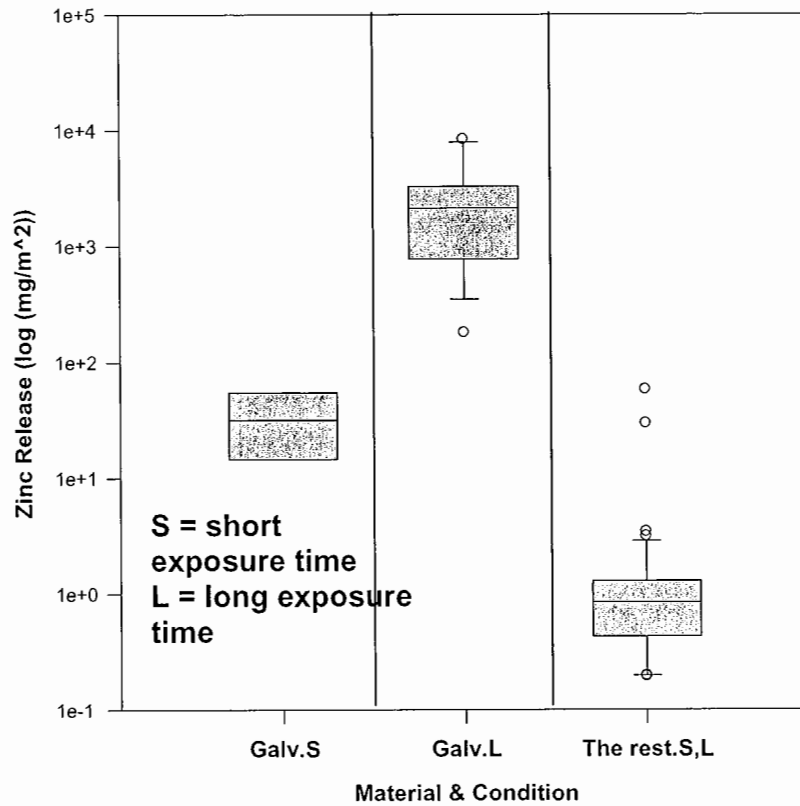
Zinc Releases. Natural pH.

Group box plot for zinc release in mg/m² for materials immersed in bay and river waters (Ogburn 2013).

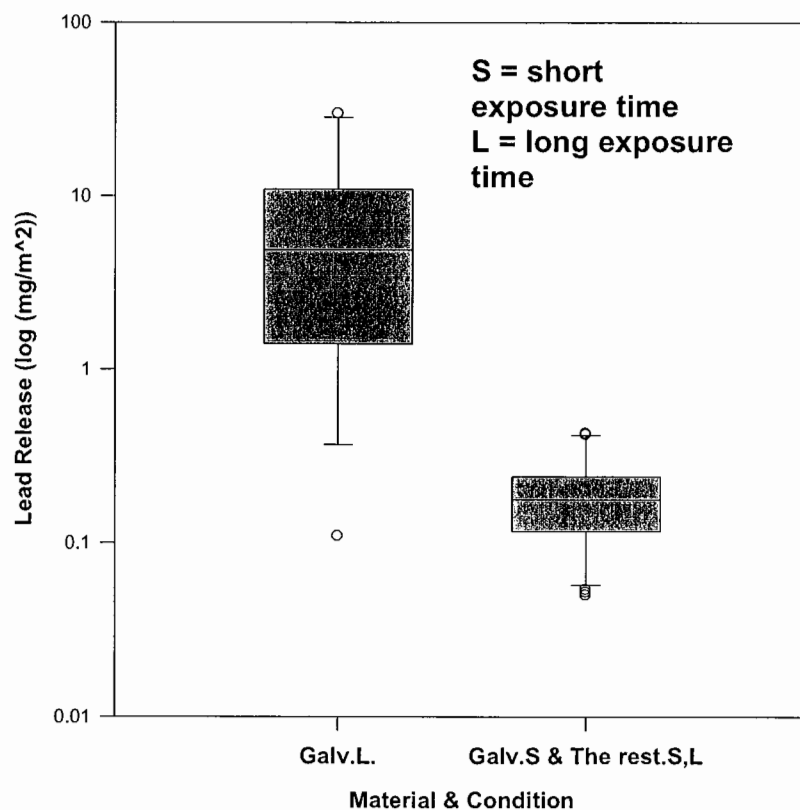
Lead Releases. Controlled pH.

Group box plot for lead release in mg/m^2 for materials immersed in pH 5 and pH 8 waters (Ogburn 2013).

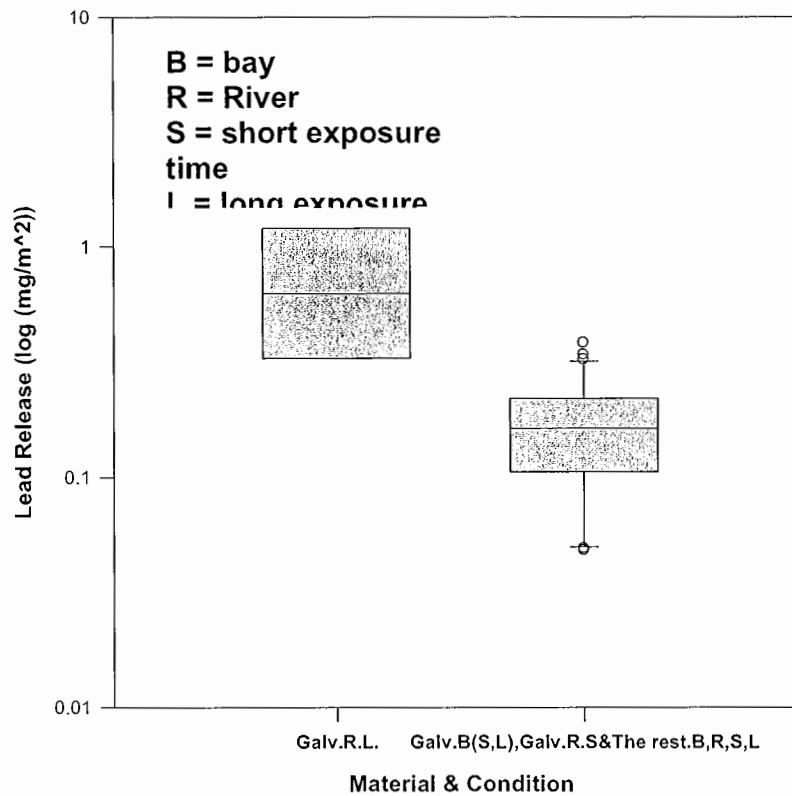
Lead Releases. Natural pH.

Group box plot for lead release in mg/m^2 for materials immersed in bay and river waters (Ogburn 2013).

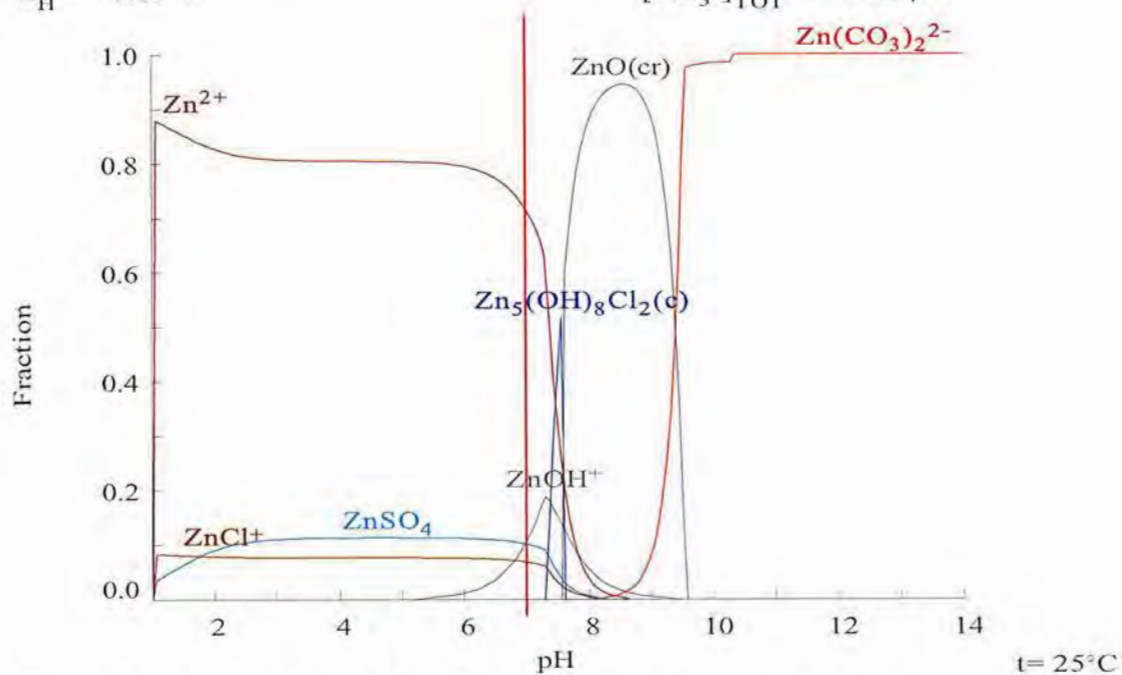
Fraction diagram of zinc for steel pipe section immersed into bay water after three months of exposure (Ogburn 2013).

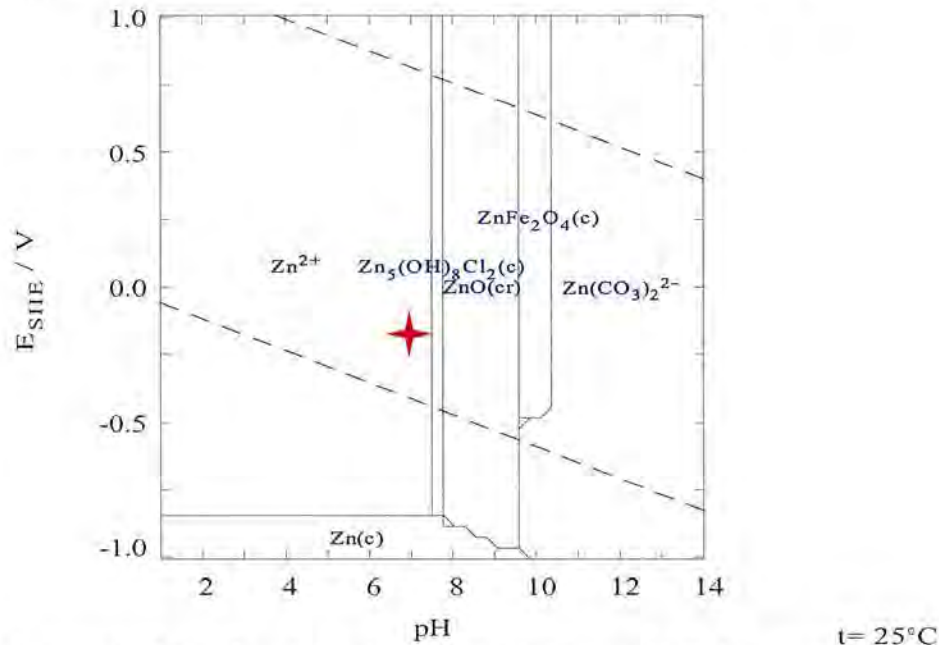
Pourbaix diagram of zinc for steel pipe section immersed into bay water after three months of exposure. Note: the symbol is located at the conditions measured during these tests (Ogburn 2013).

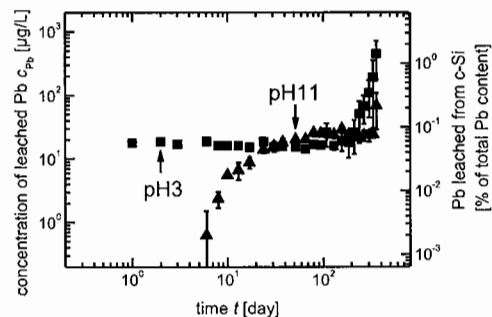
Fig. 3. (Color online) Time-dependent leaching of Pb from c-Si module pieces within different pH solutions. Values are given as absolute concentrations in $\mu\text{g/L}$ and as percentage amount regarding the total content of the particular element.

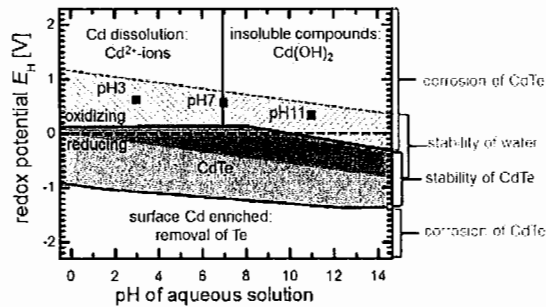
Fig. 4. (Color online) Highly simplified potential-pH (Pourbaix) diagram for CdTe in aqueous solutions at $T = 25\text{ }^{\circ}\text{C}$ showing only predominant Cd species.⁶⁾ Stability and corrosive regions of CdTe are shown. Measured redox potentials in solutions with pH 3, 7, and 11, which are used in the leaching experiments, are located at oxidizing redox potentials E_H .

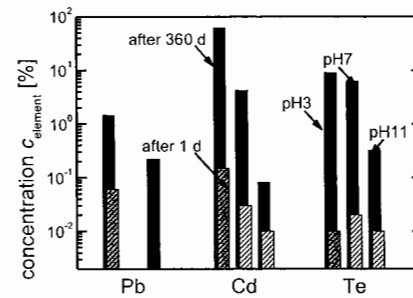
Fig. 5. (Color online) Amount of eluted toxic elements as Pb, released from c-Si module pieces, and Cd and Te out of CdTe module pieces after $t = 1$ day (hatched bars) and after $t = 360$ days (solid bars) in different solutions.
