# Pier 3 Condominiums – Philadelphia, PA

## ROOFTOP MECHANICAL SOUND STUDY – REVISION 1

February 22, 2022

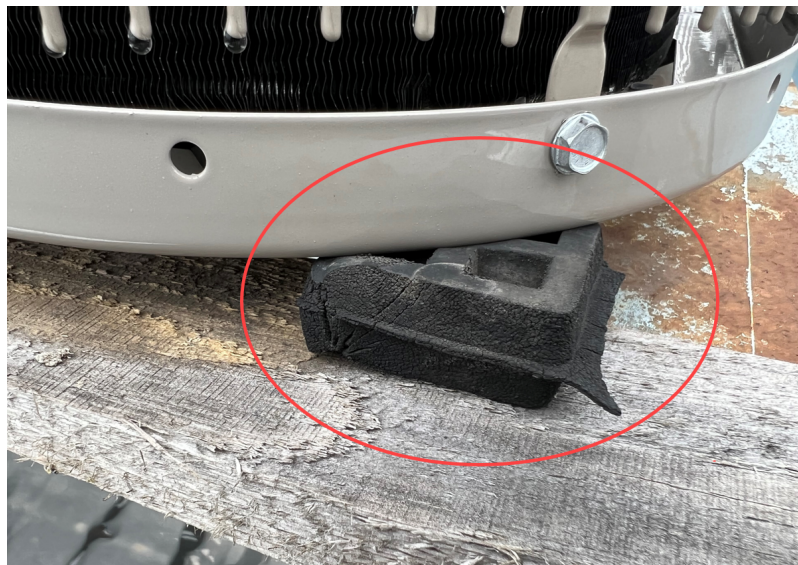
- Vibration isolation, where installed, appeared to be neoprene pads such as Mason Super W.
- In several instances, vibration isolation was not properly installed/loaded or was short-circuited through rigid connections, as shown in the figures below.

*Figure 2. Example of vibration isolator installation beneath CU*

Not meeting the ideal characteristics, as defined by ASHRAE above, can lead to complaints. As such, it is recommended to implement mitigation measures (such as, but not limited to, vibration isolation and equipment maintenance) to reduce the perceptibility of *Prominent Discrete Tones* and to minimize fluctuations in sound level to 6 dB or less.

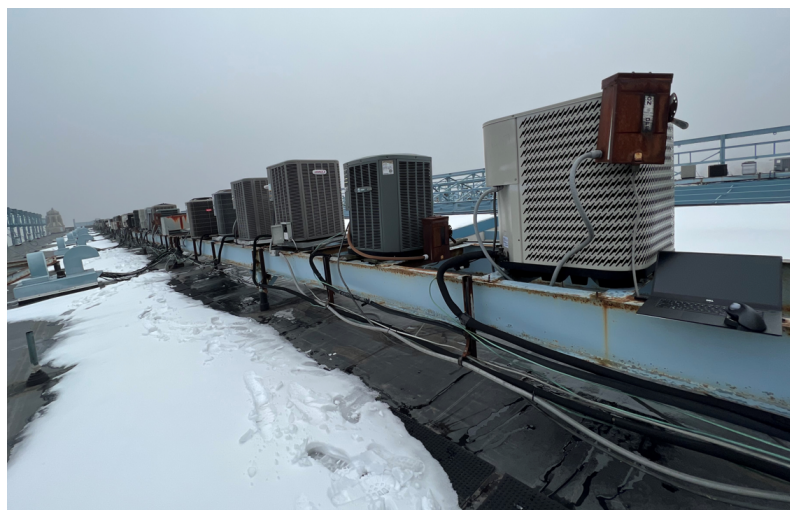
- The mounting of all rooftop CUs to their respective dunnage is inconsistent.
- In general, it was noted that attempts were made to install vibration isolation for the northern row of CUs that span the entire length of the building from east to west. The southern row of units was not provided with vibration isolation.

*Figure 3. Northern row of rooftop CUs*

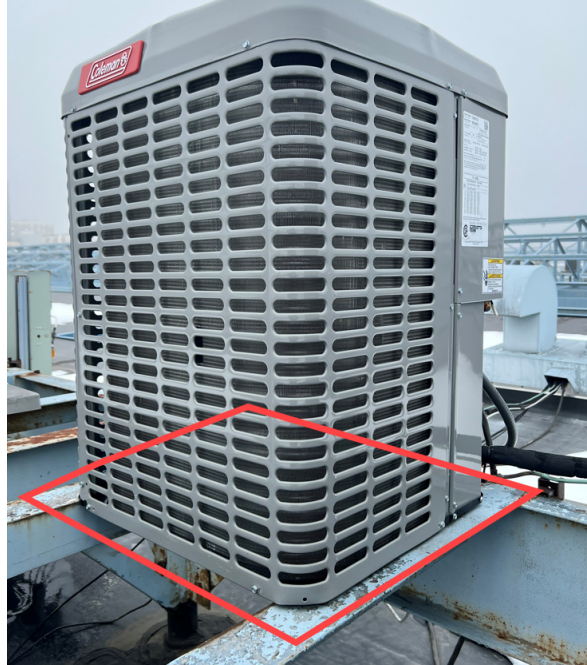
Figure 4. Example CU above Unit 434 rigidly bolted to dunnage

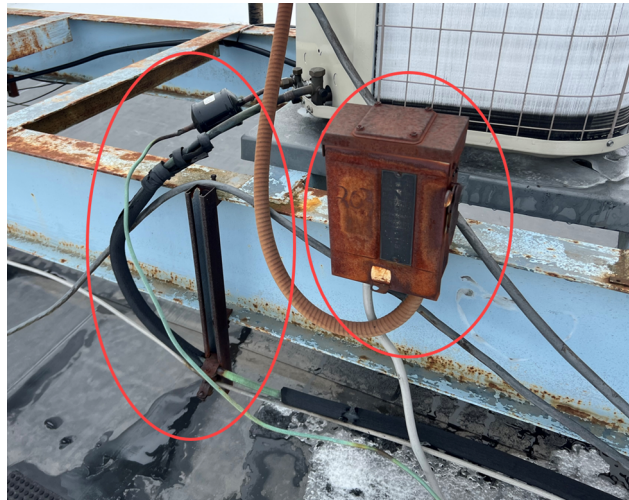
- CU piping or other conduit was rigidly contacting the unit, the dunnage, and the rooftop structure in many locations.
  - Qualitatively, vibration was felt in the dunnage and roof structure with the CUs on.

Figure 5. Example rigid connections to rooftop CU and dunnage

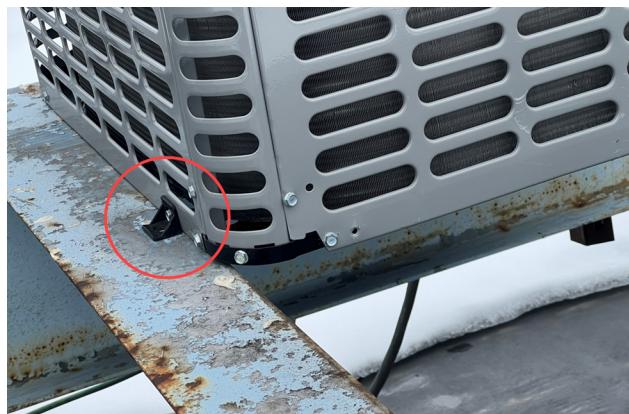
Figure 6. Example rigid connections to rooftop CU and dunnage

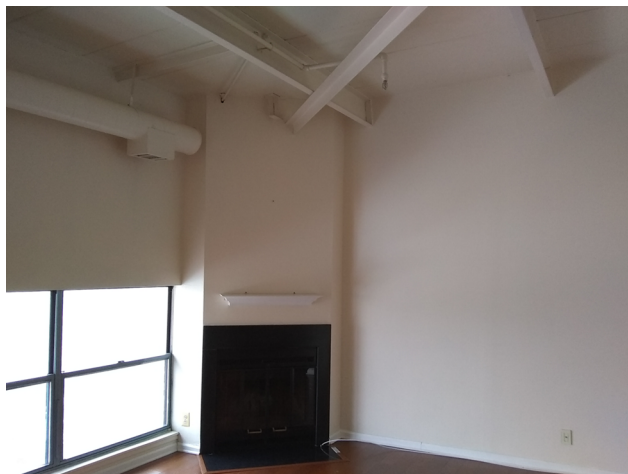
Figure 7. Unit 403 living room existing conditions

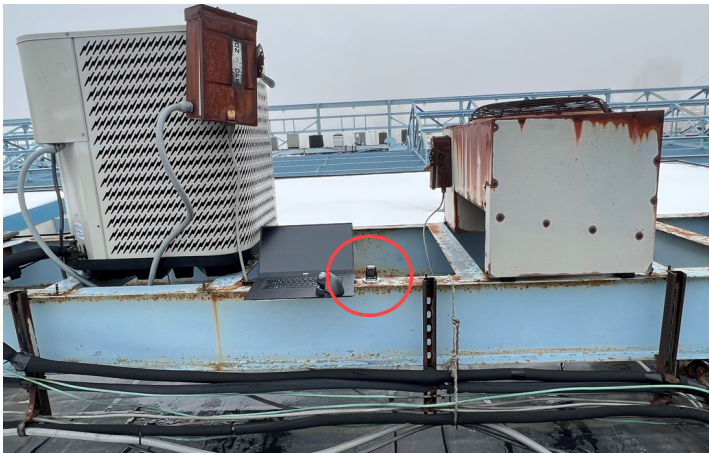
Figure 9. Node 3874 attached to CU dunnage

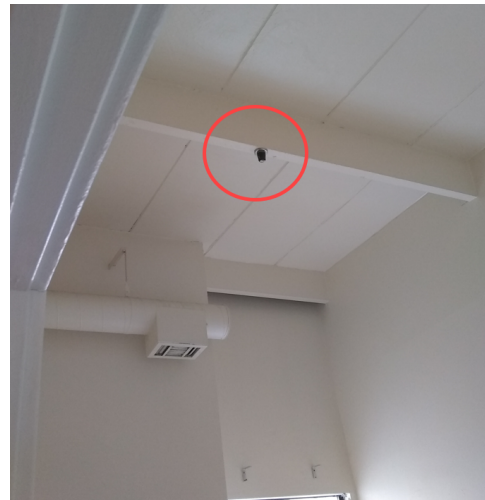
Figure 10. Node 3866 attached to Unit 403 ceiling structure

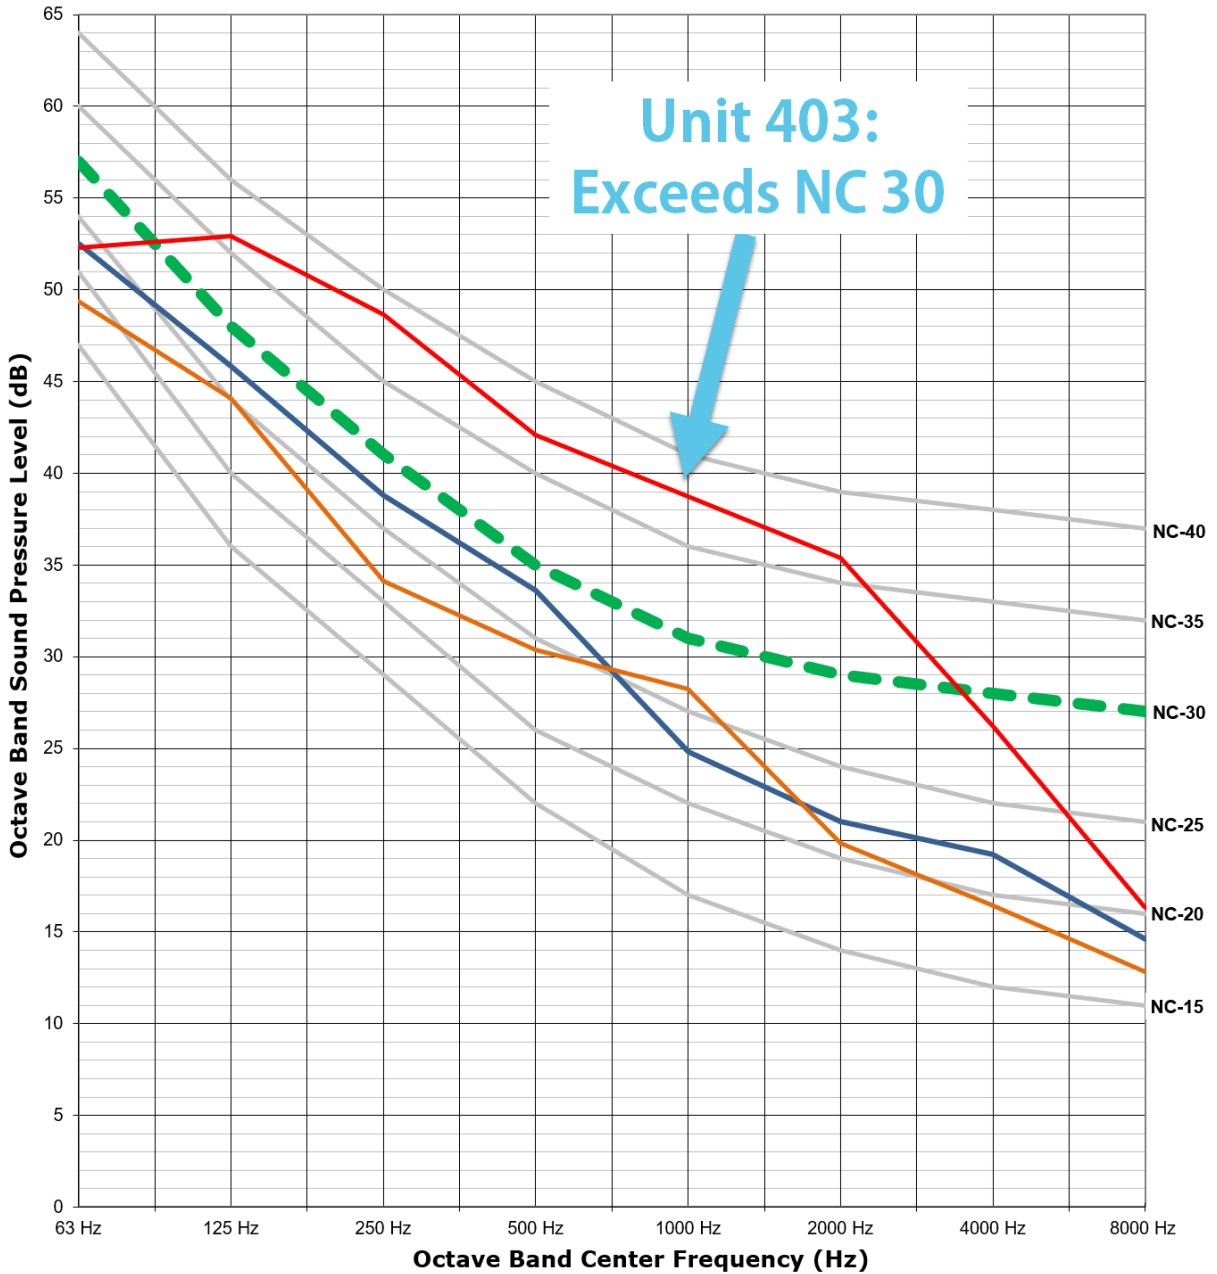
As shown in the table above, the airborne sound levels measured in the residential units when the CUs are powered down meet the overall design goal. When the CUs are operating, the overall design goal is met in all units, except for Unit 403, where the goal is exceeded by 10 dB. The 'ideal characteristics' of the sound, per ASHRAE however, were not satisfied in any space when the CUs were operating.

Figure 11 shows the measured sound levels vs. the NC curves; the dashed green line being the goal.

Figure 11. Noise Criteria (NC) Level in Each Unit with CUs Operational

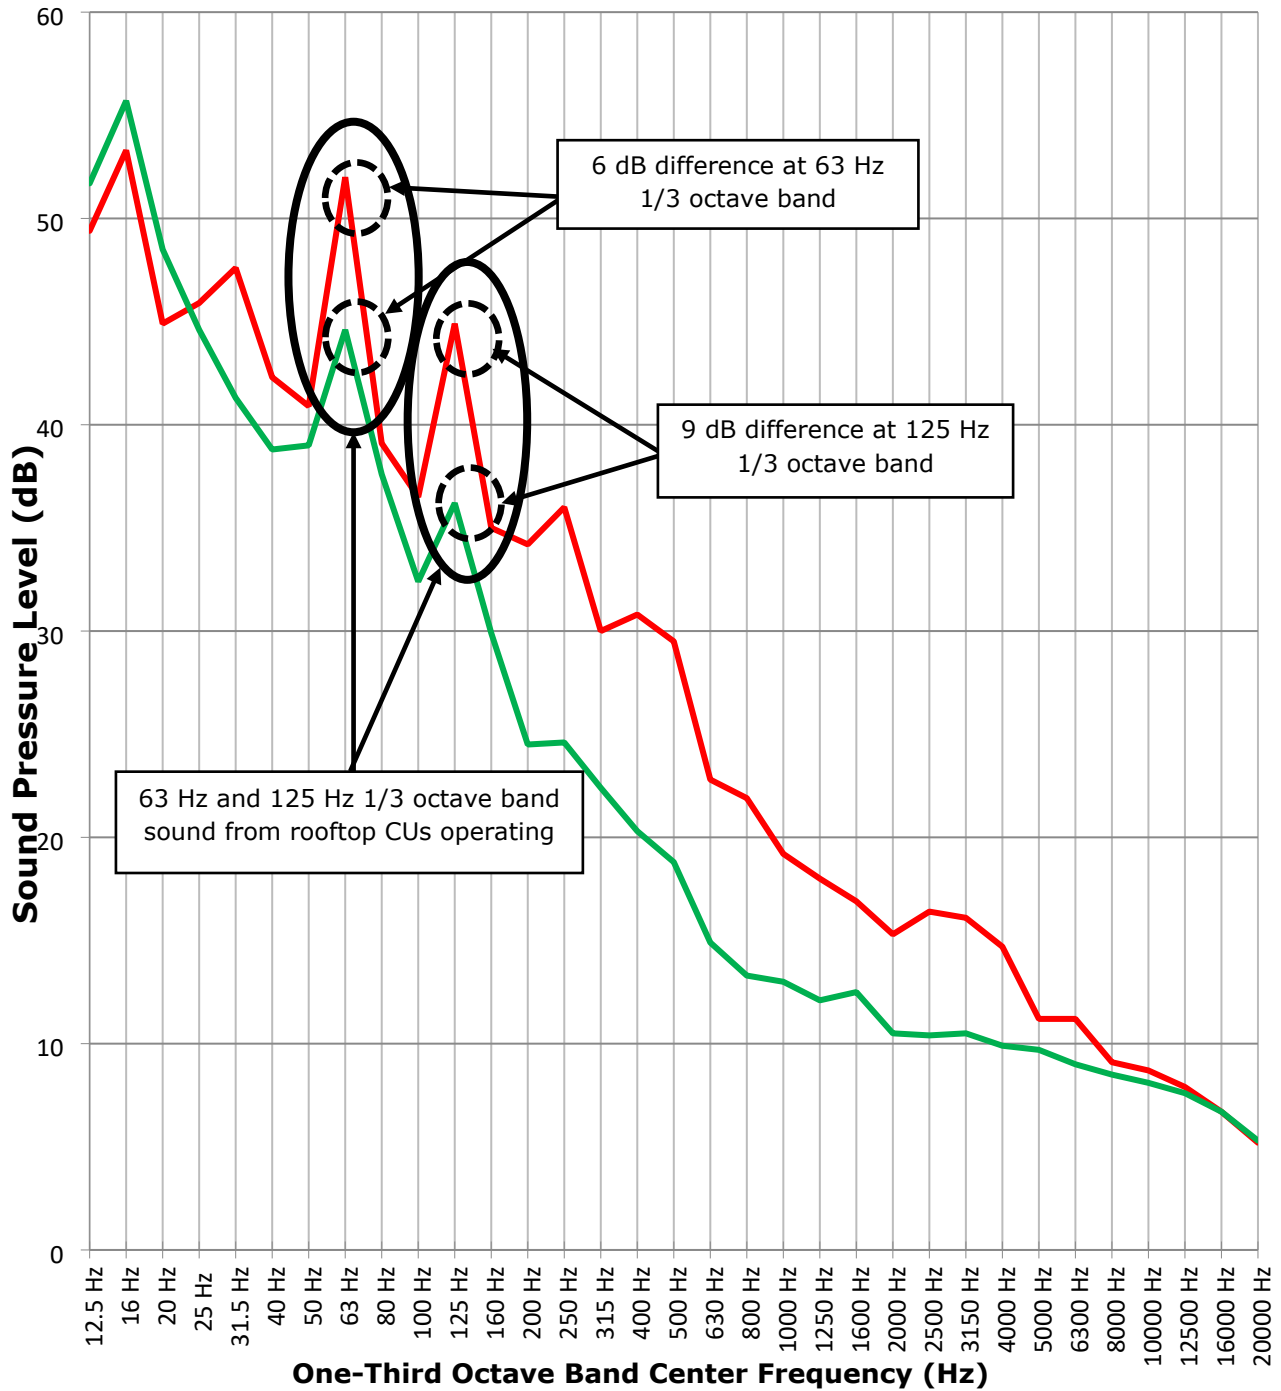
Figure 12 shows the one-third octave band spectrum measured in Unit 407; tonal characteristic highlighted.

- While the rooftop CUs were operating, the measured sound levels in the 63 Hz and 125 Hz 1/3 octave bands were measured to be 6-9 dB louder than when the CUs were not operating.
  - This would ideally be less than 6 dB to reduce perceptibility of these tonal characteristics.
- The overall difference in sound level (CUs on vs. off) in Unit 407 and Unit 403 was 8 dB or greater.
  - This would ideally be less than 6 dB to reduce awareness of units being on vs. off.
  - The less than 6 dB difference should still not exceed NC 30/35 dBA when the units are on.
- The increase in sound and vibration levels was experienced in all areas tested; this is not exclusive to Unit 407.

Figure 12. Sound Level Measurement Comparison – Unit 407

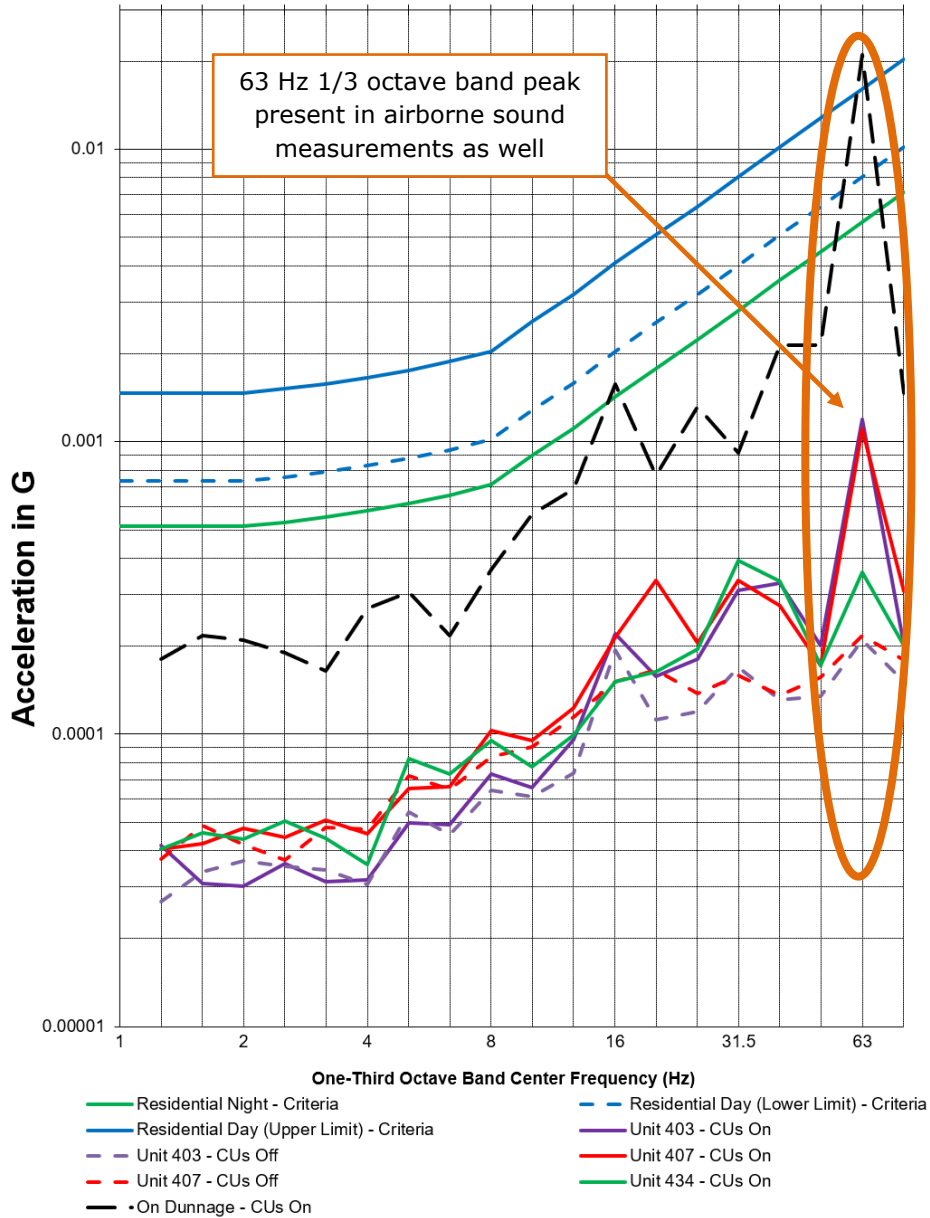
Figure 13 shows the vibration criteria for residential spaces and the measured vibration on the office ceiling in Units 403, 407, and 434. A measurement from the CU dunnage is included for reference with the CU on/CU off conditions.

Figure 13. Vibration Transmission –Rooftop CUs On vs Off

As shown in Figure 13, there is a clear vibrational peak at 63 Hz, which is the same peak frequency from the airborne measurements. The measurements indicate that vibration is present in the structure.
