# HOME INSPECTION REPORT

204 Sample Circle  
Kihei, Hawaii

prepared by  
**Mark Thorman**  
*Mark Thorman Home Inspections*  
*www.MauiHomeInspections.com*  
**808-874-3456**

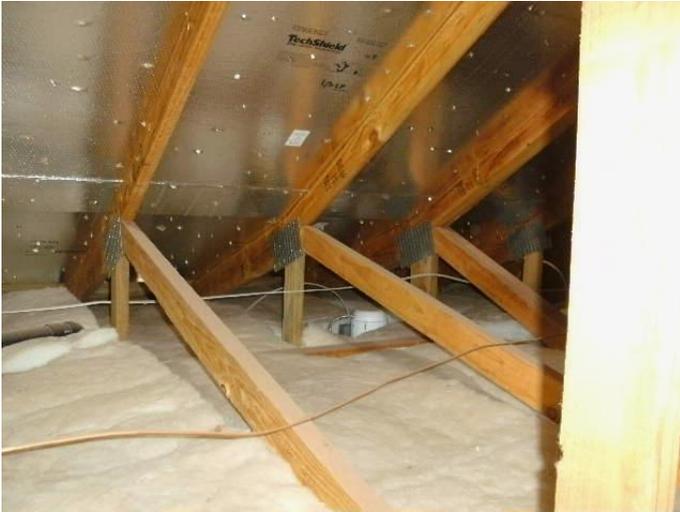
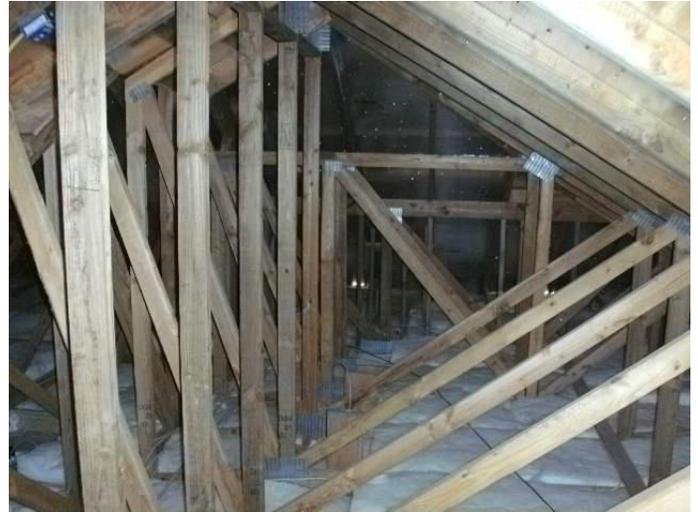
**Comments:** The **hurricane resistance rating** for this home could not be determined, as most of the components that affect the rating are not accessible, i.e. most straps, hold down brackets and bracing are covered by exterior and interior wall coverings. **Hurricane straps were noted at the trusses in the attic area and at the foundation-to-wall connection.** This is a component typical for a home of this age. The overall condition of the *accessible* portions of the structure was noted to be good and no evidence of a significant defect was noted, although:

- **The exhaust fans of the right hallway bathroom and master bedroom bathroom were noted to vent directly into the attic.** Recommend providing exterior vent terminations by installing the proper exterior vent hood to prevent moisture build-up in the attic area.

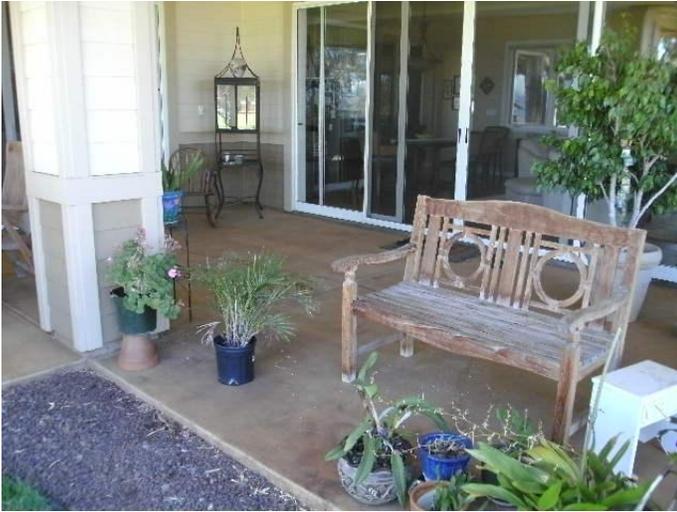
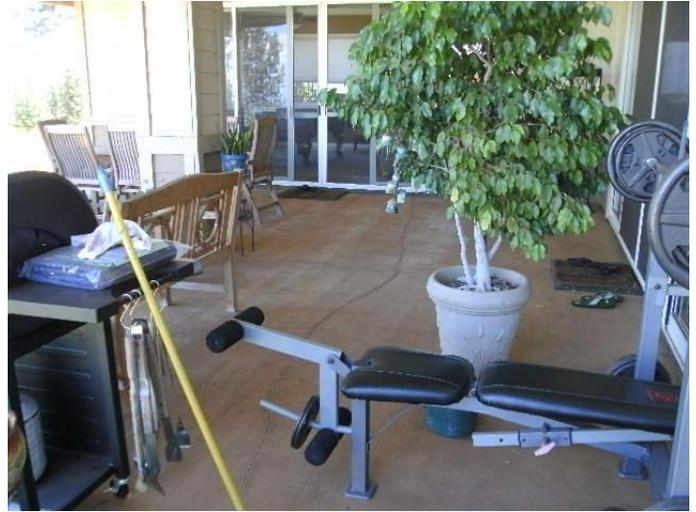
**Comments:** The overall condition of the exterior hard surfaces was noted to be fair with settling cracks typical for a home of this age, although:

- **Slight erosion was noted at the soil at the back of the lanai.** Recommend adding additional soil around and under the affected area to ensure proper support.

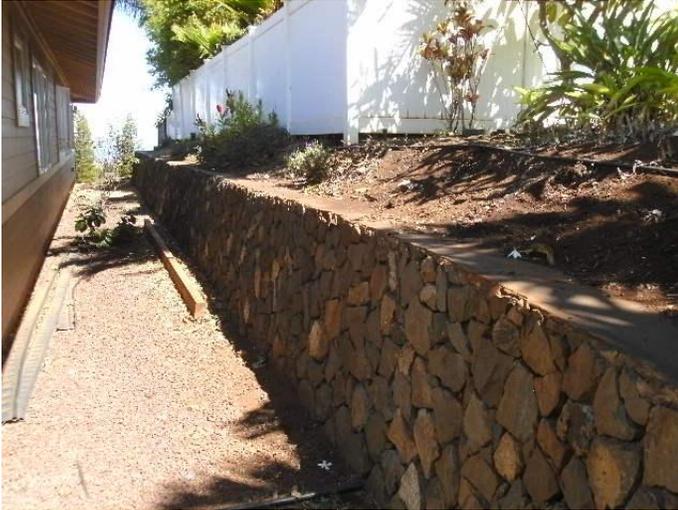
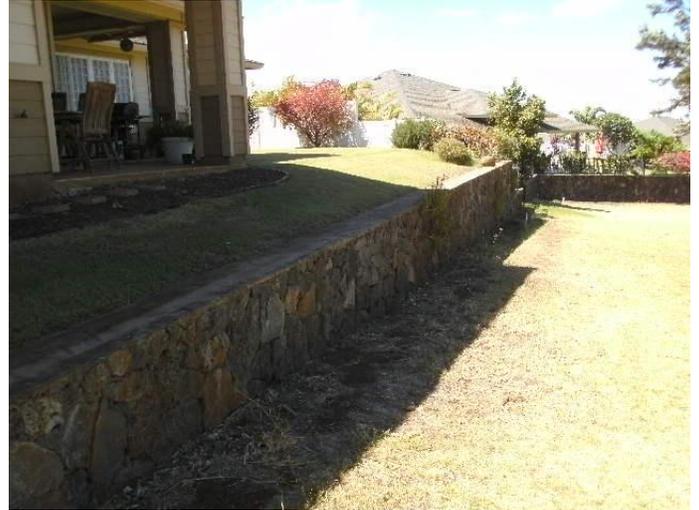
**Comments:** The overall condition of the retaining walls was noted to be good with minor wear and settling cracks noted.

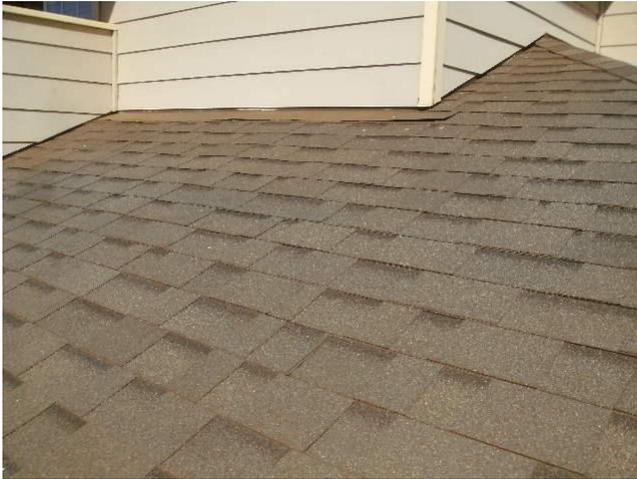
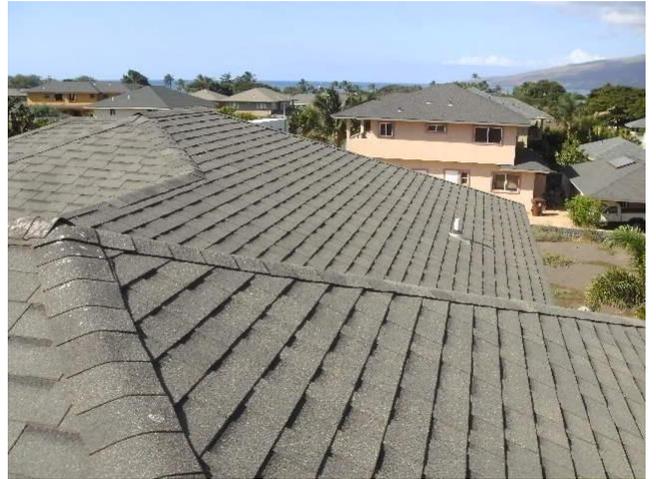
**Comments:** The overall condition of the roof was noted to be fair with typical wear noted, although:

- **Loose, damaged and missing ridge cap was noted at the second floor roof.** Recommend repairs to prevent moisture infiltration.

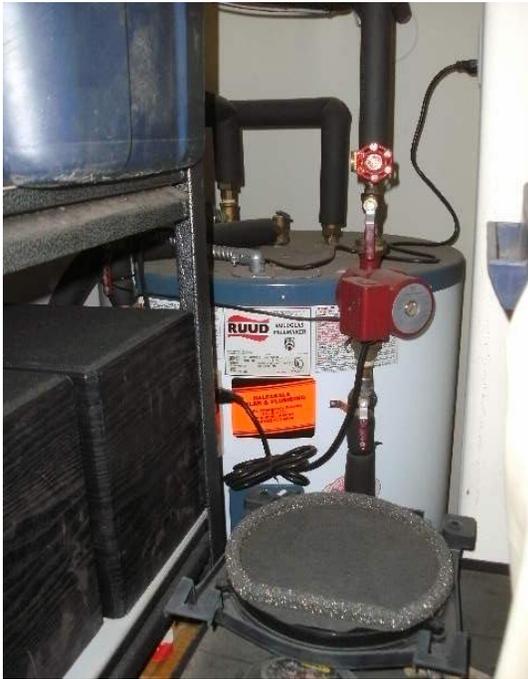
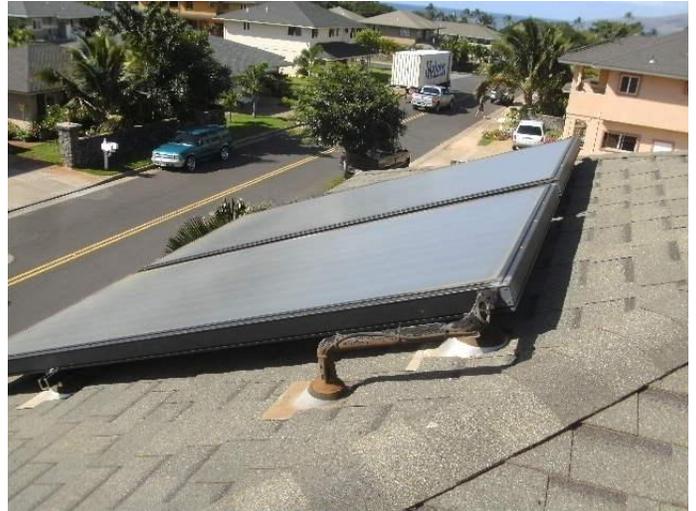
**Comments:** The overall condition of the *accessible* portions of the water heating system was noted to be good, although:

- **A leak was noted at the drain valve of the water heater.** Recommend repairs to prevent the leak.

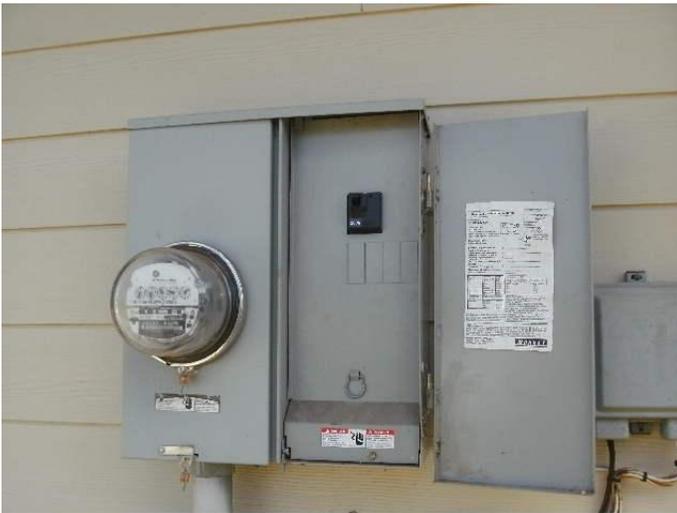
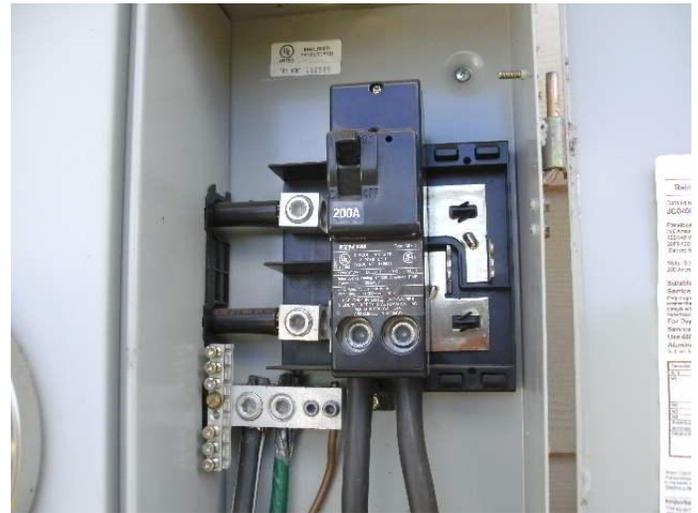
**Comments:** The overall condition of the main panel was noted to be good.

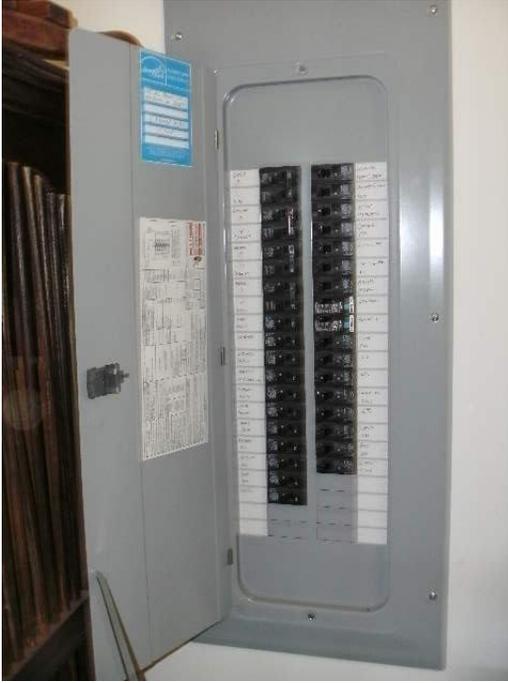
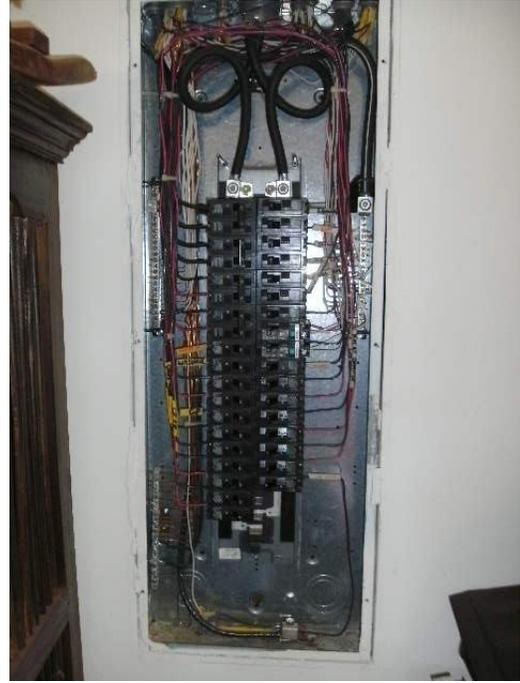
**Comments:** AFCI (Arc Fault Circuit Interrupter) protected outlets were noted at the outlets in bedroom #2 and #3. AFCI's are a relatively new safety feature for residential construction that protects the bedrooms of a home from defective wiring or appliances by shutting off the circuit when a defect is noted. The overall condition of the sub-panel was noted to be good, although:

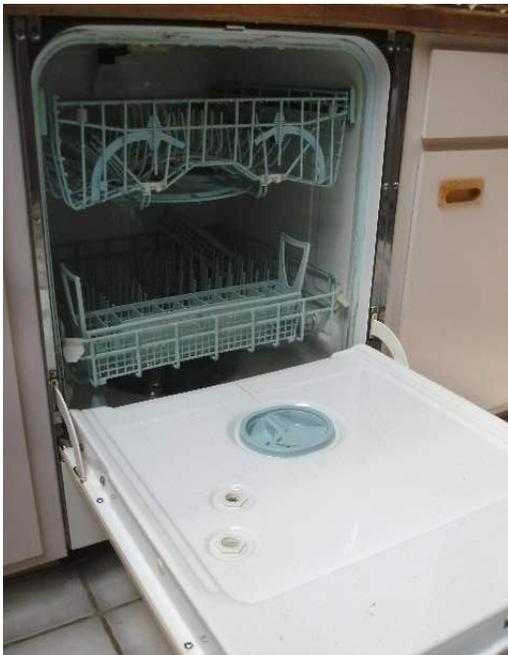
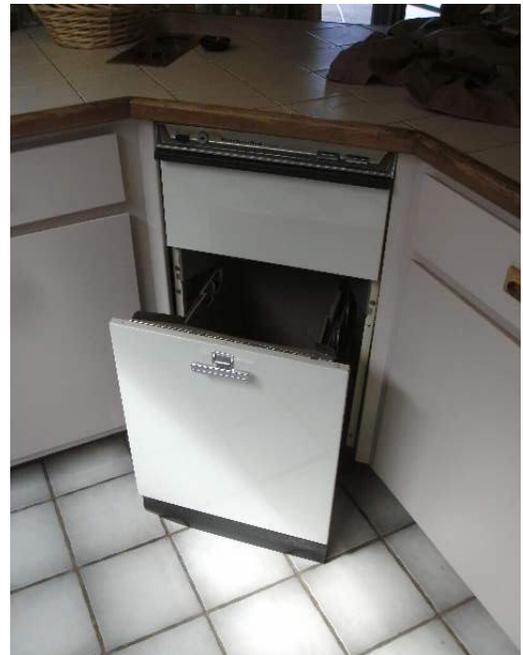
**Comments:** The unit was operated and noted to be functional. The overall condition was noted to be fair with typical wear noted.

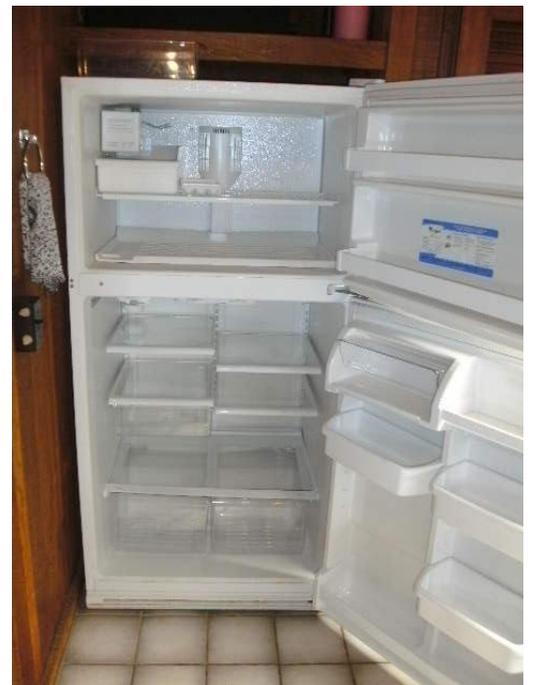
- **I was unable to test the ice maker, as there was insufficient time during the inspection for the ice maker to run through an entire cycle.** Recommend activating the unit for 24 hours and further evaluation be made at that time.

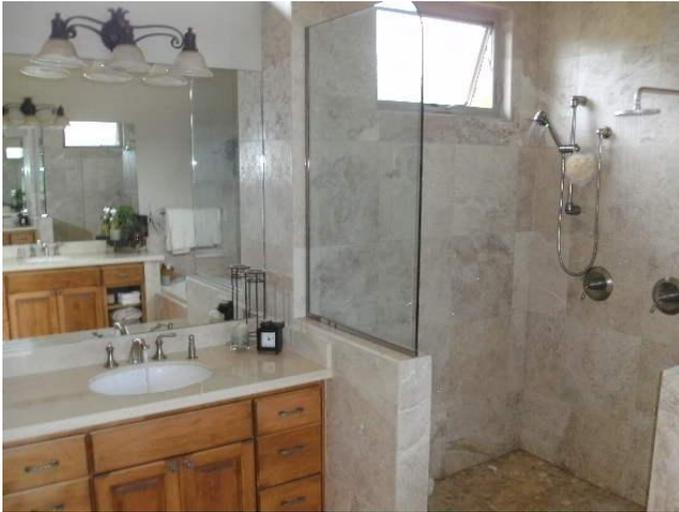
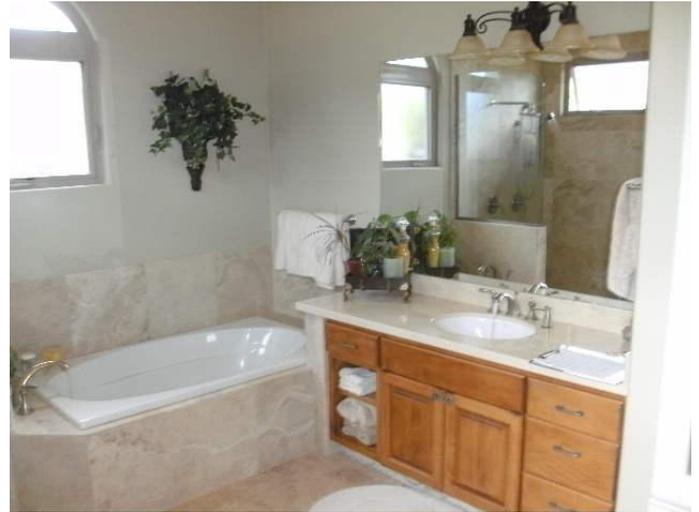
**Comments:** The overall condition of the bathroom was noted to be good with minor wear noted.
