HOME INSPECTION REPORT

123 Sample Circle

Kihei, Hawaii

Mark Thorman Home Inspections

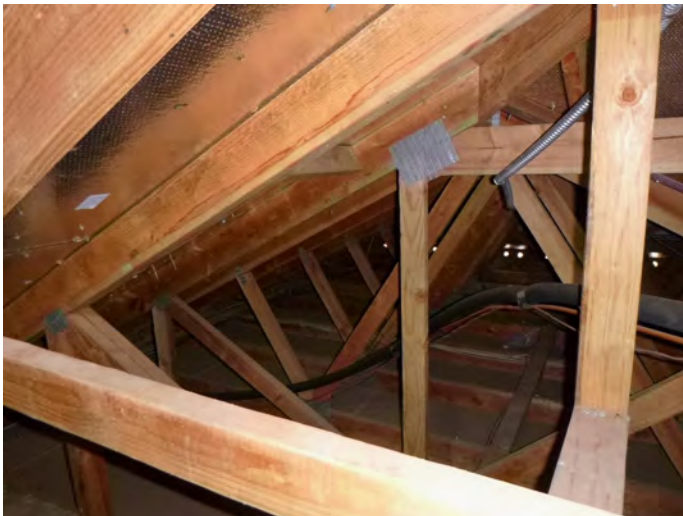
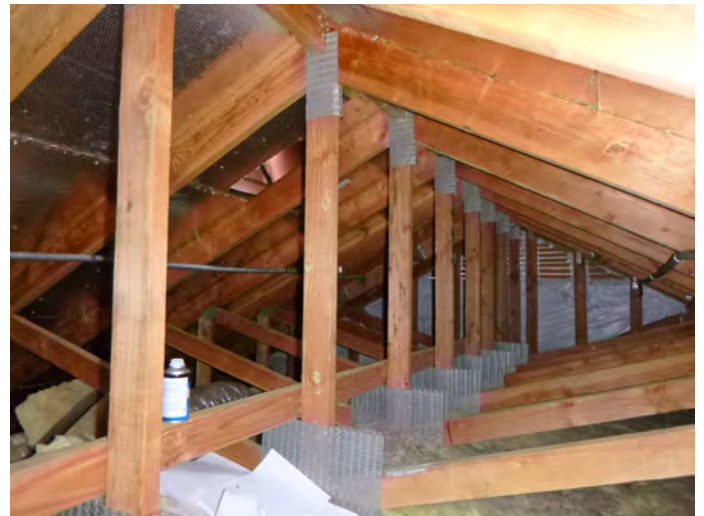
Comments: The **hurricane resistance rating** for this home could not be determined, as most of the components that affect the rating are not accessible, i.e. most straps, hold down brackets and bracing are covered by exterior and interior wall coverings. **Hurricane straps were noted at the trusses in the attic area.** This is a component typical for a home of this age. The overall condition of the

accessible portions of the structure was noted to be good and no evidence of a significant defect was noted, although:

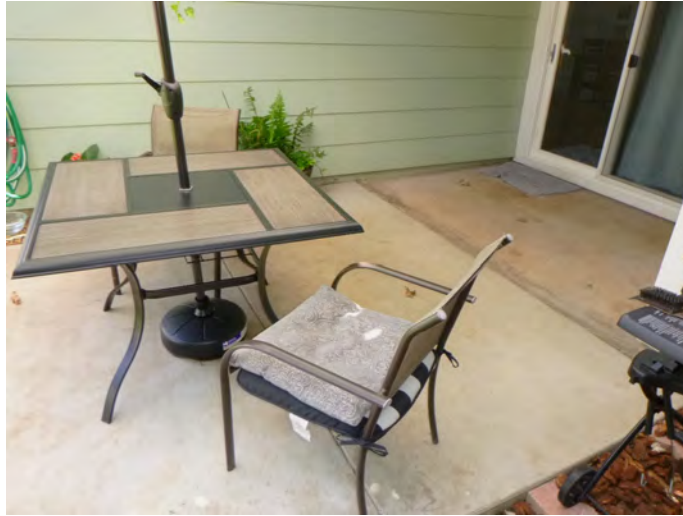
Comments: The overall condition of the exterior hard surfaces was noted to be good with settling cracks typical for a home of this age.

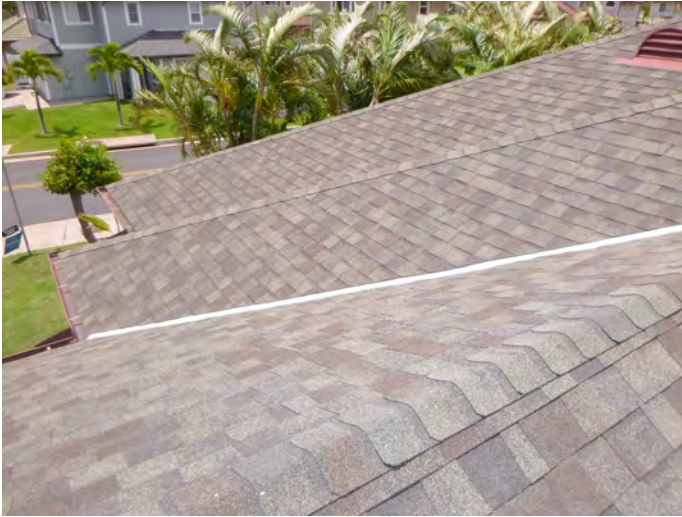
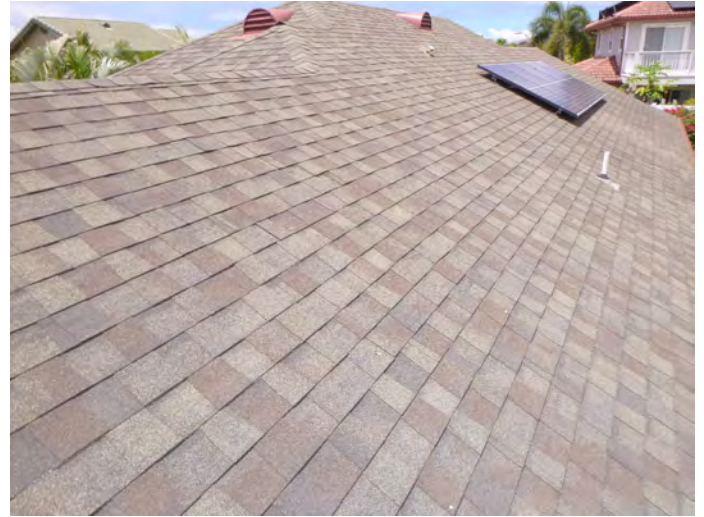
Comments: The overall condition of the *accessible* portions of the roof was noted to be fair with typical wear noted, although:

- There are several exposed nail heads and numerous raised nail heads popping through the roof shingles and ridge caps. The raised nails appear to be a result of crooked and under-driven nailing. Recommend removing the raised nails and sealing the holes and exposed nail heads with roofing cement in order to prevent moisture infiltration. Contact a licensed roofing contractor for further evaluation and repairs.

- **Several damaged shingles were noted at the back left corner of the roof.** This appears to be the result of past vegetation that was in contact with the roof. Contact a licensed roofing contractor for further evaluation and repairs.

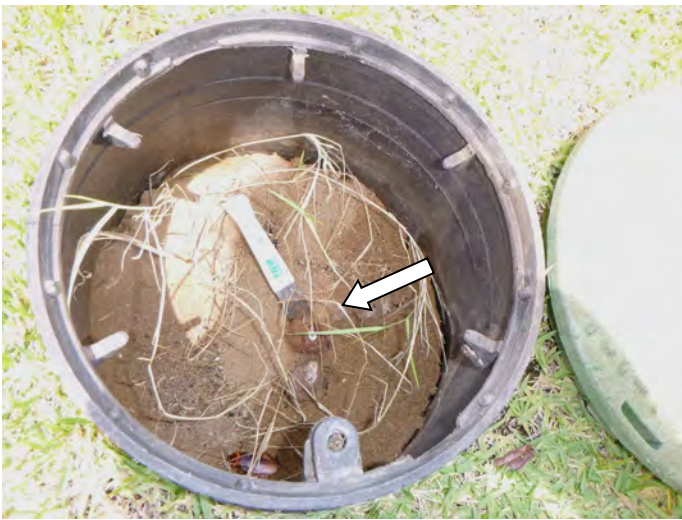
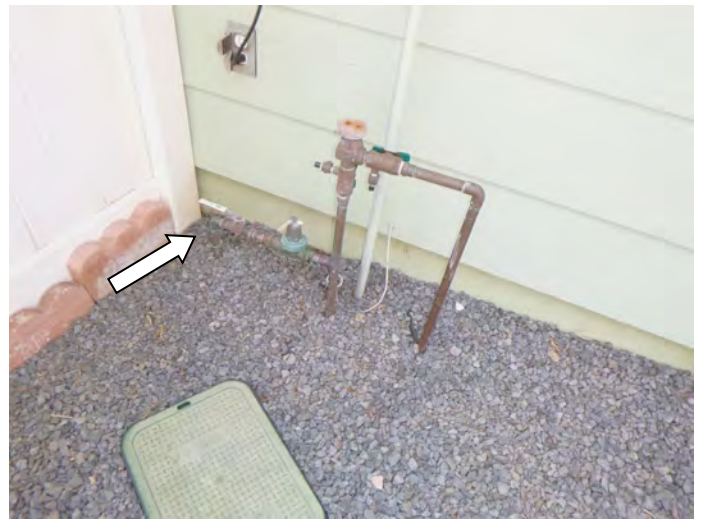
Comments: The overall condition of the shutoff valves was noted to be fair with typical wear and corrosion noted.

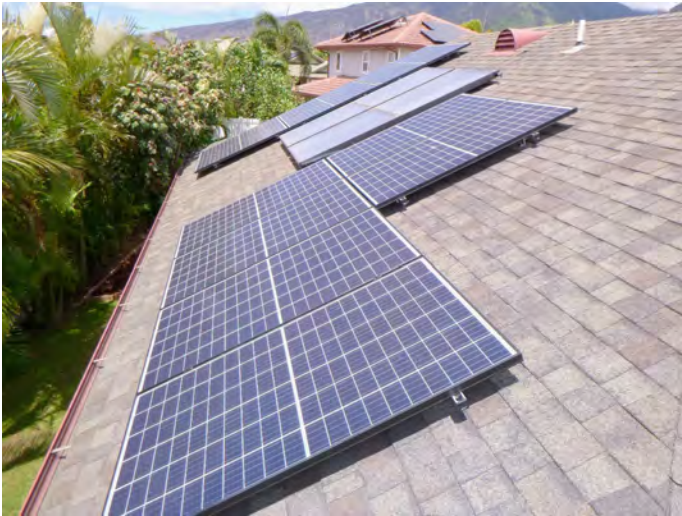
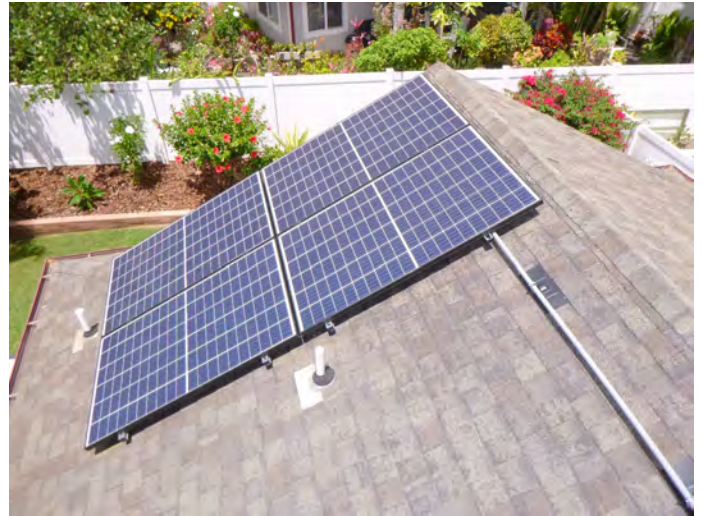
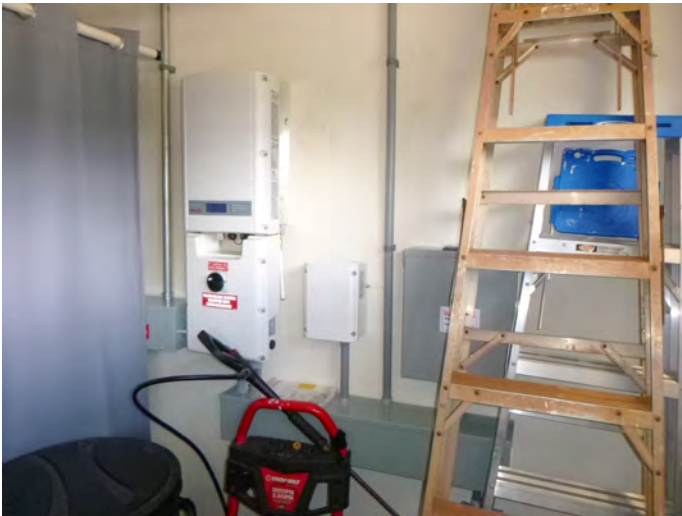
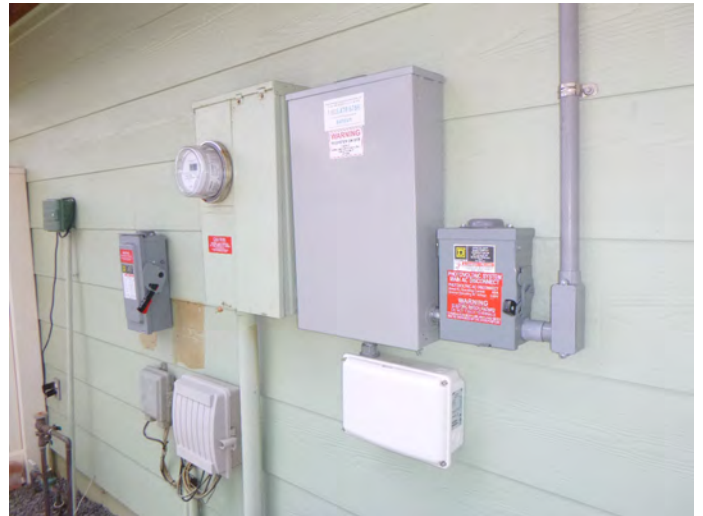
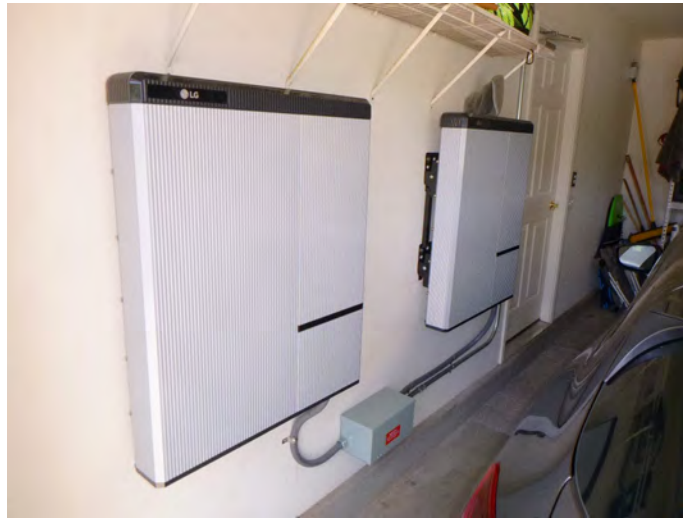
Comments: The overall condition of the photovoltaic solar power system was noted to be good.

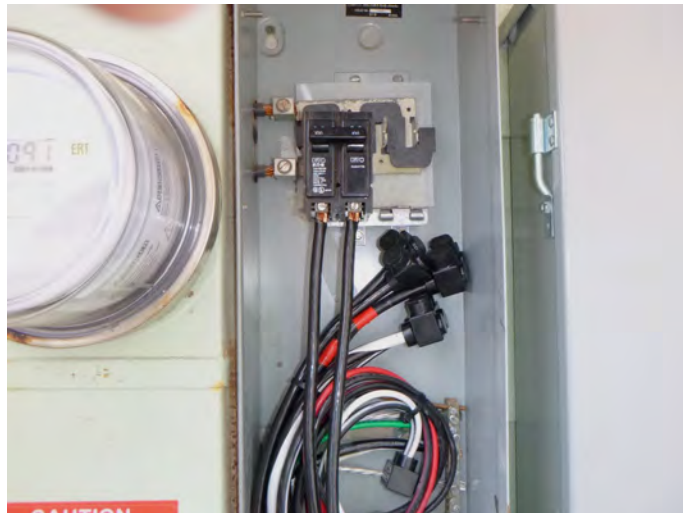
Comments: The overall condition of the main panel was noted to be good with typical wear and corrosion noted.

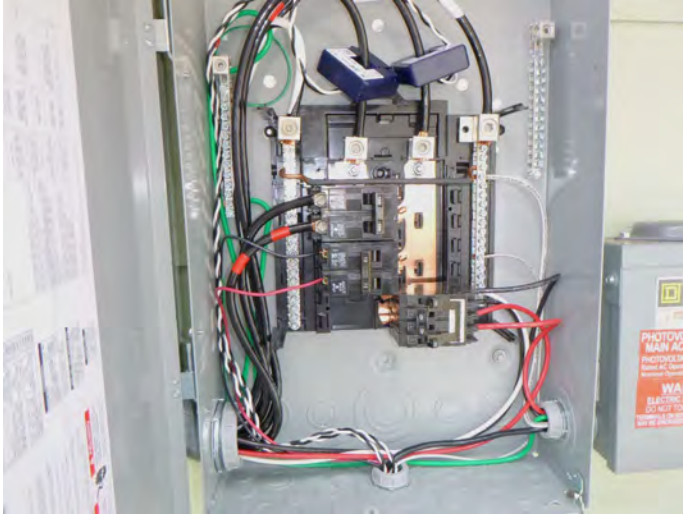
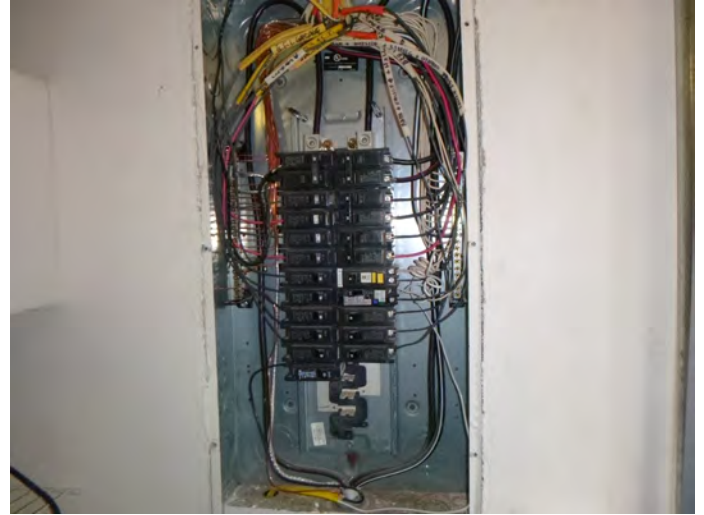
Sub-panels B and C

Comments: AFCI (Arc Fault Circuit Interrupter) protected circuits were noted at the bedroom outlets. AFCI's are a relatively new safety feature for residential construction that protects the bedrooms of a home from defective wiring or appliances by shutting off the circuit when a defect is noted. The overall condition of the sub-panels was noted to be good with typical wear noted, although:

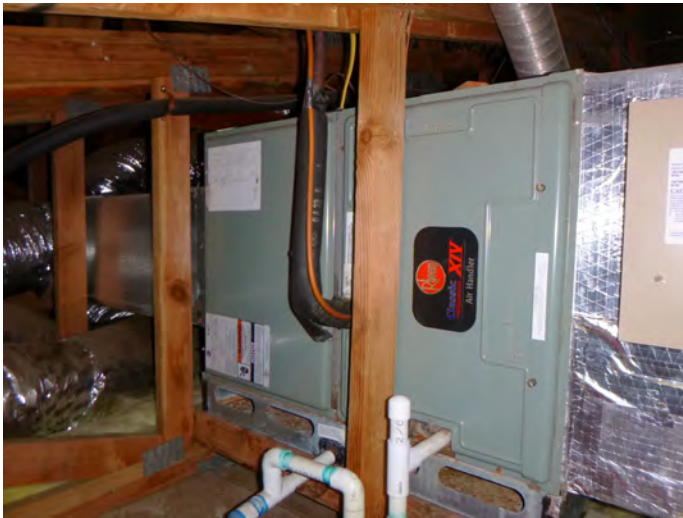
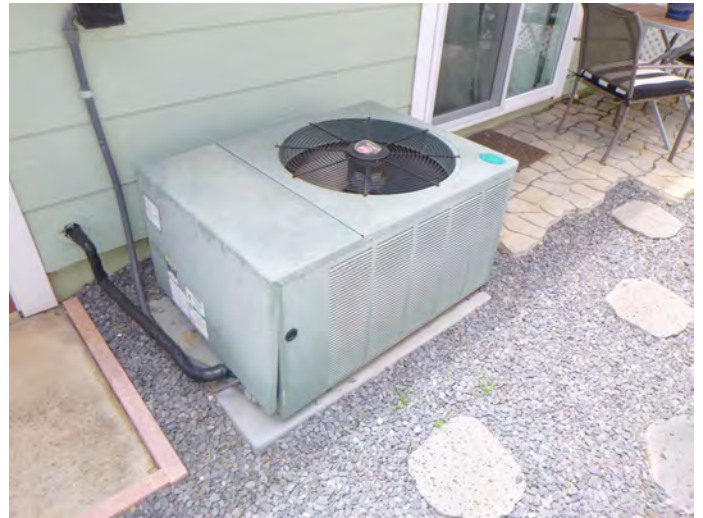
Comments: The system was operated and was noted to be functioning properly. The overall condition of the system was noted to be fair with typical wear and corrosion noted, although:

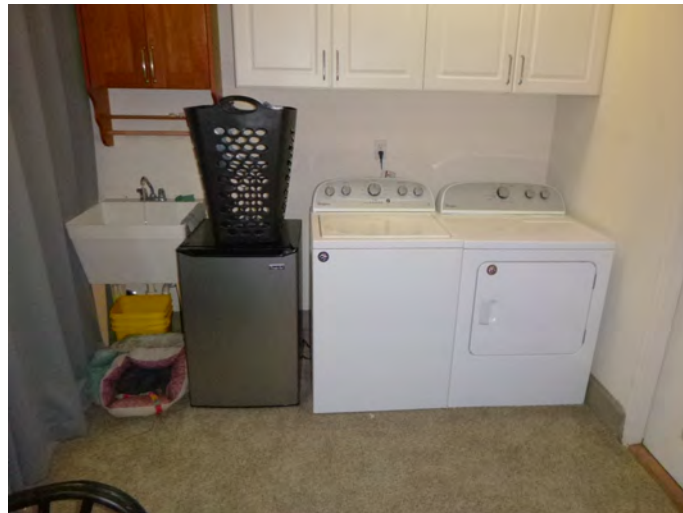
Comments: There is adequate water and waste piping, a sink, a 240 electrical outlet for an electric dryer and exterior dryer venting is provided. The washer and dryer were operated and were noted to be functional. The overall condition of the washer and dryer was noted to be good.

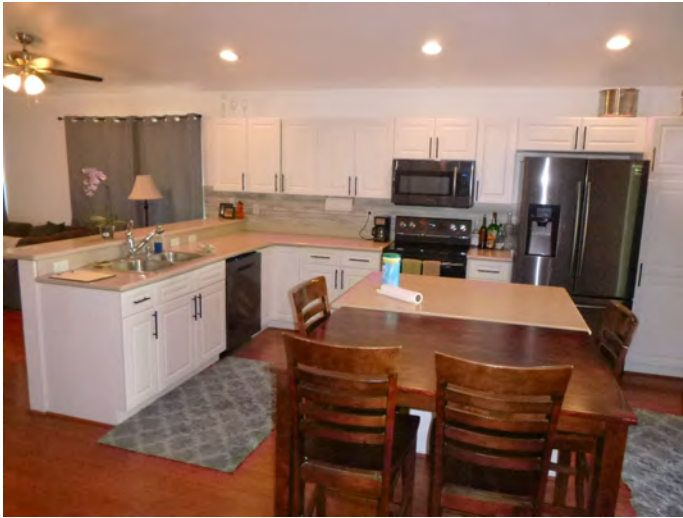
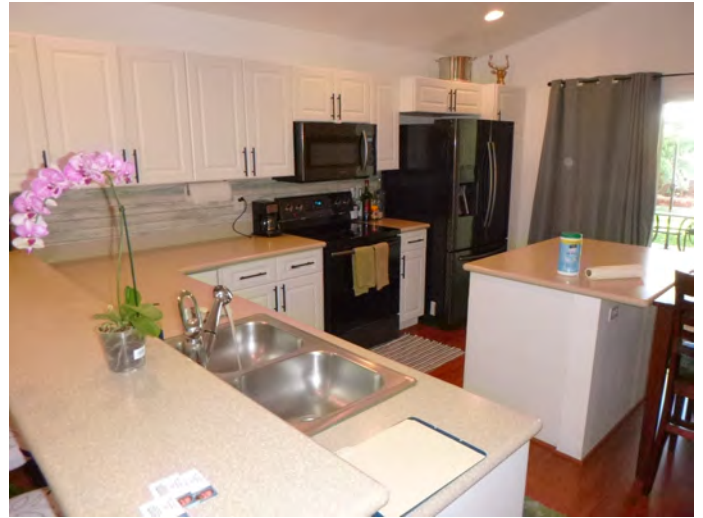
Comments: The overall condition of the kitchen was noted to be good.

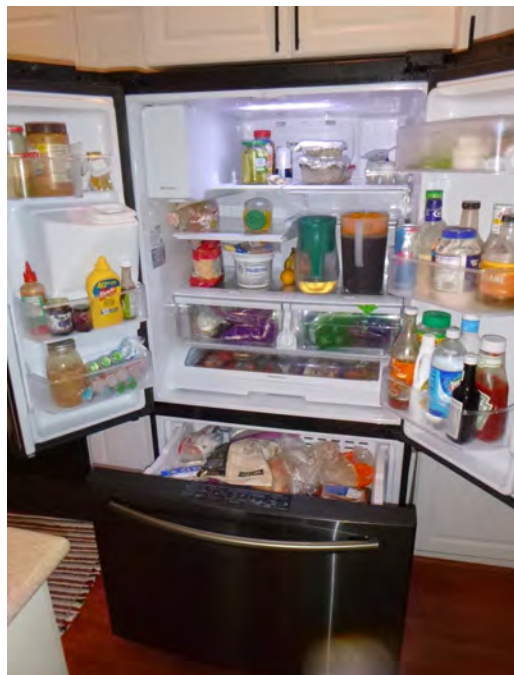
Comments: The unit was noted to be functional and the overall condition of the refrigerator was noted to be good.

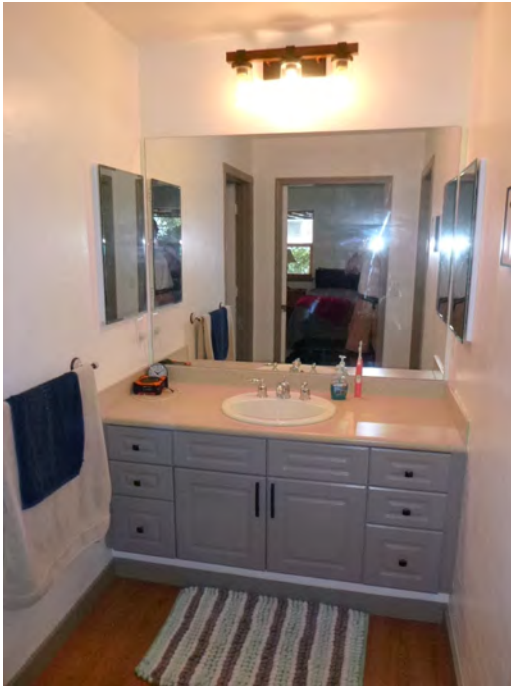
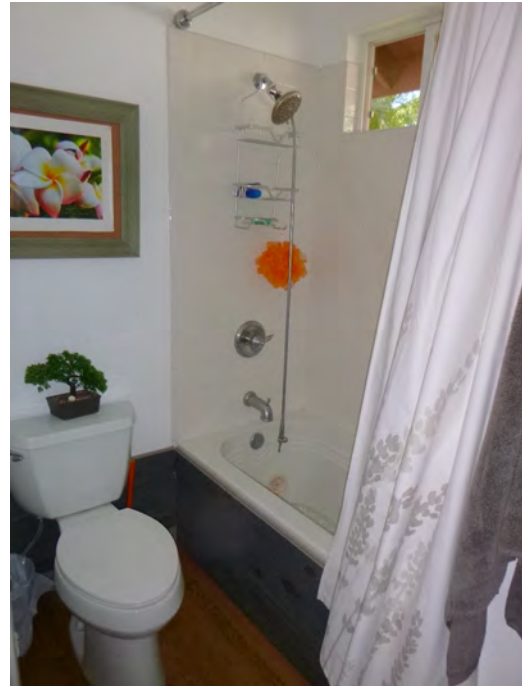
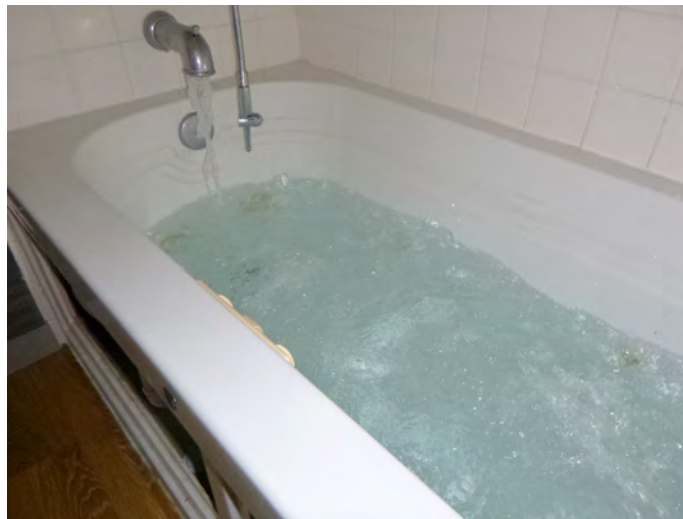
Comments: The hydro massage bathtub was operated and was noted to be functional. The overall condition of the bathroom was noted to be fair with typical wear noted, although:
