# Home Report

47 Dockhead Street  
Saltcoats  
KA21 5ED

# single survey

<b>Property address</b>	47 Dockhead Street Saltcoats KA21 5ED
-------------------------	---

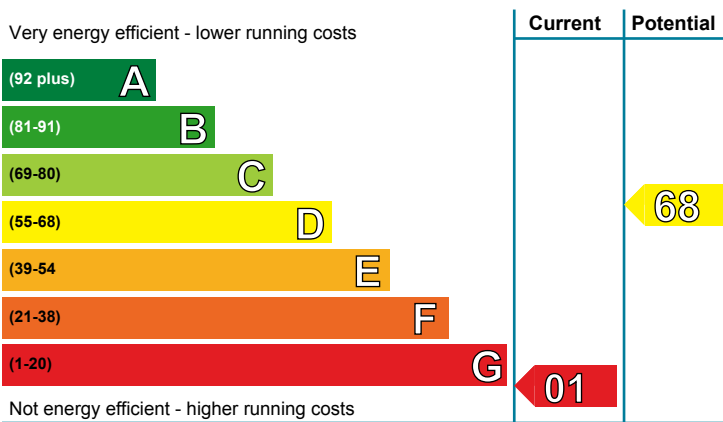
## Energy Efficiency Rating

This graph shows the current efficiency of your home, taking into account both energy efficiency and fuel costs. The higher this rating, the lower your fuel bills are likely to be.

Your current rating is **band G (1)**. The average rating for EPCs in Scotland is **band D (61)**.

The potential rating shows the effect of undertaking all of the improvement measures listed within your recommendations report.
